**SGS MUSCOWPETUNG**

**ABORIGINAL CONSTRUCTION MONITORING**

**WEEKLY REPORT**

**SPREAD 3**

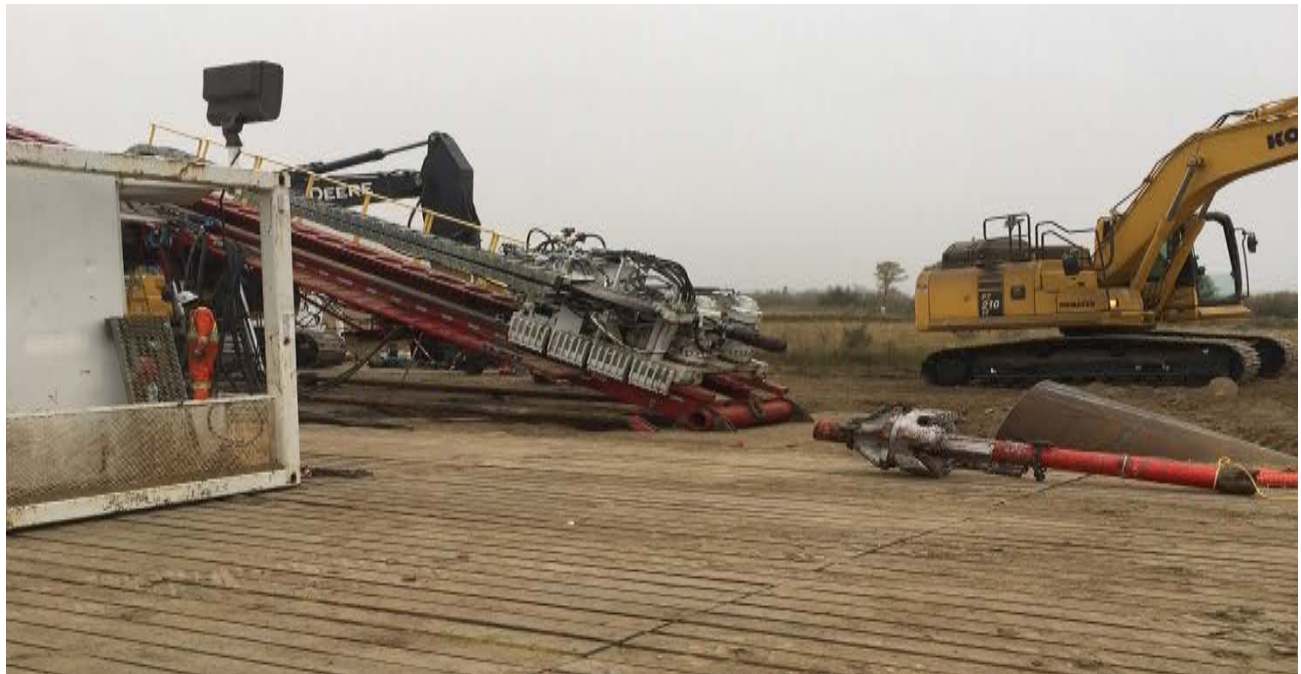
(drilling equipment North Saskatchewan River)

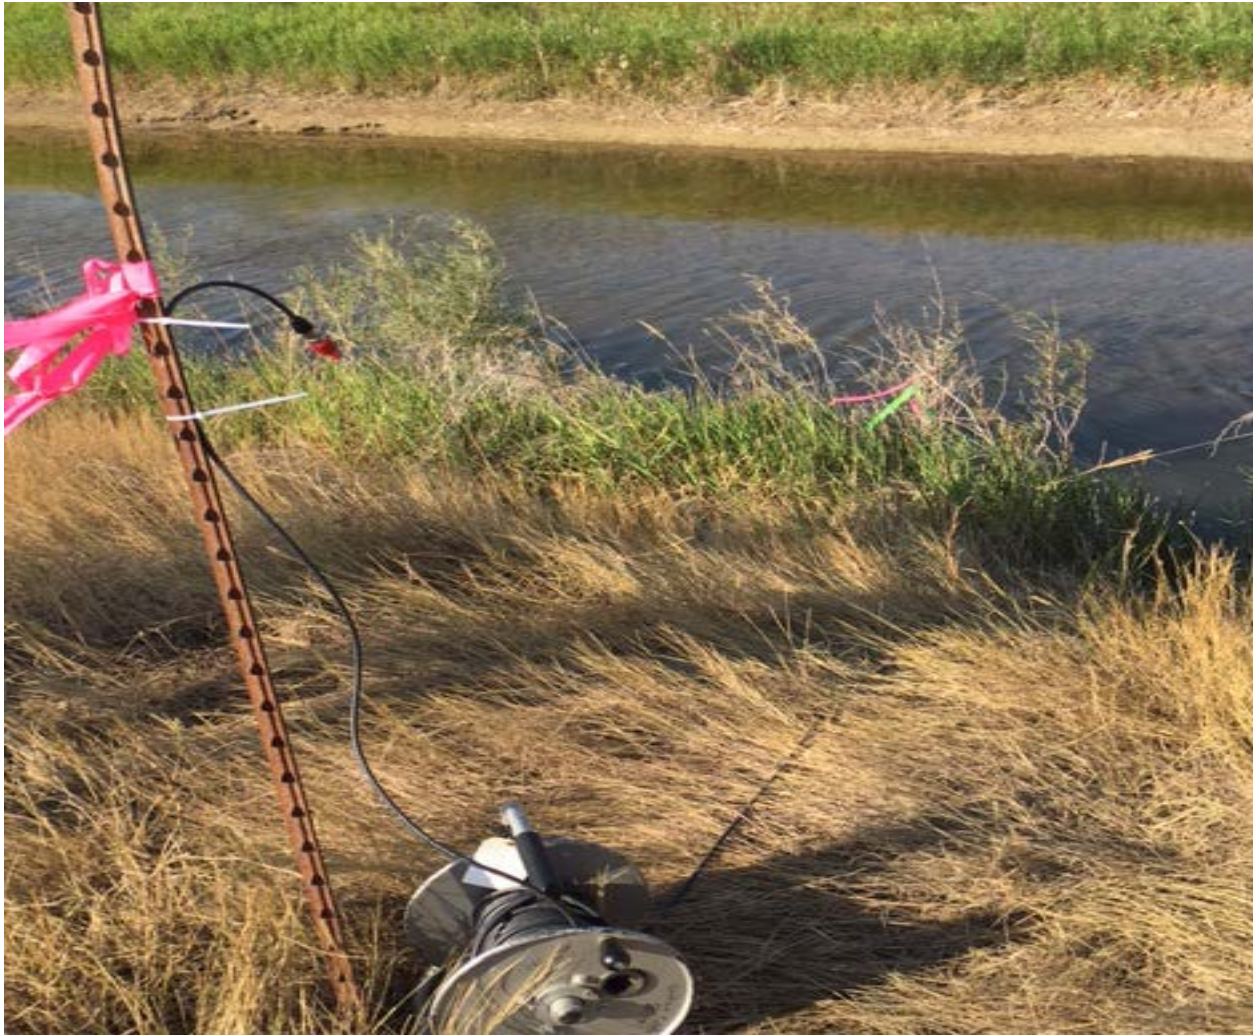
(GPS equipment used for monitoring water at the canal)

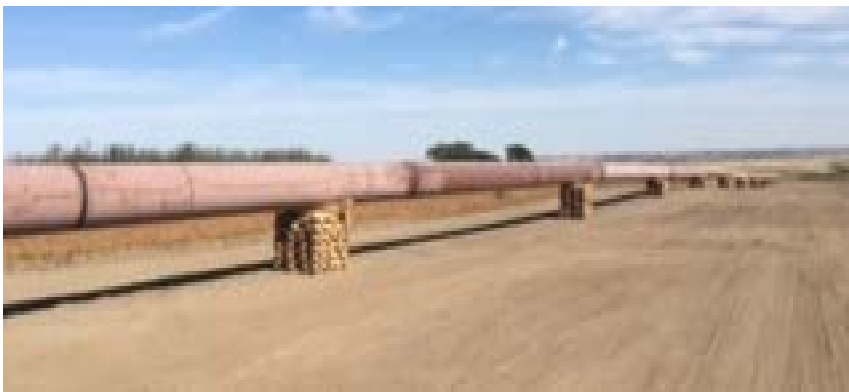
(Pipe strung up, welded and waiting to be pulled under canal when drilling is finished)
