SGS MUSCOWPETUNG

ABORIGINAL CONSTRUCTION MONITORING

WEEKLY REPORT

SPREAD 4

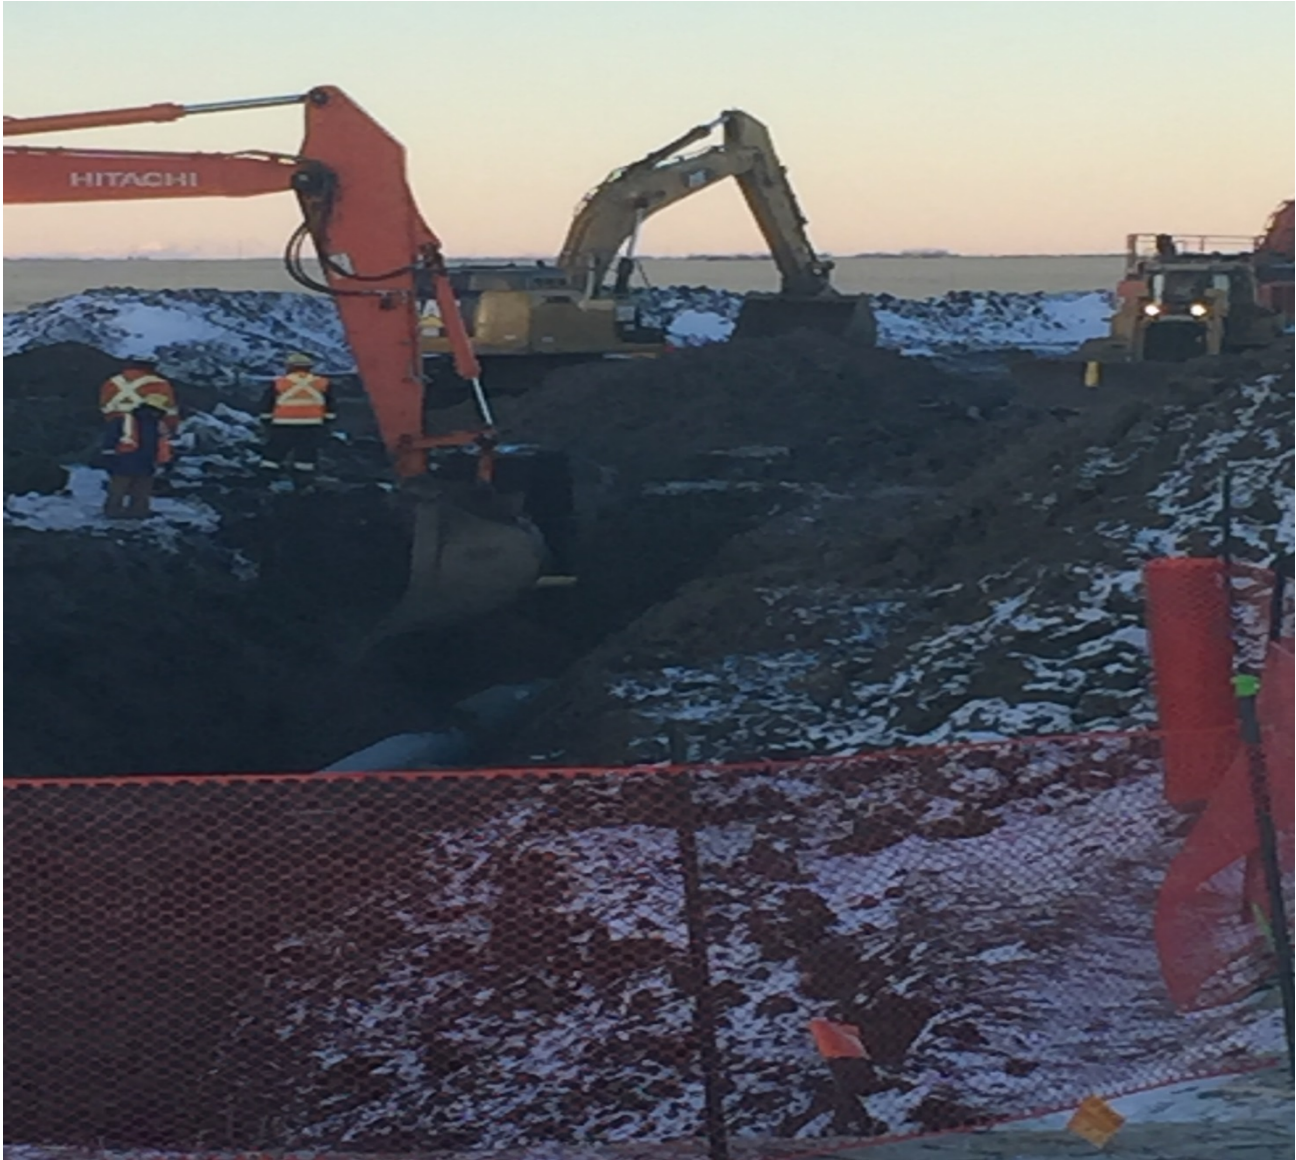
BACKFILLING PIPE AT ISKWAO CREEK

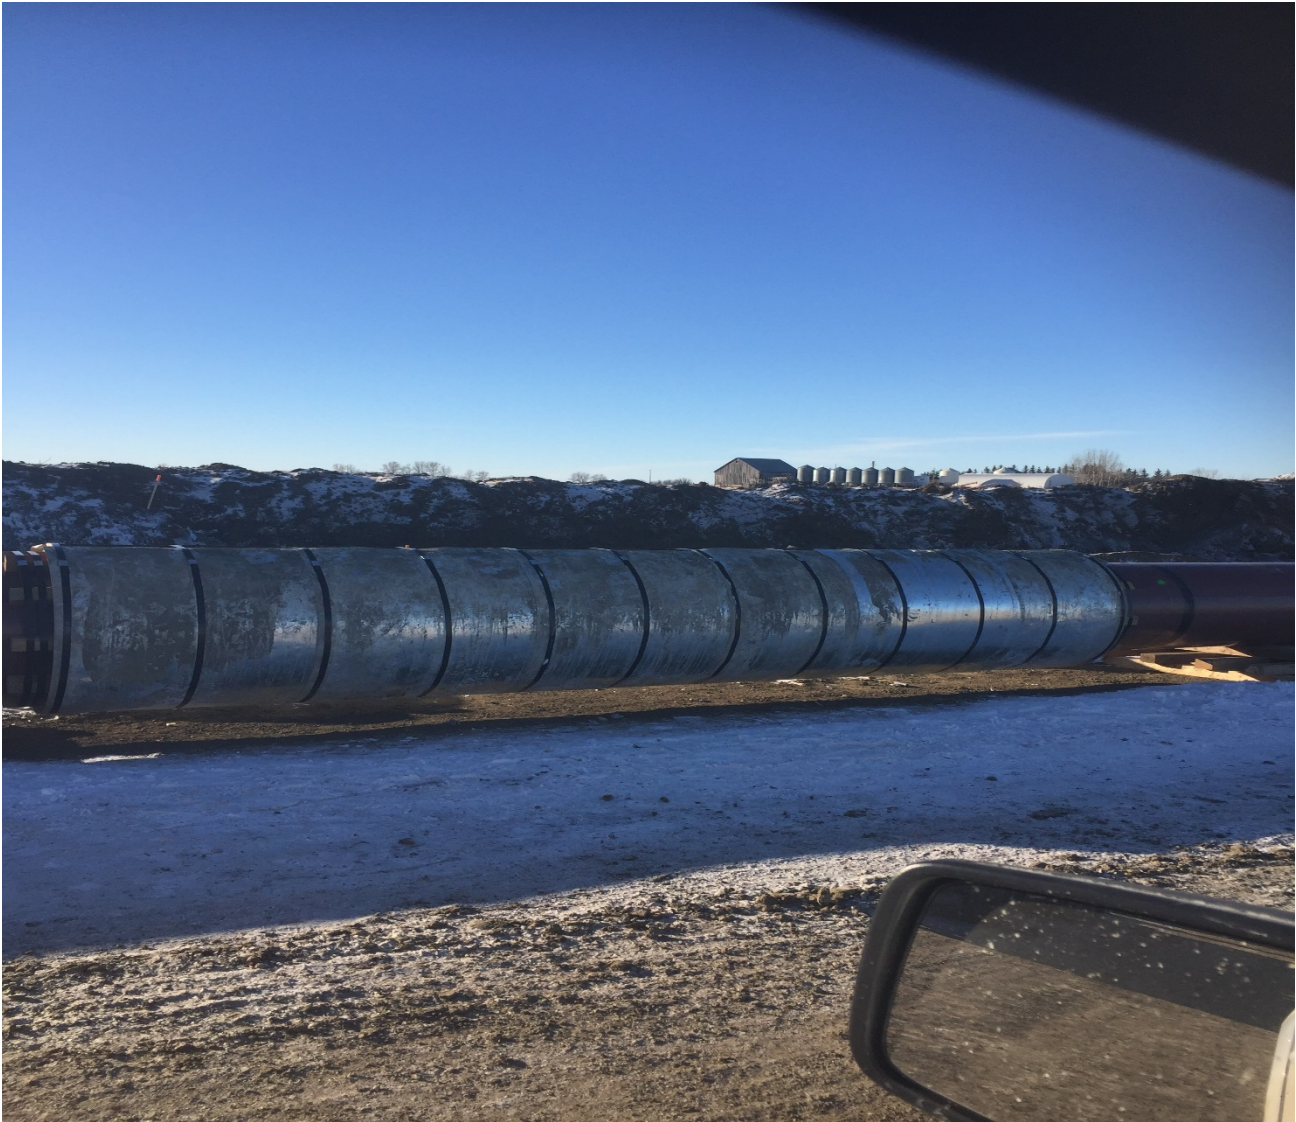
PIPE BEING PREPPED WITH CEMENT, TO BE LAID IN CREEK BED.

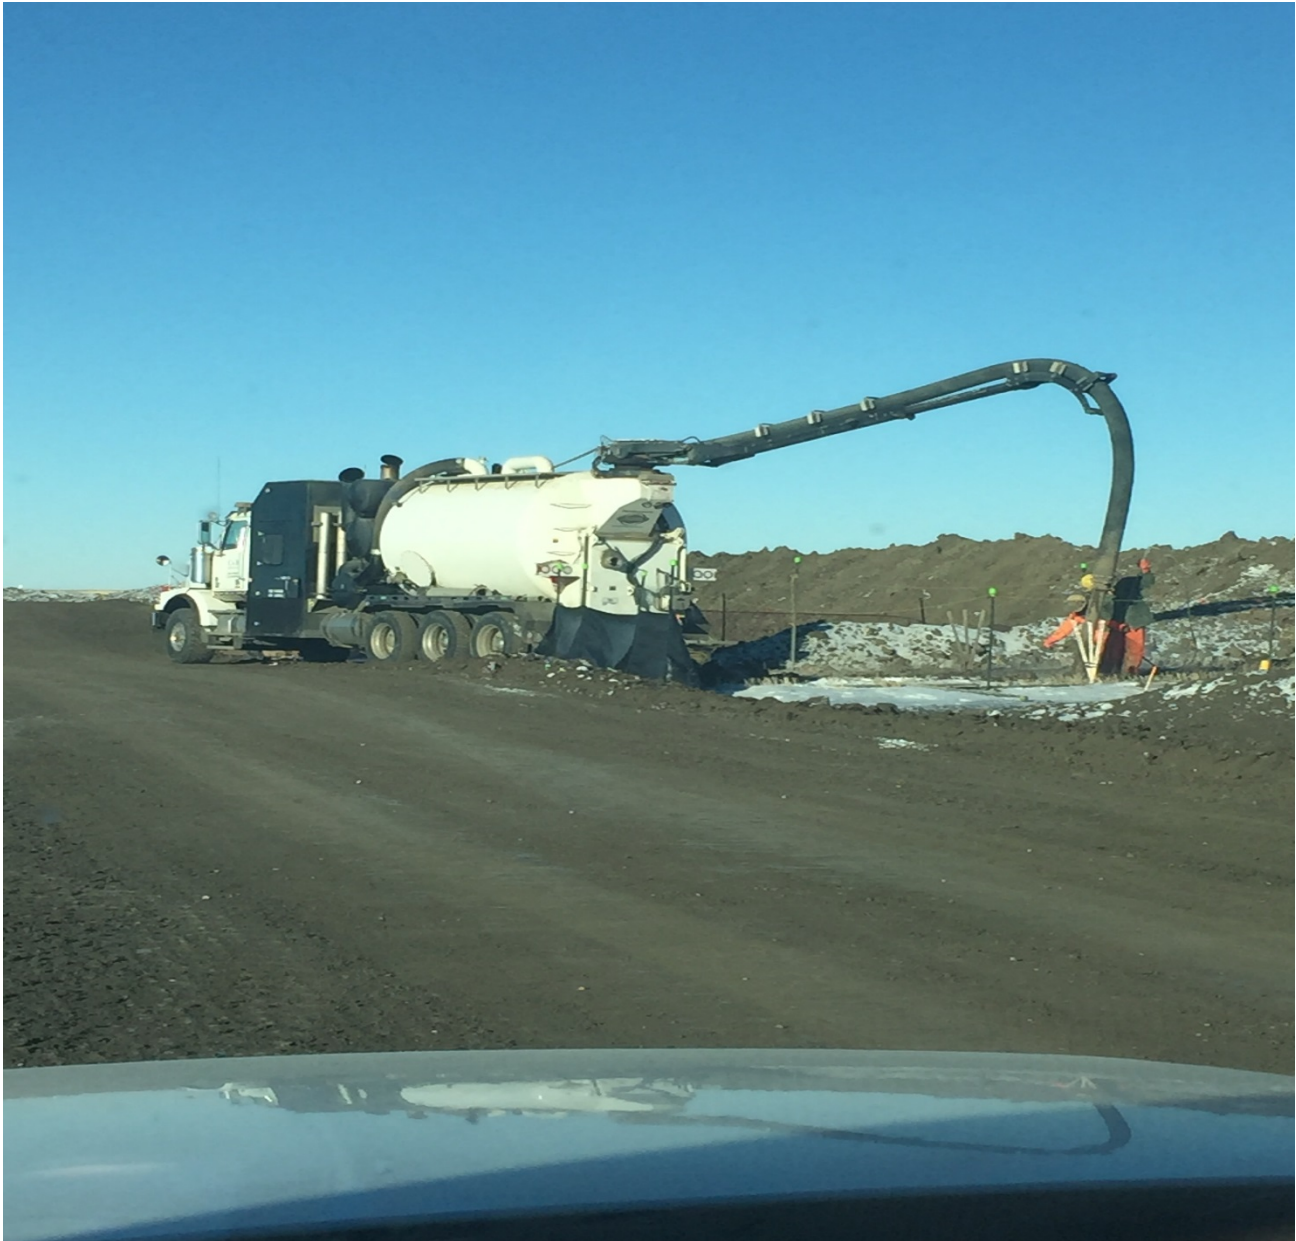
Hydrovac's locating existing lines before excavators come to trench.

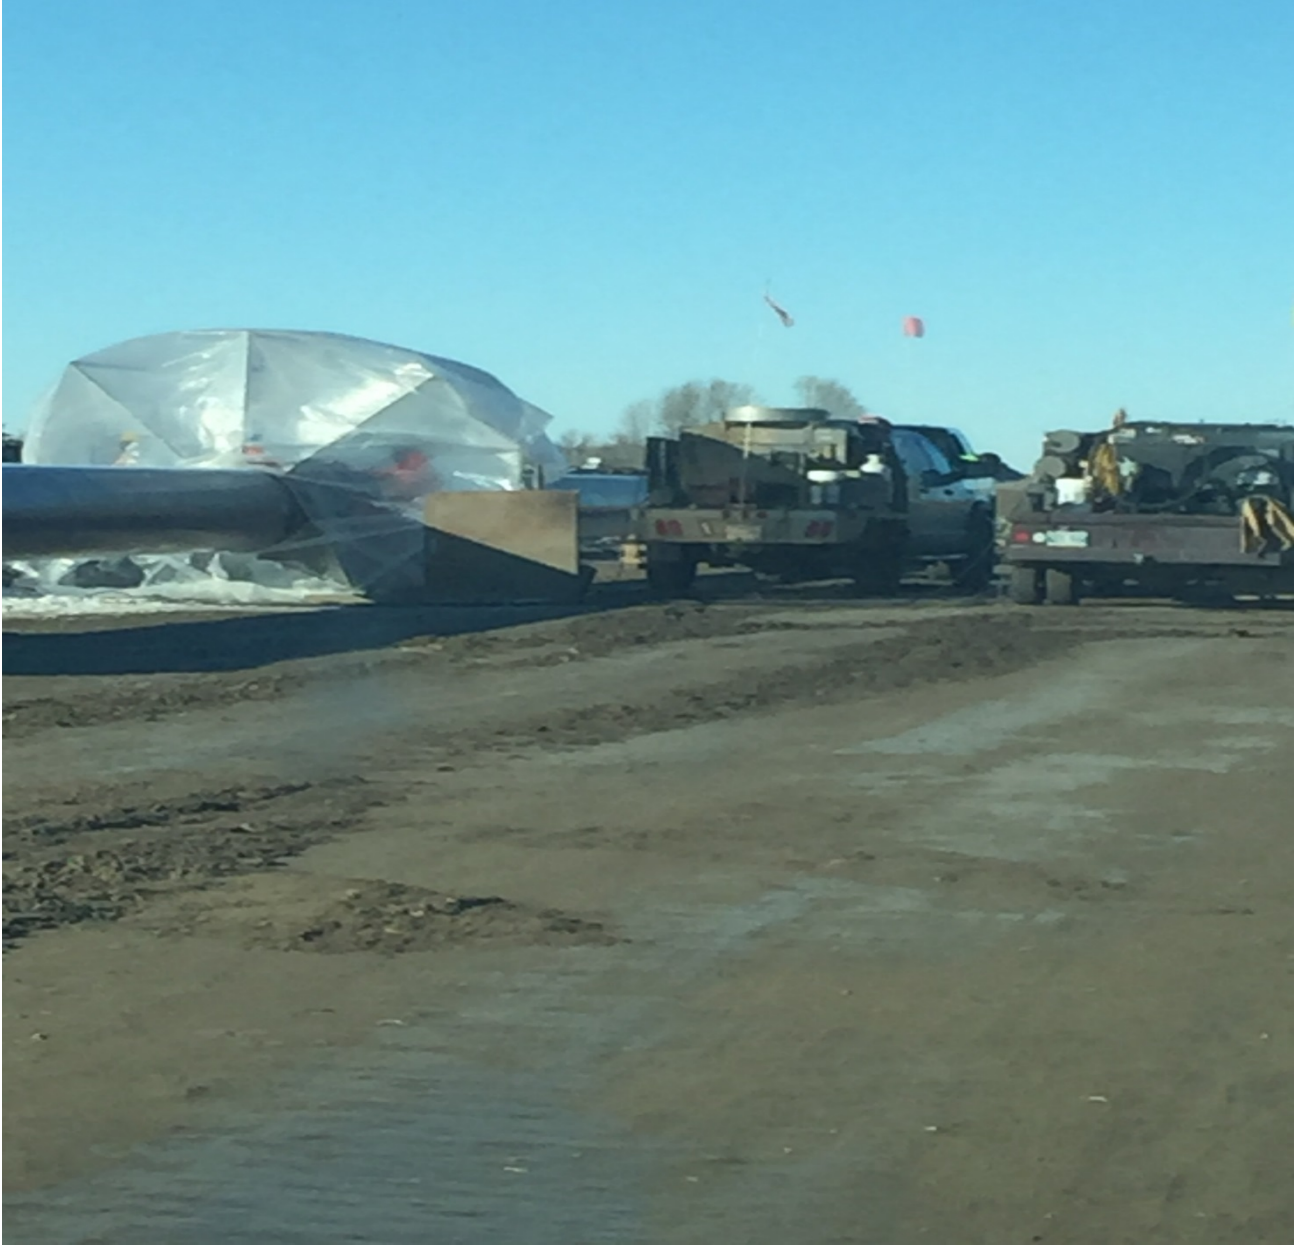
Welders working on pipe before tie-in crew arrives.
