SGS MUSCOWPETUNG

ABORIGINAL CONSTRUCTION MONITORING

WEEKLY REPORT

JANUARY 29TH TO FEBRUARY 4TH, 2018

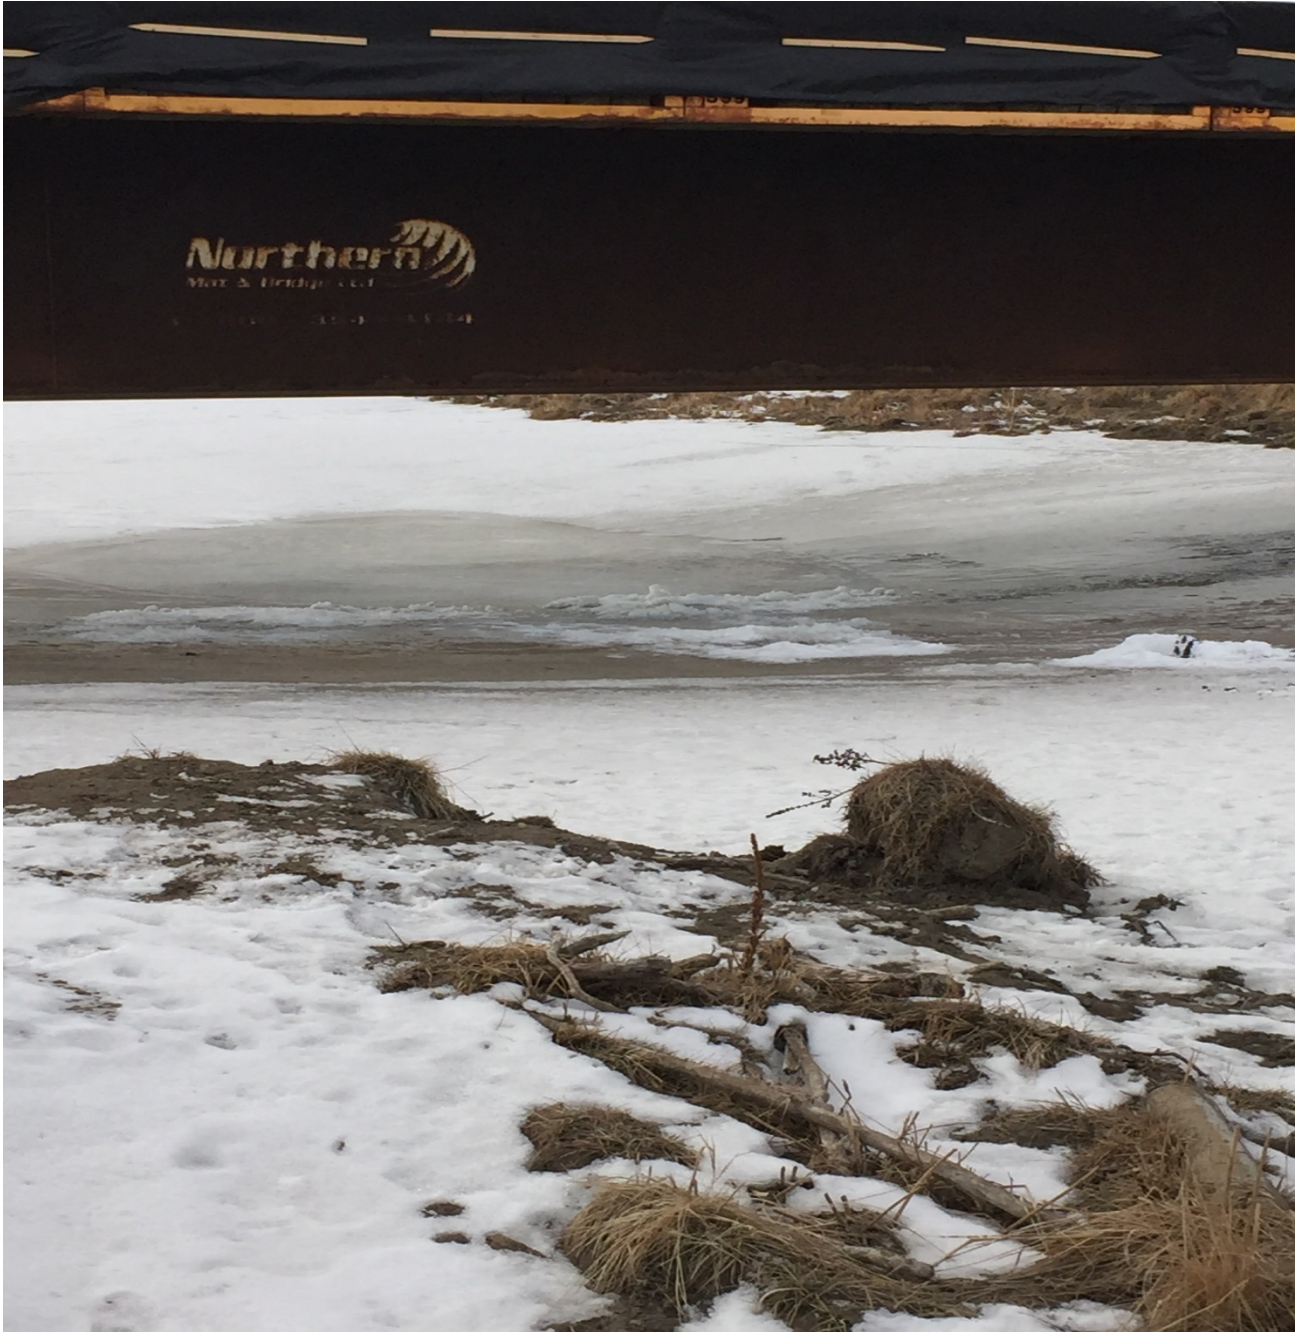
HIGH HILL CREEK WATERCOURSE

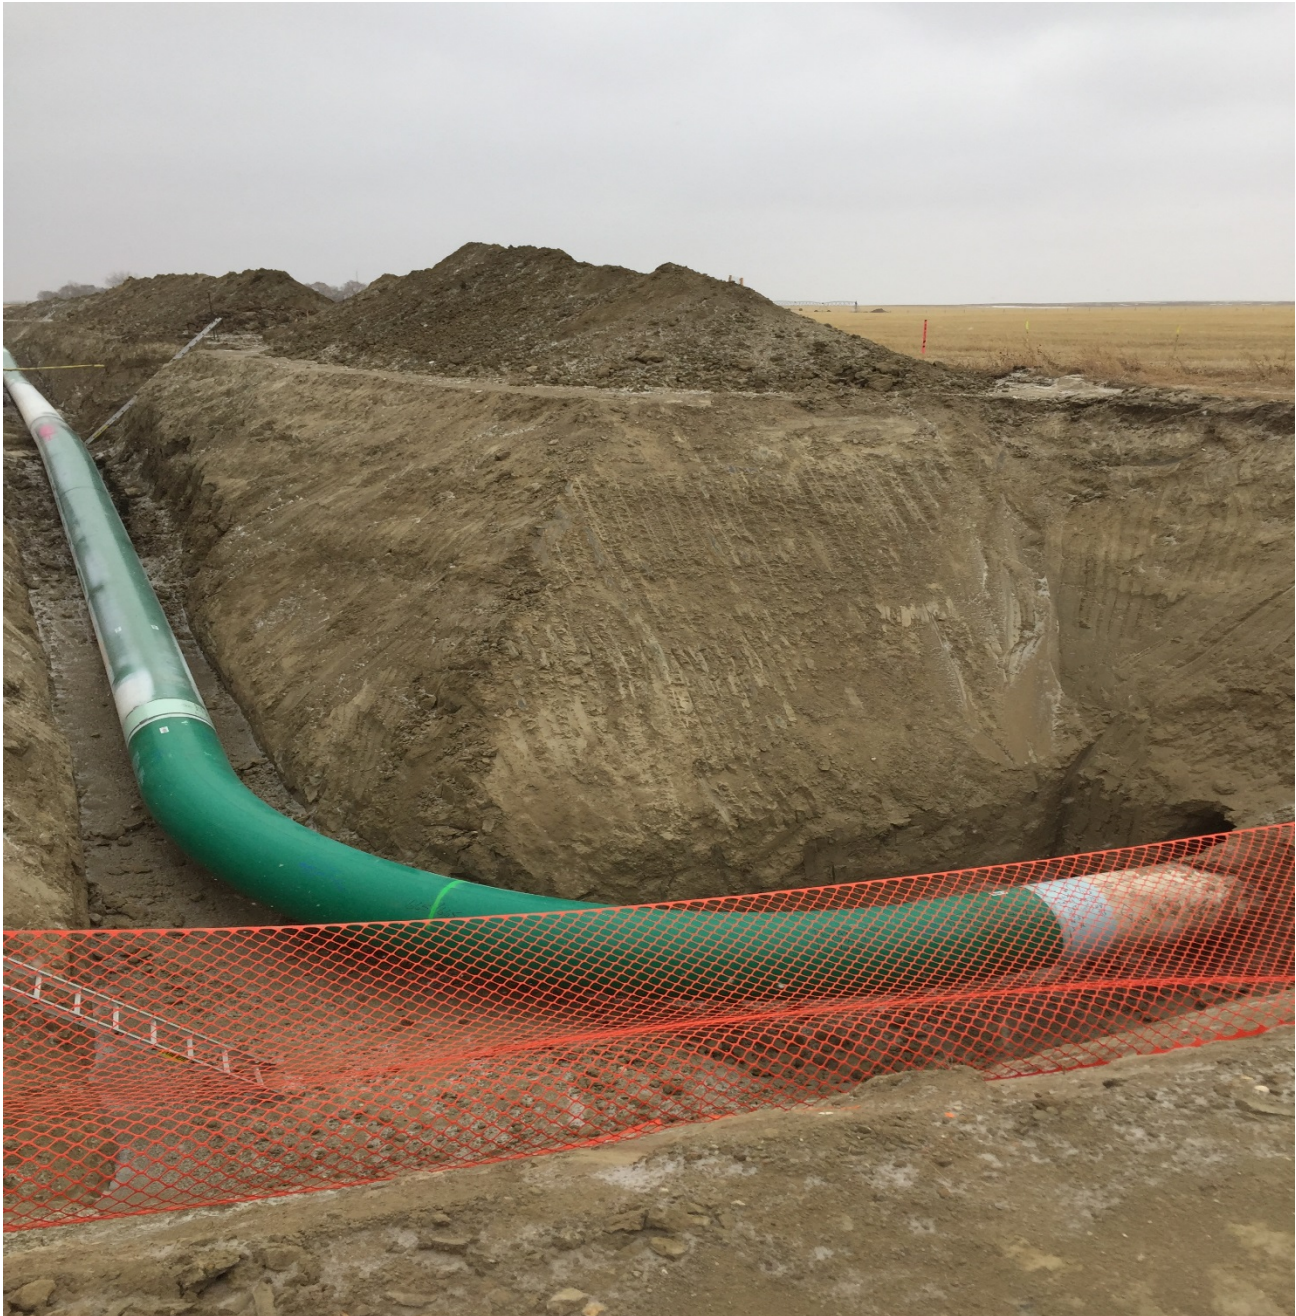
PIPE IN TRENCH WITH A HOT BEND IN IT

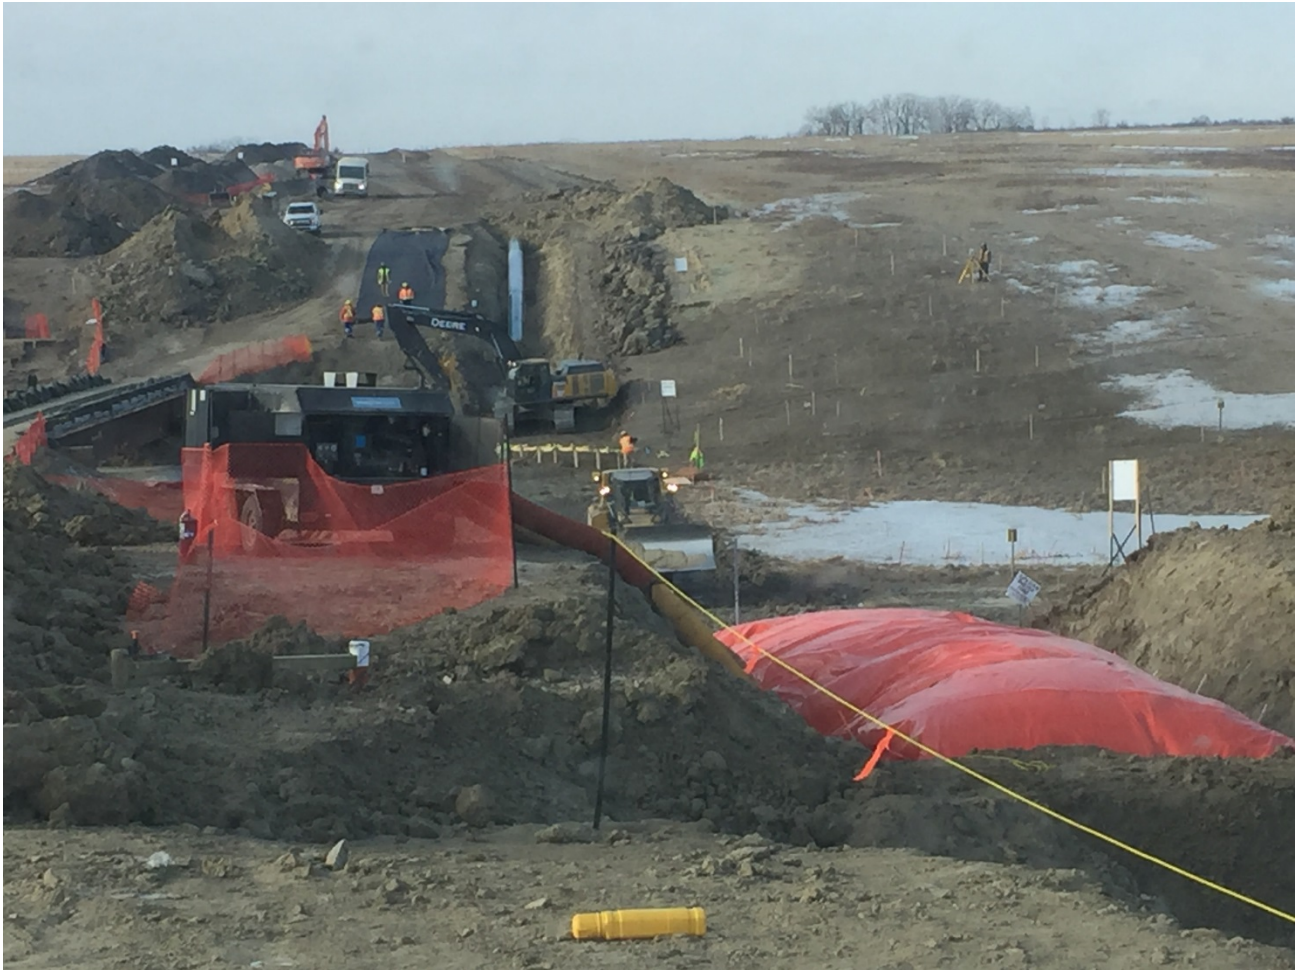
HIGH HILL CREEK WITH OPEN CUT THROUGH ROAD
(GENERATOR AND TARP ARE HELPING FILLCRETE SET)

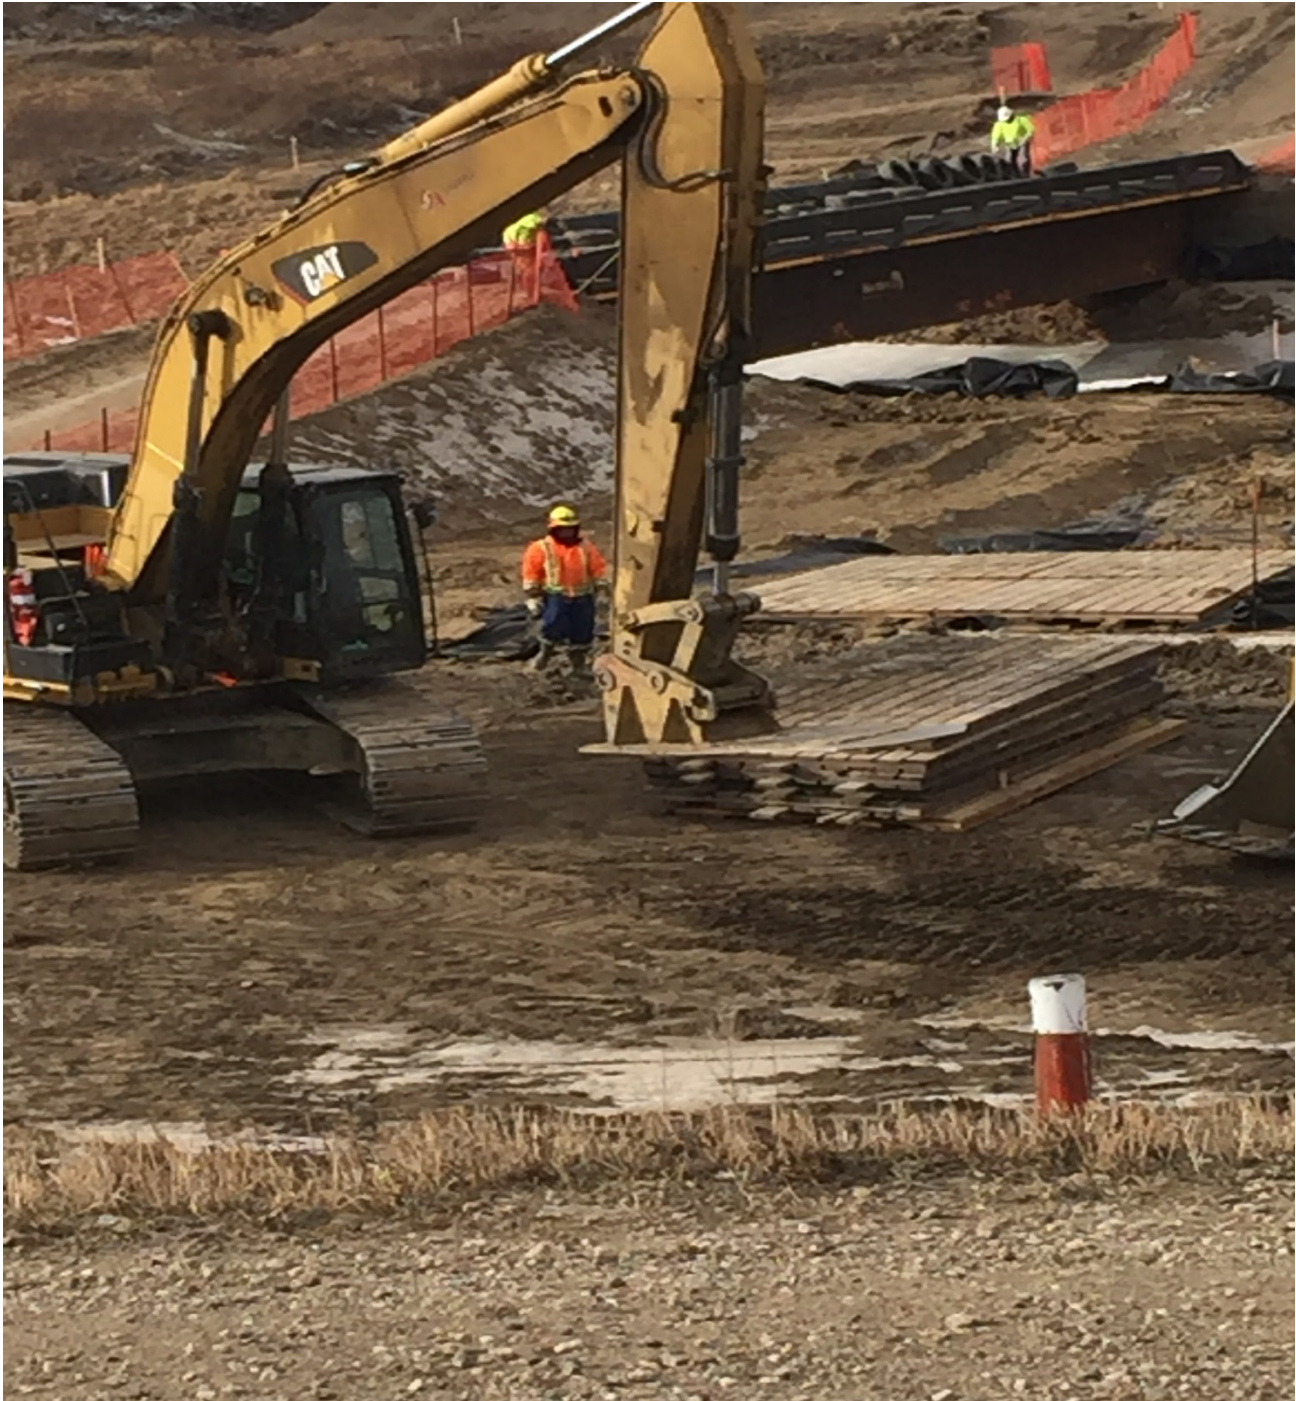
EXCAVATOR LAYING DOWN MATTING BY BRIDGE FOR WALKWAY

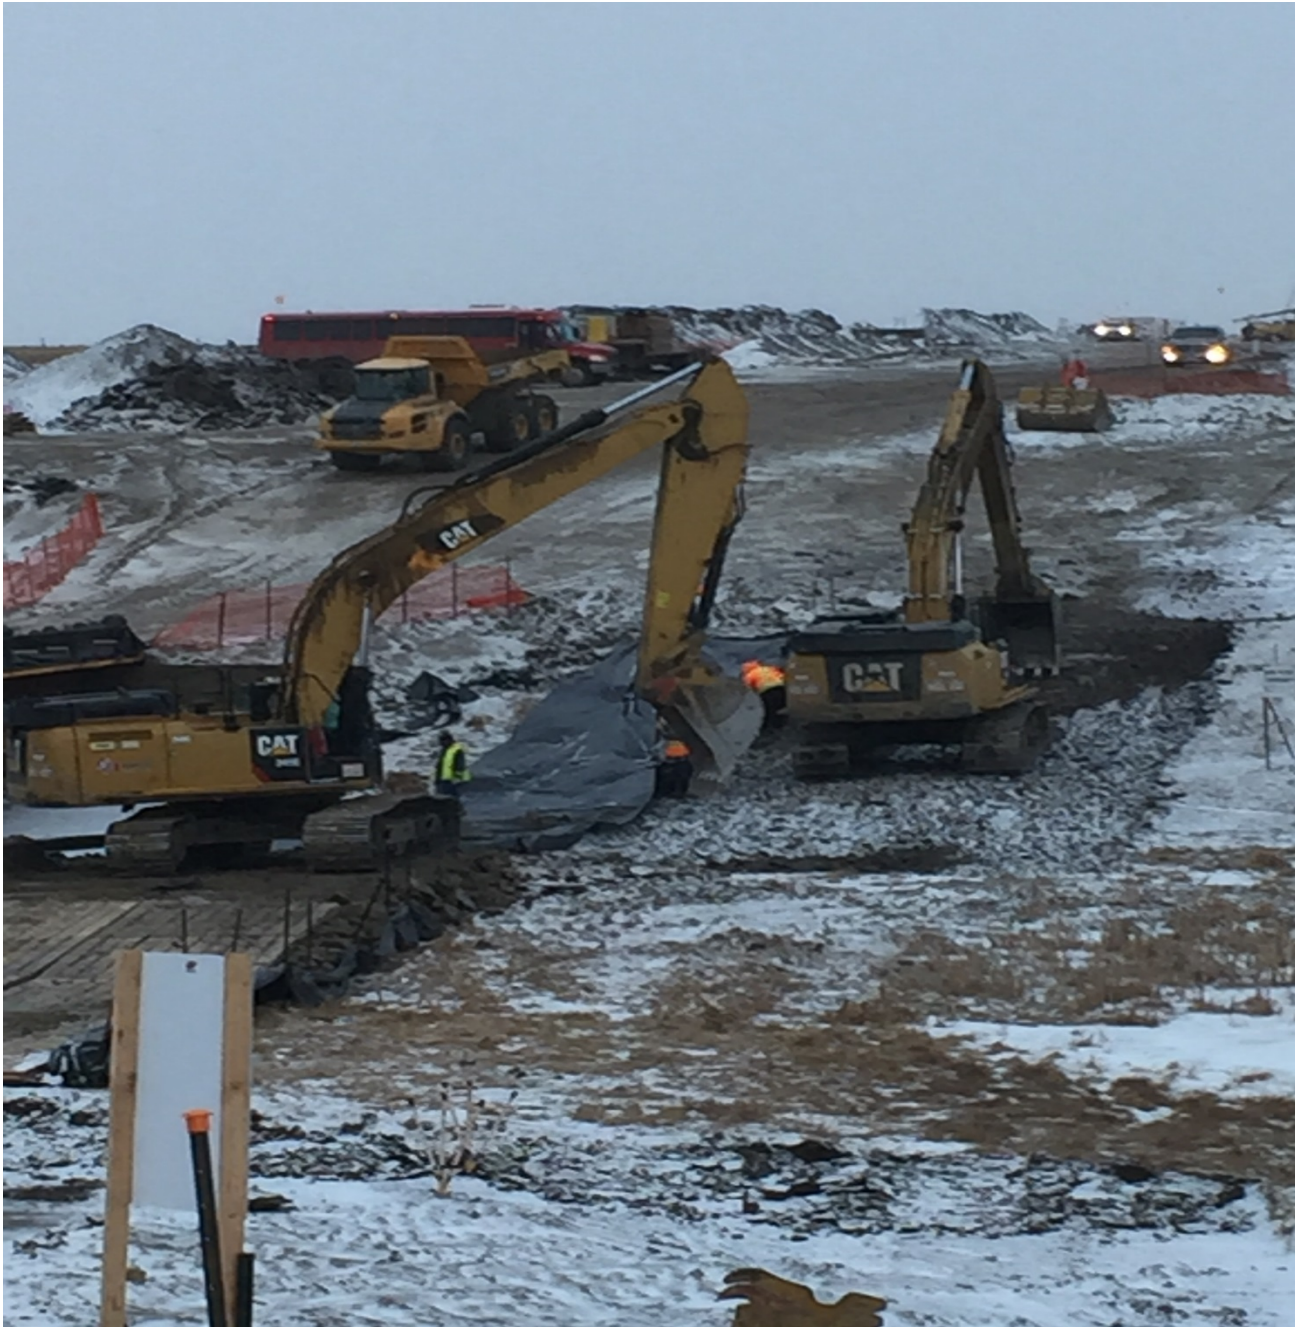
LAYING DOWN GEO TO PRESERVE GROUND WHEN FINISHED

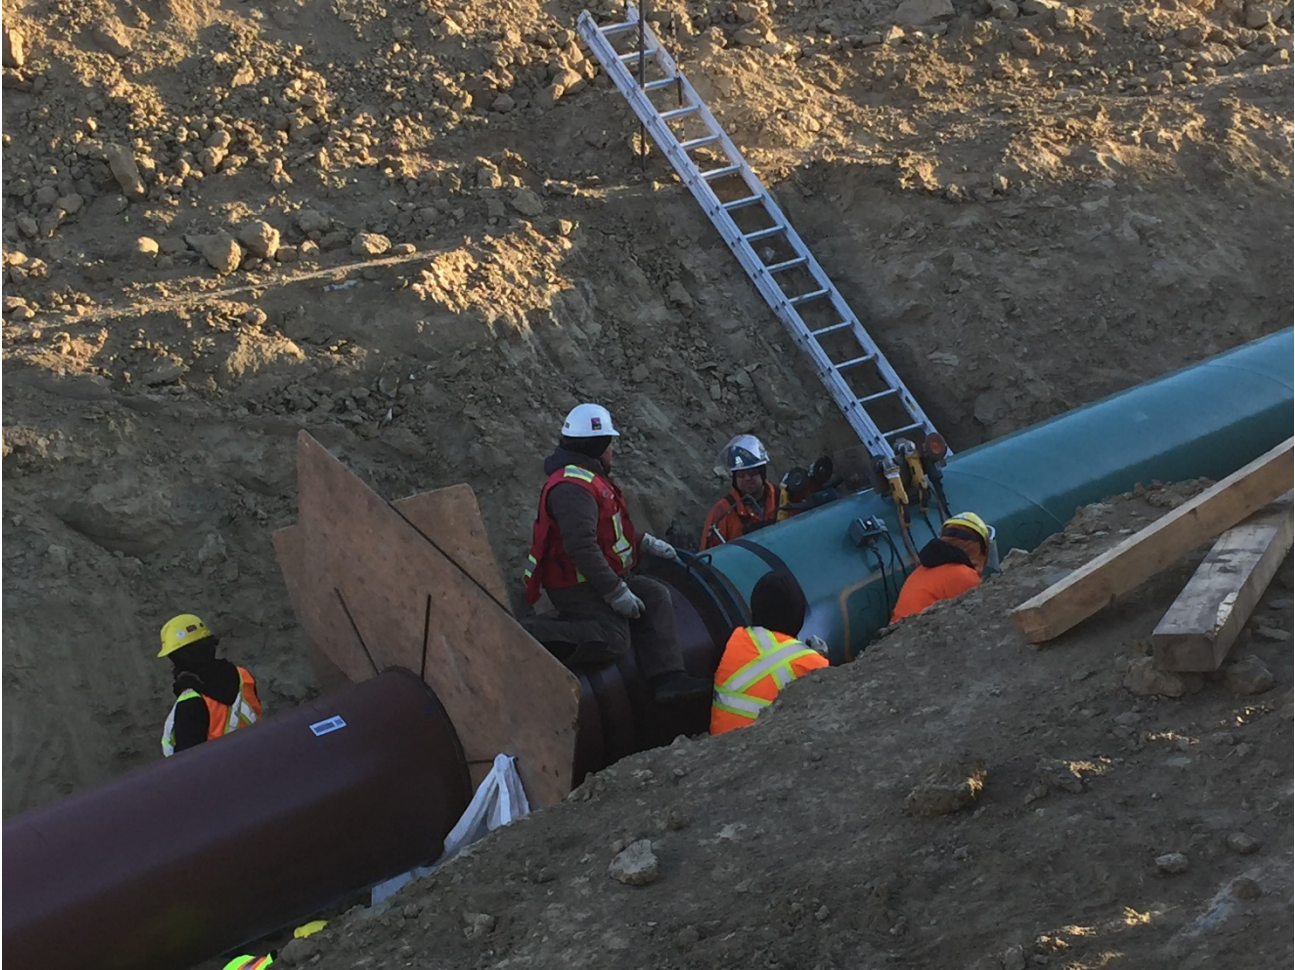
WELDING CREWS COMPLETING TIE-INS.

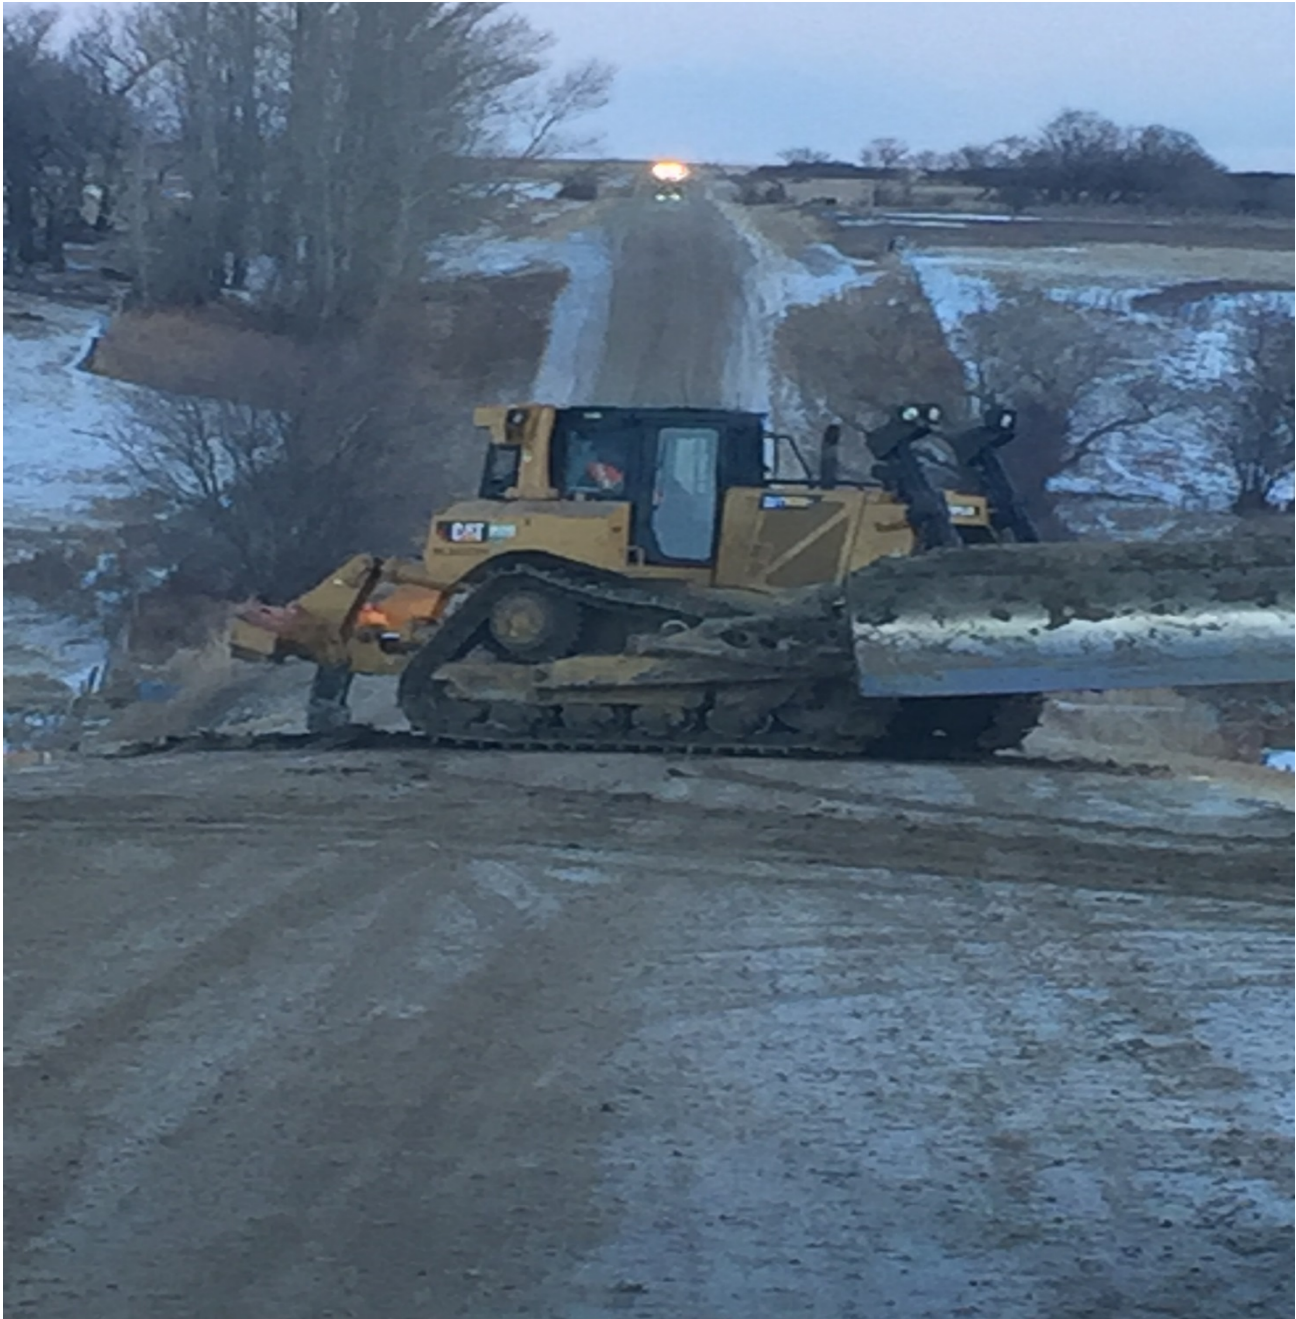
DOZERS RIPPING UP ROAD TO MAKE OPEN CUT.

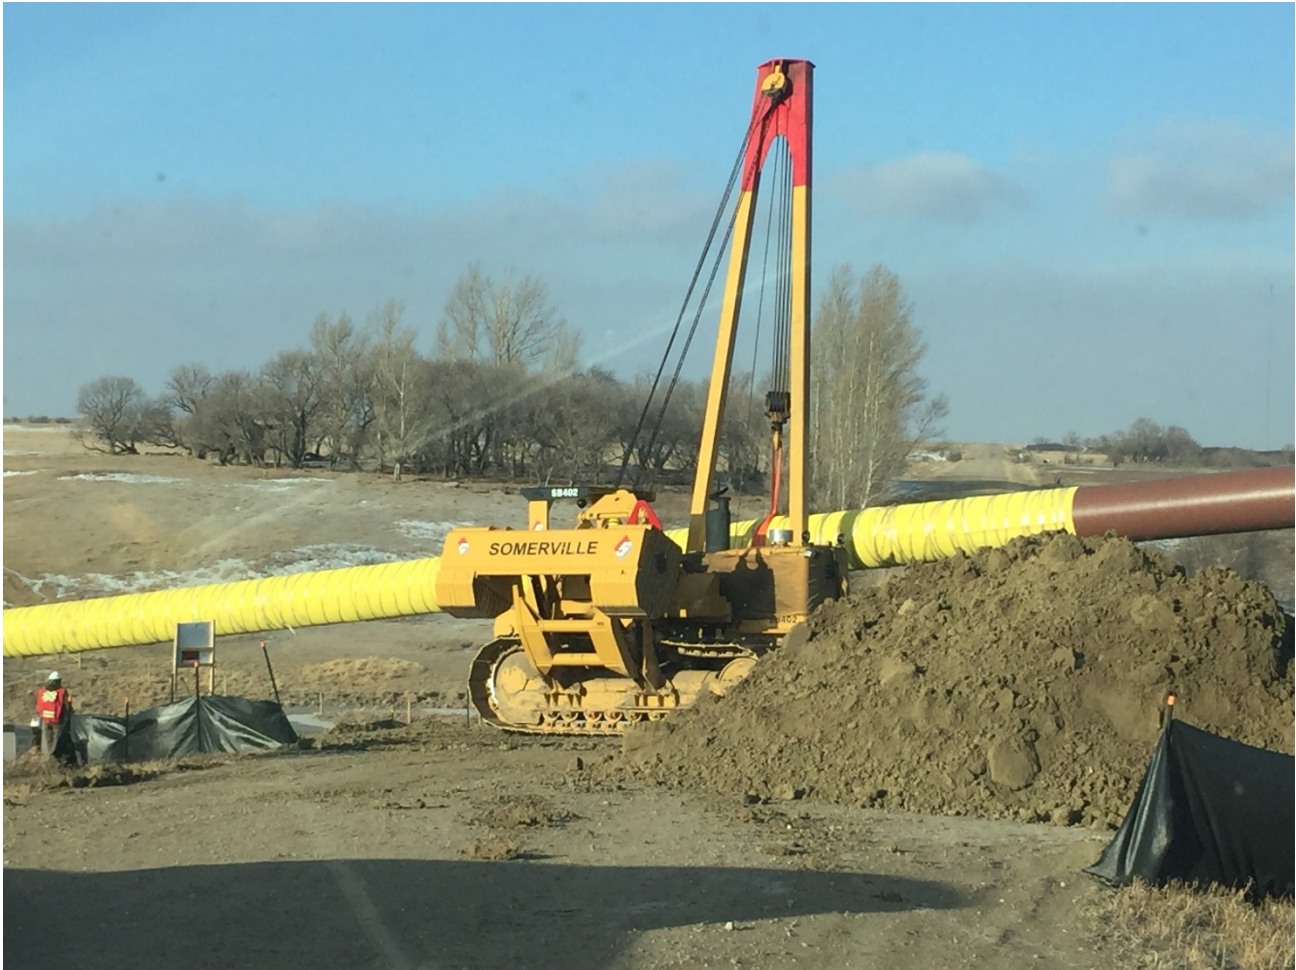
SIDE BOOMS LOWERING PIPE ACROSS ROADWAY.

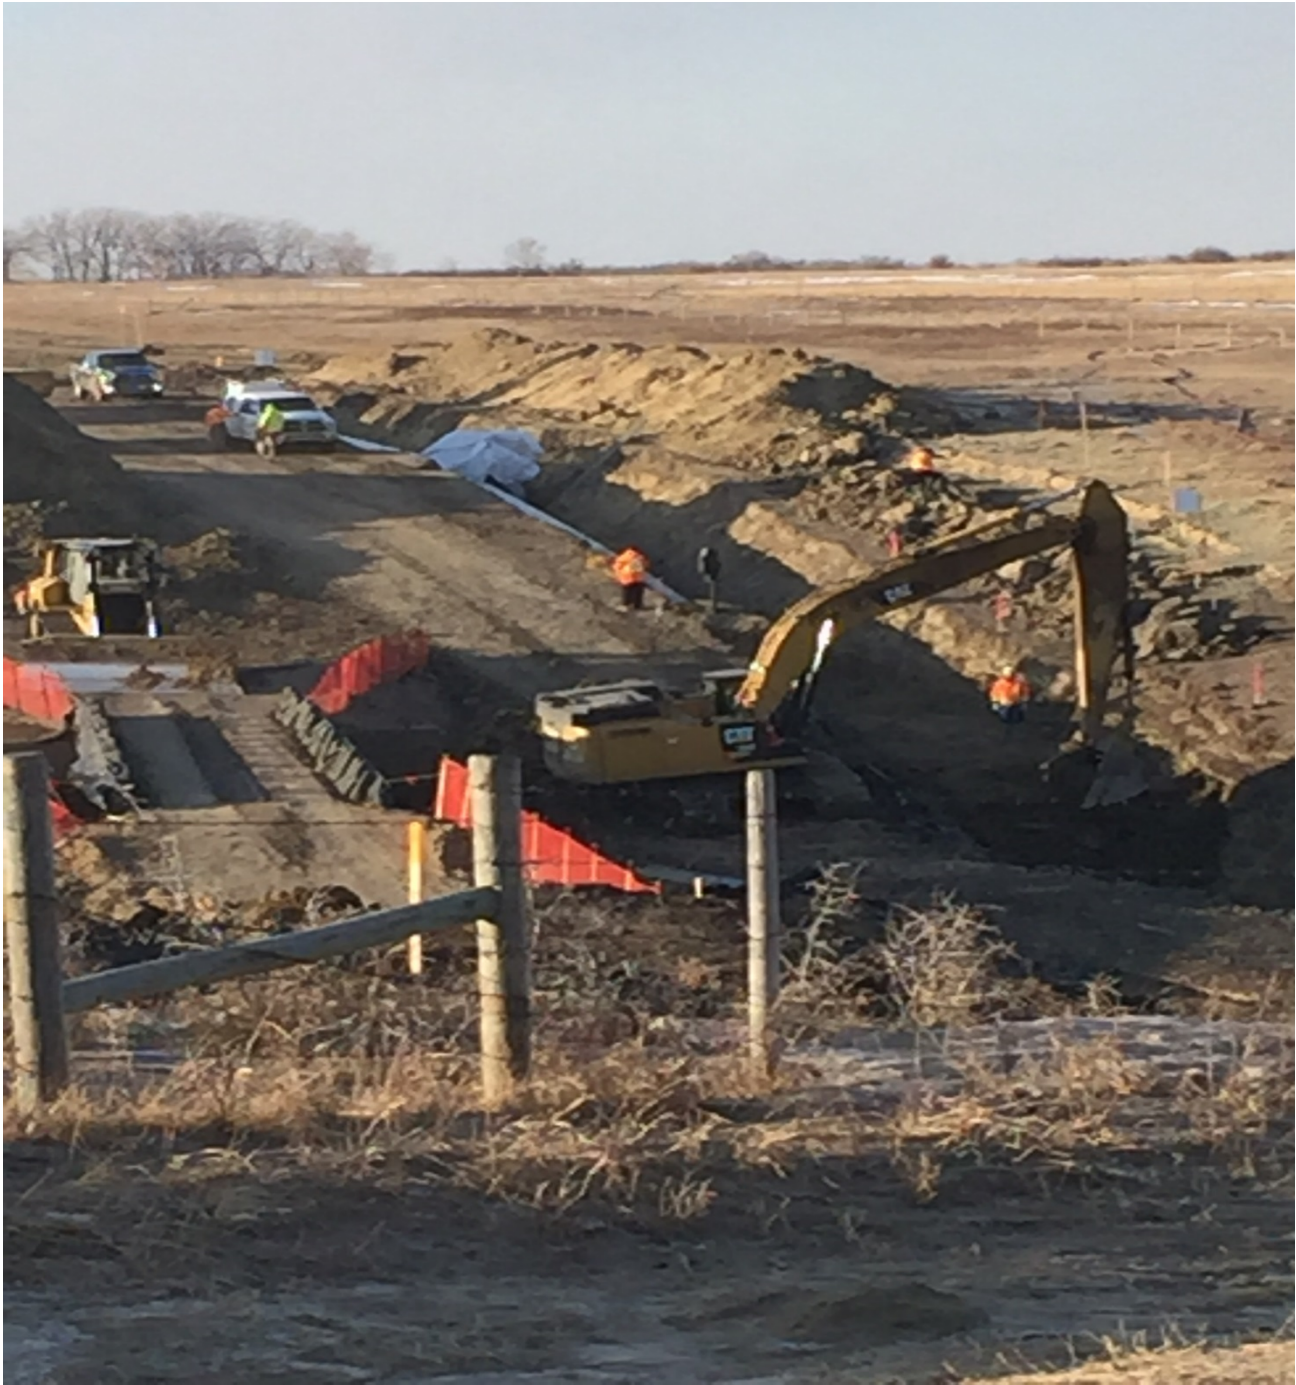
EXCAVATORS DIGGING TRENCH AT HIGH HILL CREEK.

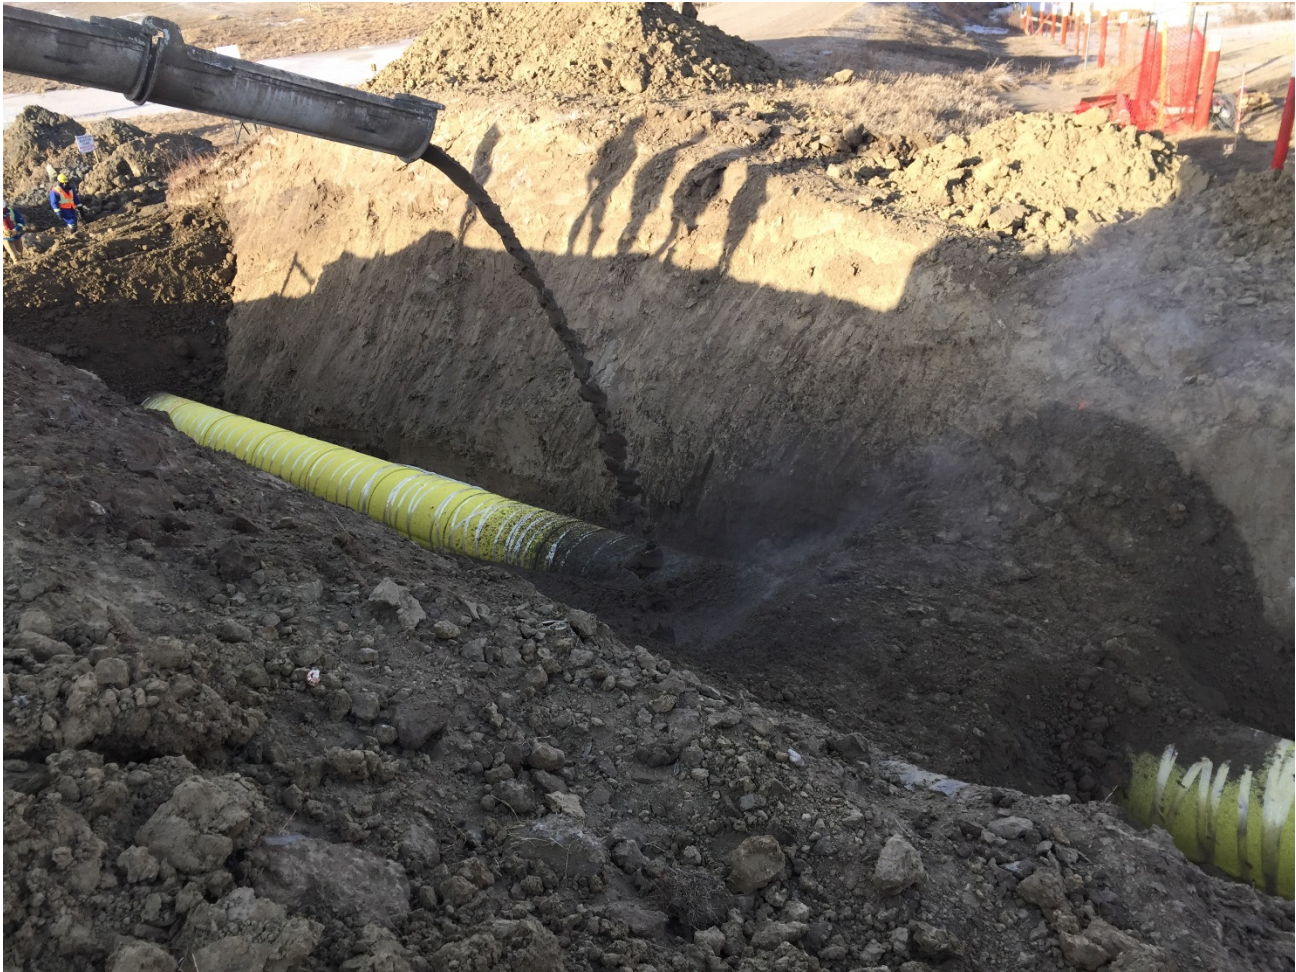
CEMENT TRUCK POURING FILLCRETE ON PIPE ACROSS ROADWAY.
