SGS MUSCOWPETUNG

ABORIGINAL CONSTRUCTION MONITORING

WEEKLY REPORT

MAY 13TH TO MAY 19TH, 2019.

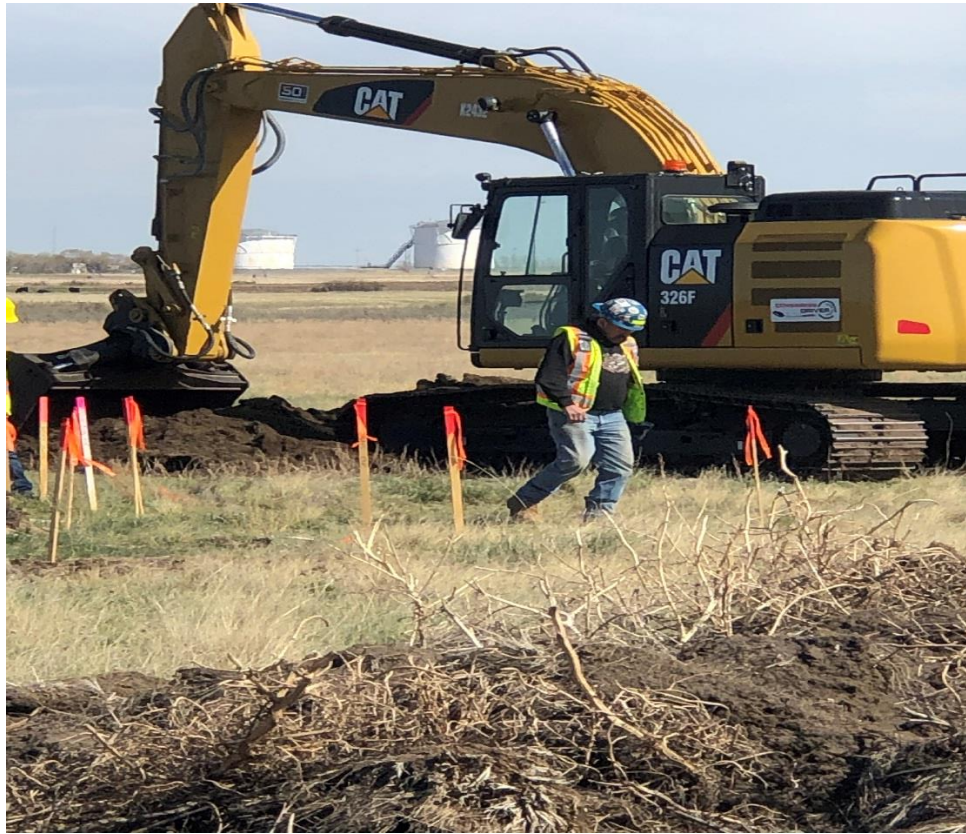
Stripping top soil from MLVB 14 to access road.

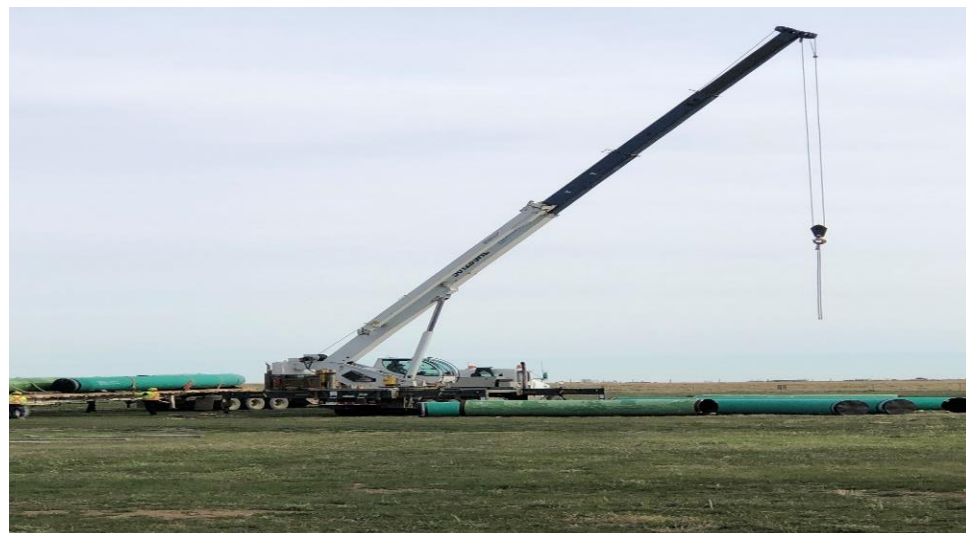
Loading pipe onto trucks with crane. Bethune pipe yard.

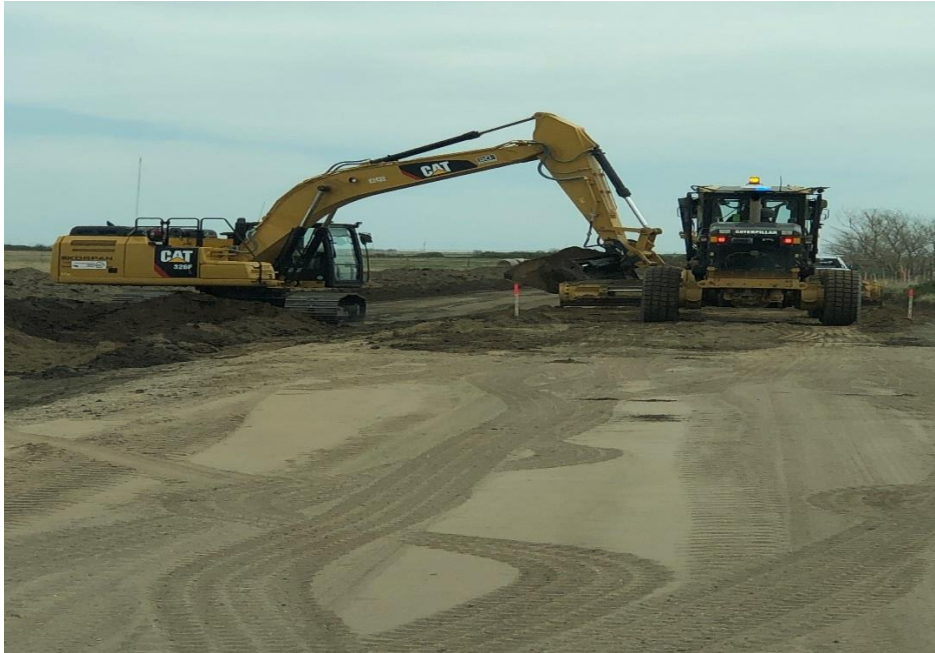
Building up access road. MKVB 14.

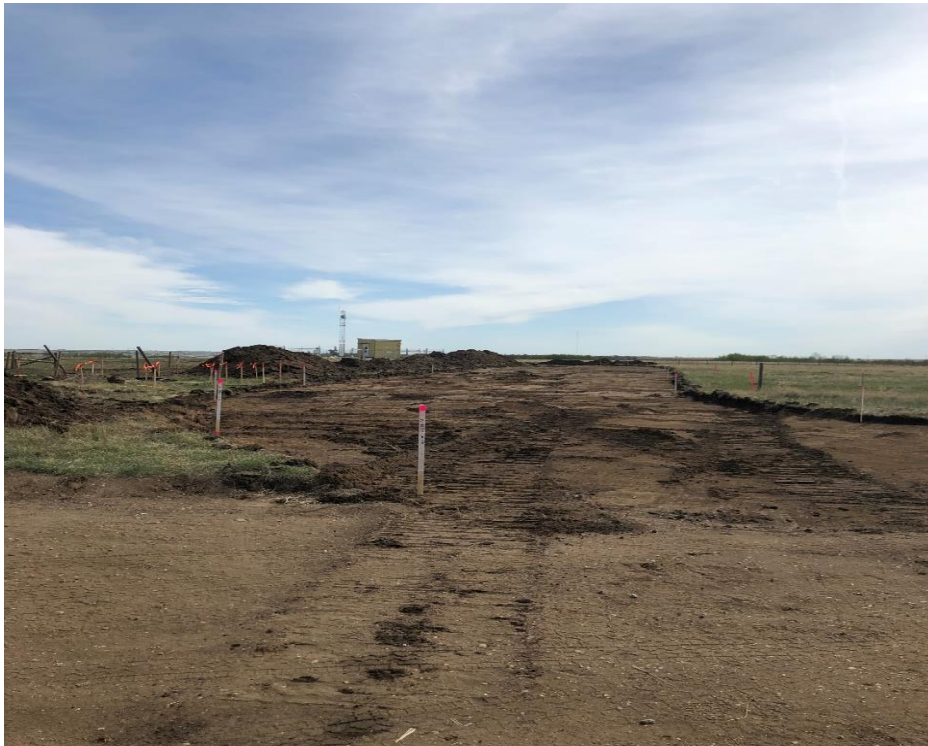
Top soil completely stripped from valve 14 to access road.
