SGS MUSCOWPETUNG

ABORIGINAL CONSTRUCTION MONITORING

WEEKLY REPORT

NOVEMBER 19TH TO NOVEMBER 25TH, 2018

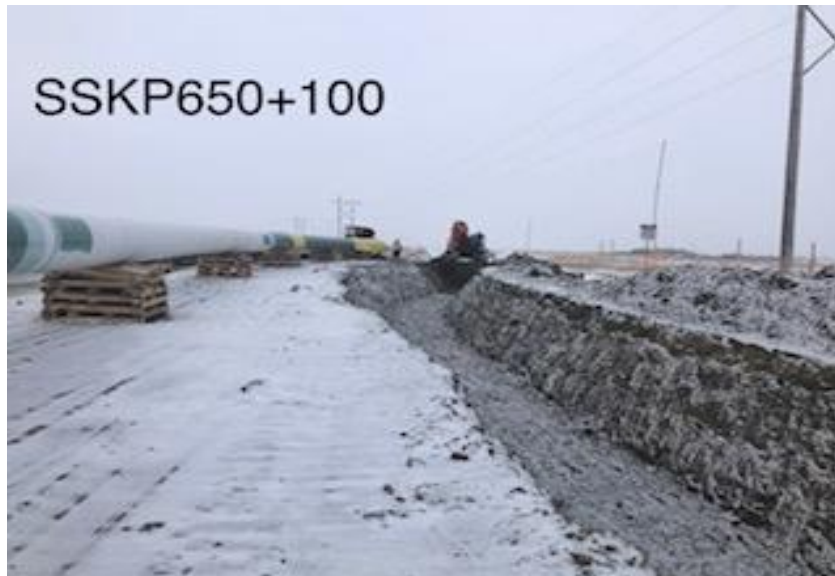
Crews working near overhead power lines – an oiler assisting during excavation.

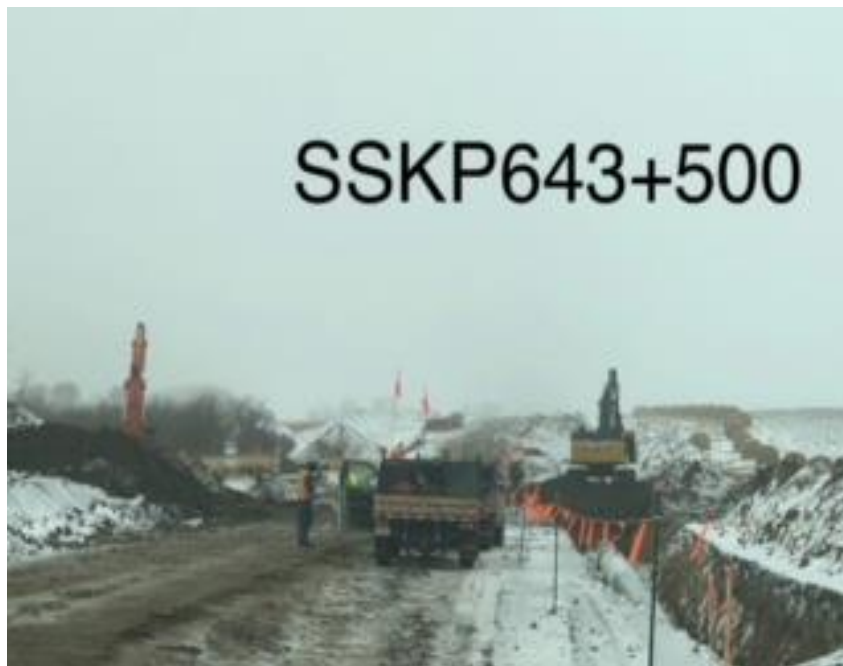
Backfill at a water course crossing SK WC71 Unnamed drainage

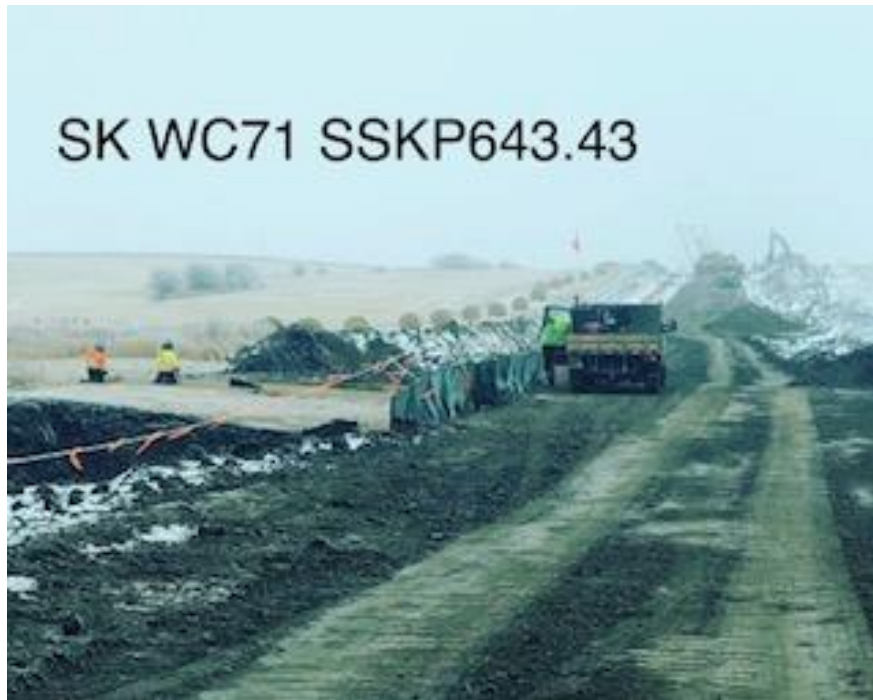
Water course crossing restoration – laying down mesh cover to encourage vegetation growth

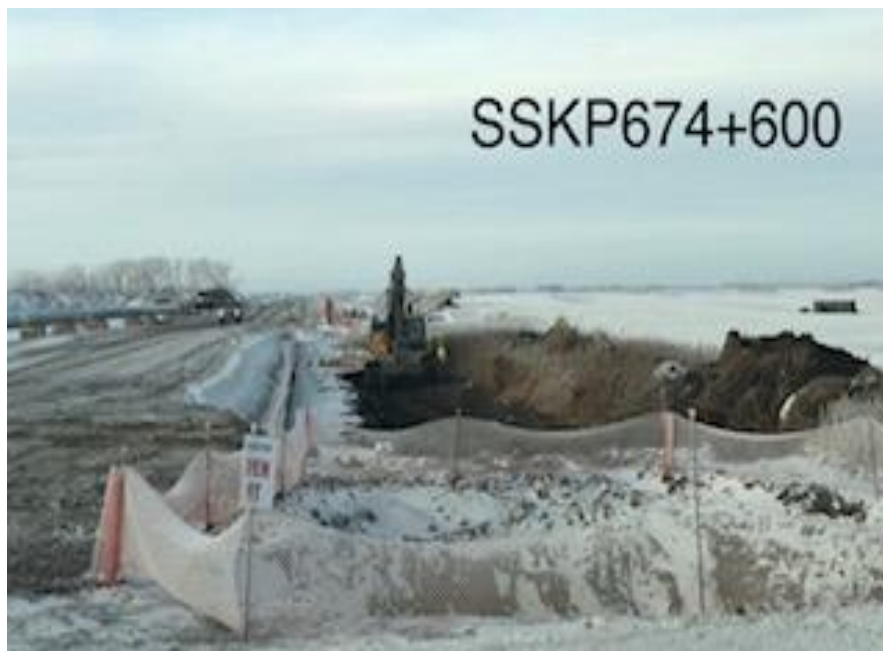
Wet Land Crossing SK629 – stripping process

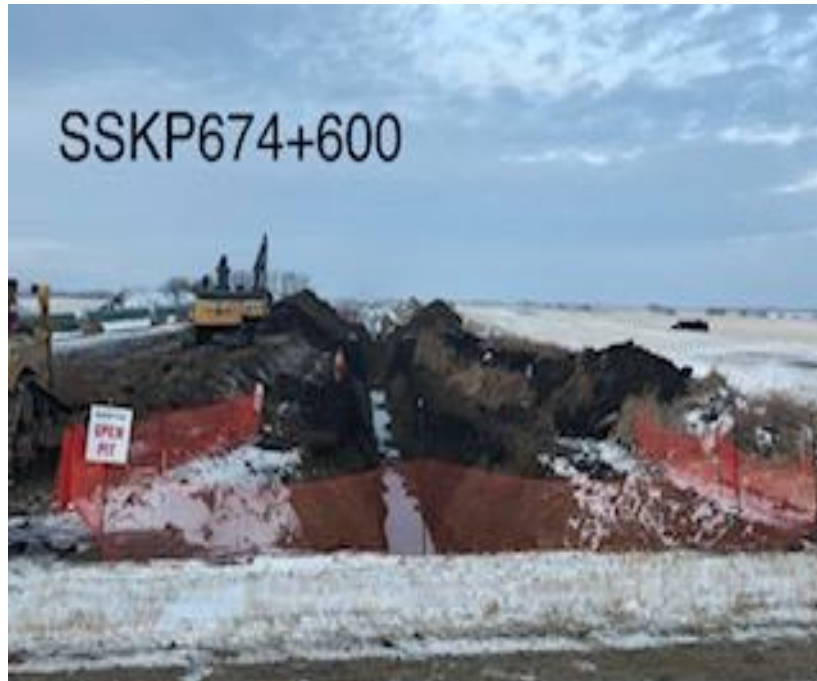
Excavated main line ditch at wet land crossing SK629

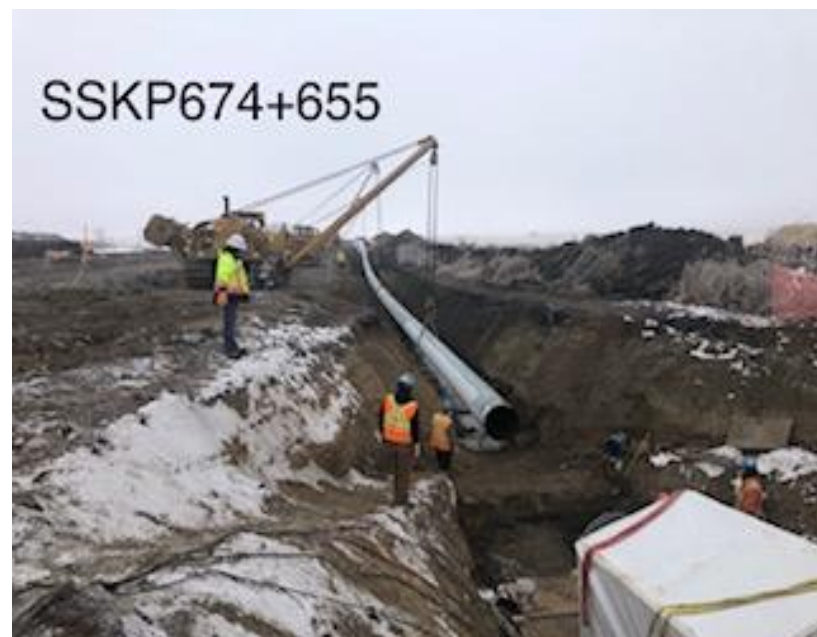
Lowering in a section at wet land crossing SK629 for tie ins on joint section
