**SGS MUSCOWPETUNG**

**ABORIGINAL CONSTRUCTION MONITORING**

**WEEKLY REPORT**

**DECEMBER 17<sup>TH</sup> TO DECEMBER 23<sup>RD</sup>, 2018**

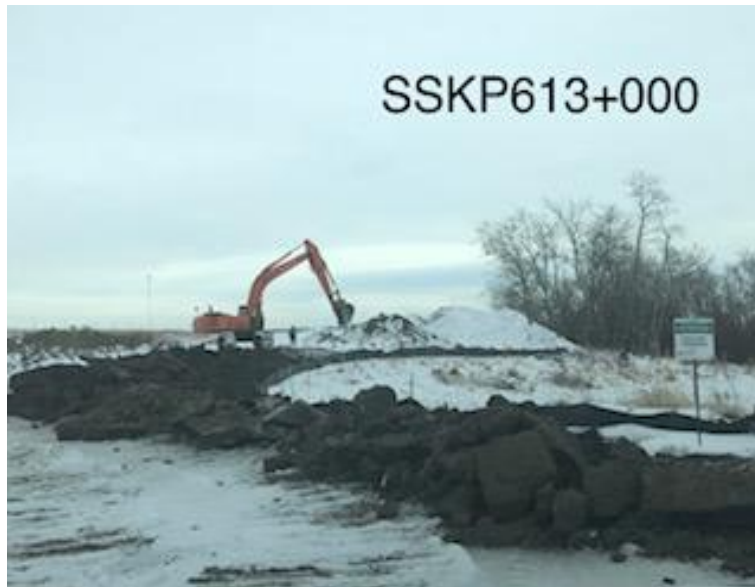
Banister crew working at wet land crossing SK483

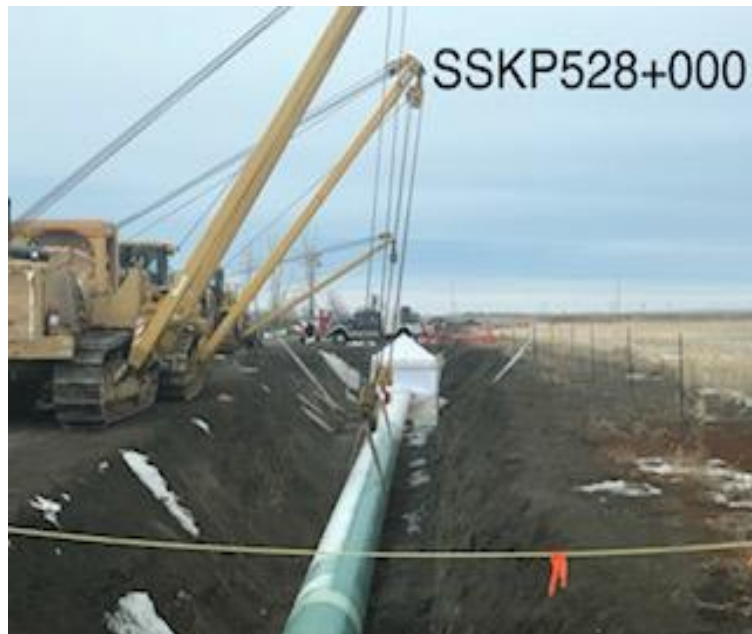
Tie In at KO

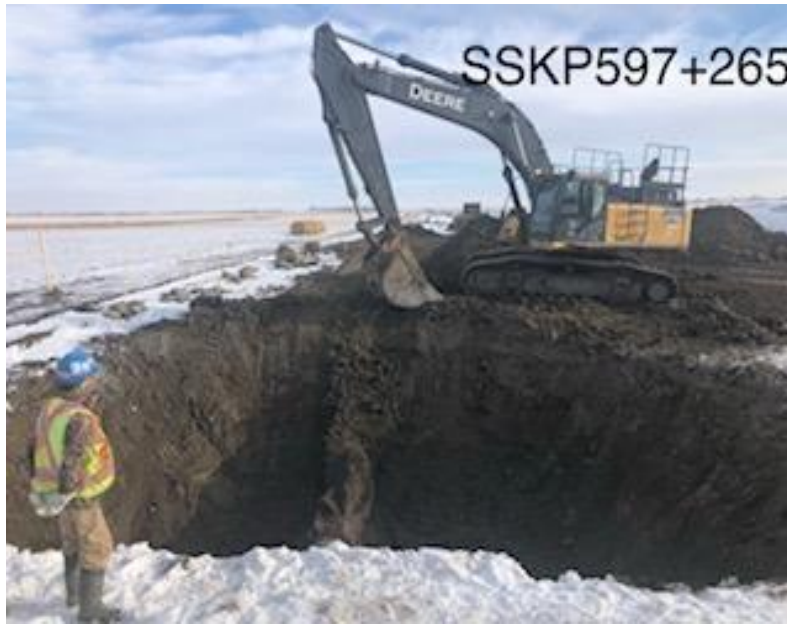
Ovality dig

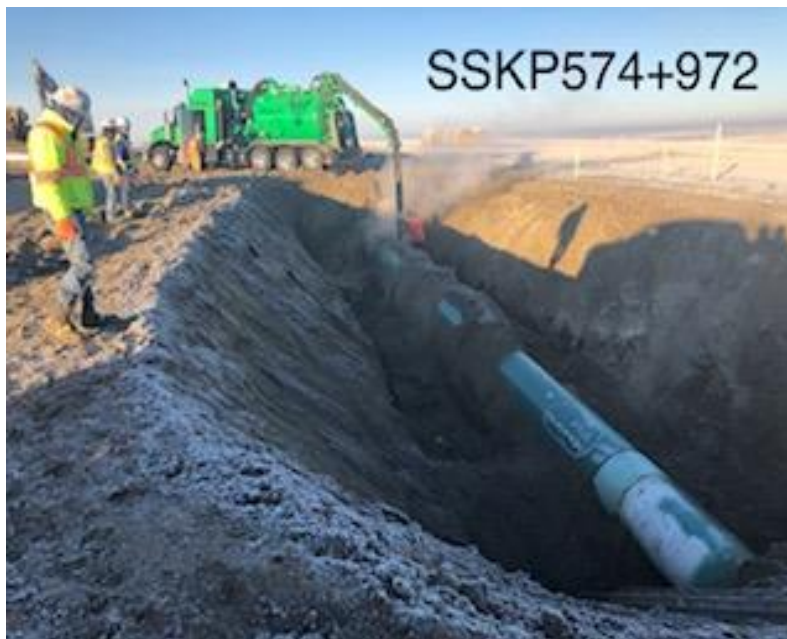
Ovality site

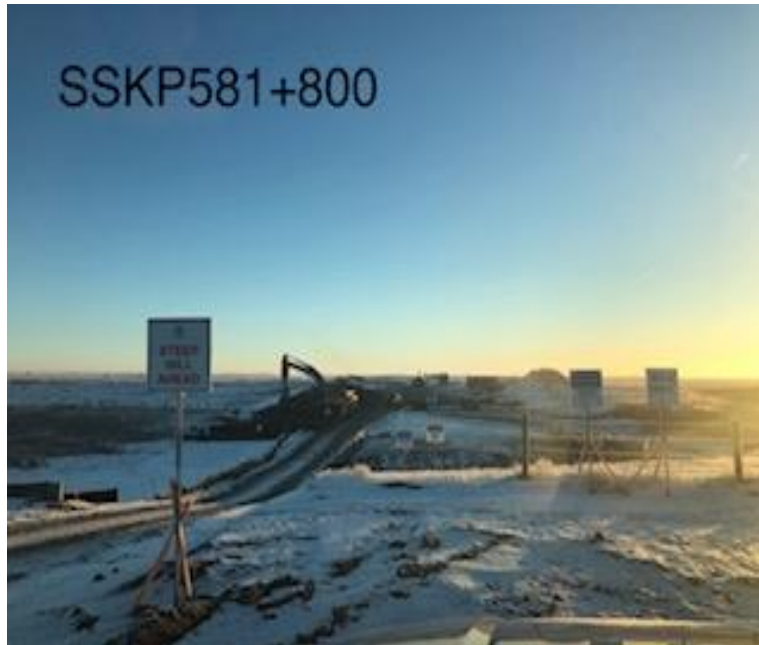
A hydro vac truck was on site potholing out an area on the ditch side east side of Water Course Crossing. Many bones creek SK WC64 SSKP581.58 also located in this area is native prairie zone and wet land crossing SK435 SSKP581.56-SSKP581.59 - The worker potholing has the required PPE on and did wear face shield, once complete the stakes & ribbon were put up and around the site hole area. Further west on right of way on the west side of Heritage resource HER124 SSKP581.42-SSKP581.62 crews were digging the ovality dig site at SSKP587+300 an inspector and hand were assisting the operator during the excavation clearing around the pipe section. An ovality is a condition in which the internal diameter of the pipe is not consistent around the entire circumference of the pipe.

Excavation at Many bones creek

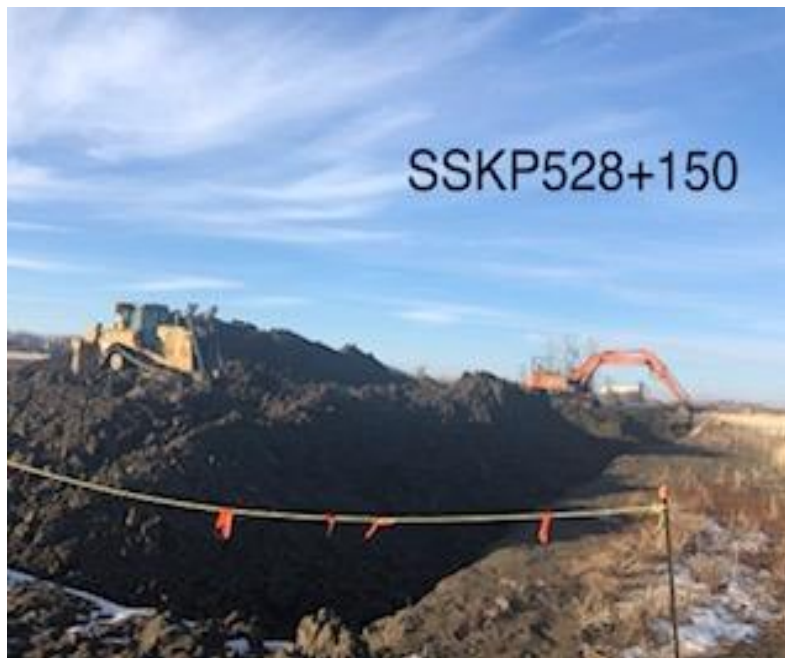
Backfill test site at Kick off
