SGS MUSCOWPETUNG

ABORIGINAL CONSTRUCTION MONITORING

WEEKLY REPORT

FEBRUARY 4TH TO FEBRUARY 10TH, 2019

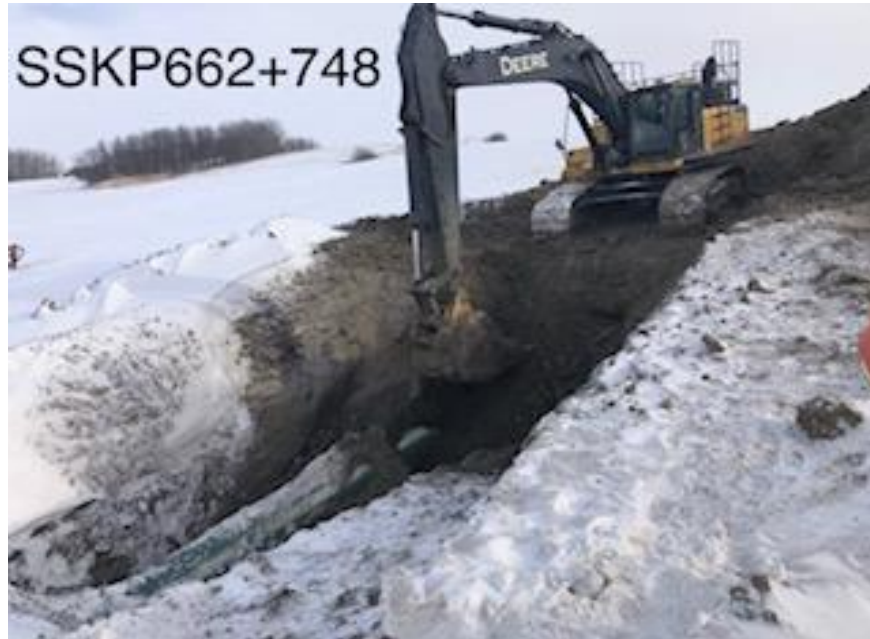
Monitored ovality excavations and backfill processes, one was on the east side of Water Course Crossing Vipond Creek SK WC72 SSKP662.54 - the ovality S111 SSKP662+748 was excavated, however, due to the depth of the cut, access stairs were added and ladders were placed for those entering the open pit. A hydro vac was also used to clean underneath the pipe before calliper measurement. Once ovality was relieved it was jeeped, coated, shaded in and put to bed.

Ovality excavation S111 SSKP662.748

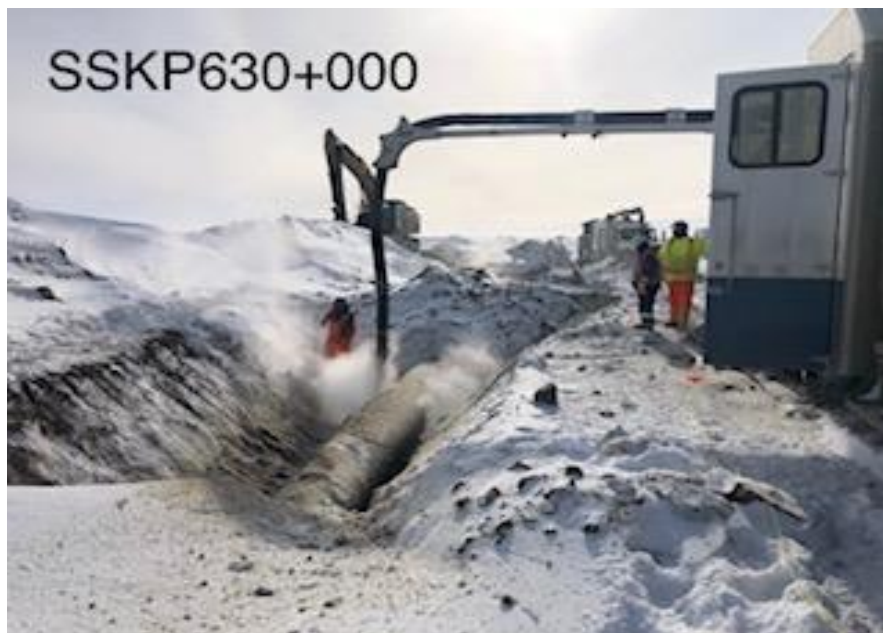
Hydro Vac clearing snow from pipeline

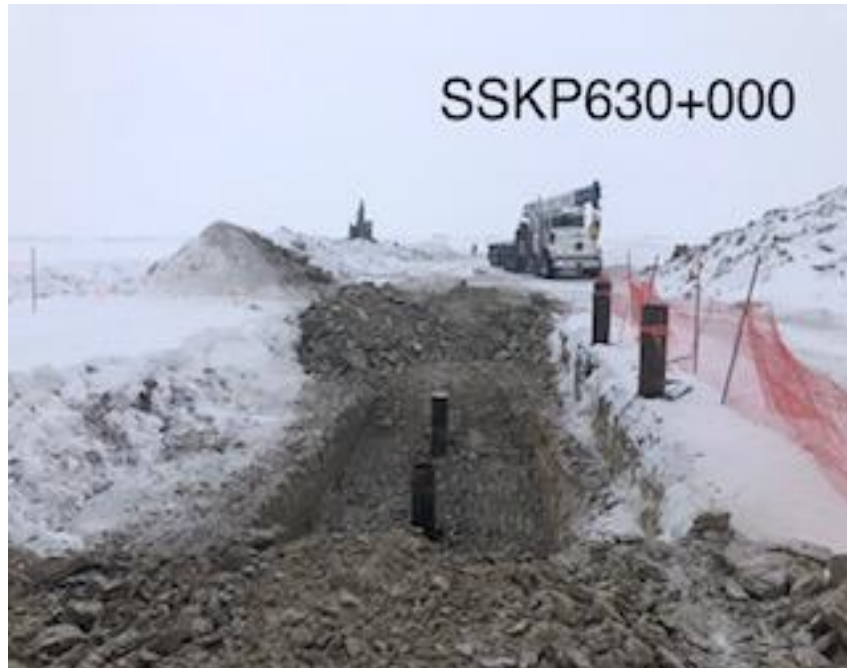
Compaction was completed at MLBV16 valve site. It took about a week to complete placement of the six (6) lifts and testing to grade. The density testing was carried out by Pinter & Associates LTD. Piles were excavated and a wire fence was installed around the area. Crew moved down to MLBV17 site which is located at SSKP676+300 west side of SF80. Two hydro vac crews were brought in to vacuum the snow from inside the trench line and valve site. Track hoe was used to remove the timber mats from inside the trench. A spotter inside the trench assisted the track hoe operator. Backfilling and compaction with density testing with nuclear gauge on the third lift by end of week.

MLBV16 Cleared around the piles
background backfilling mainline downstream of valve site

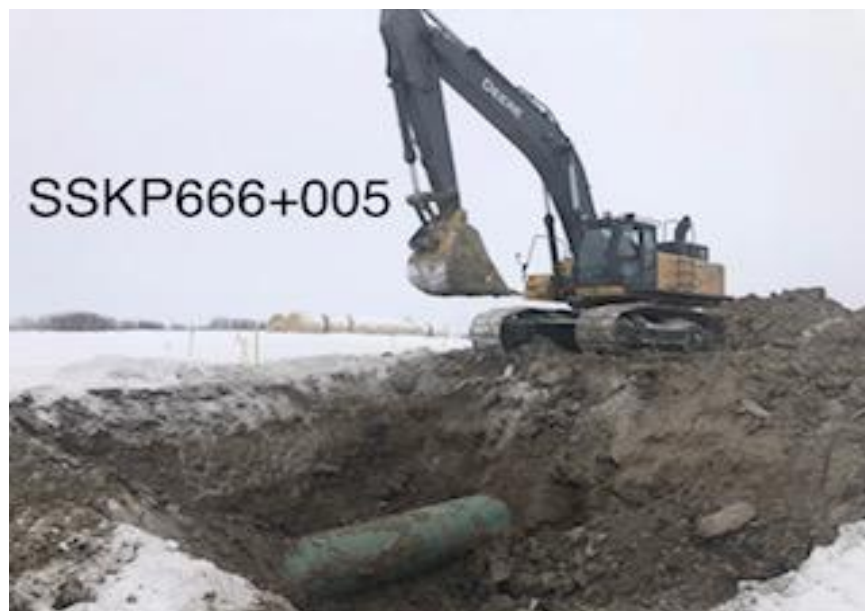
Ovality S152 excavation in wet land crossing SK598

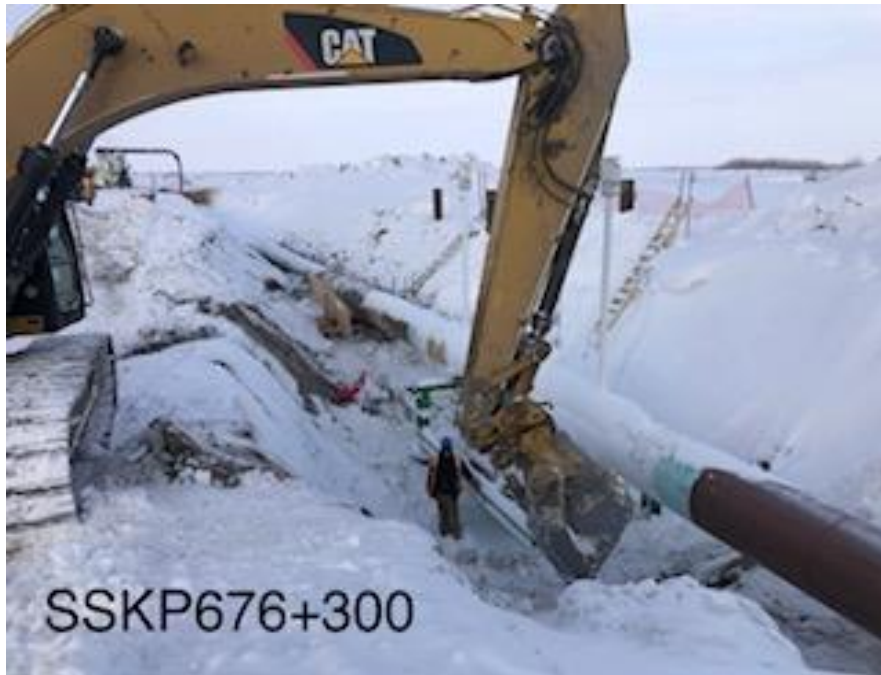
MLBV17 Cleared snow from trench line – SF80 west

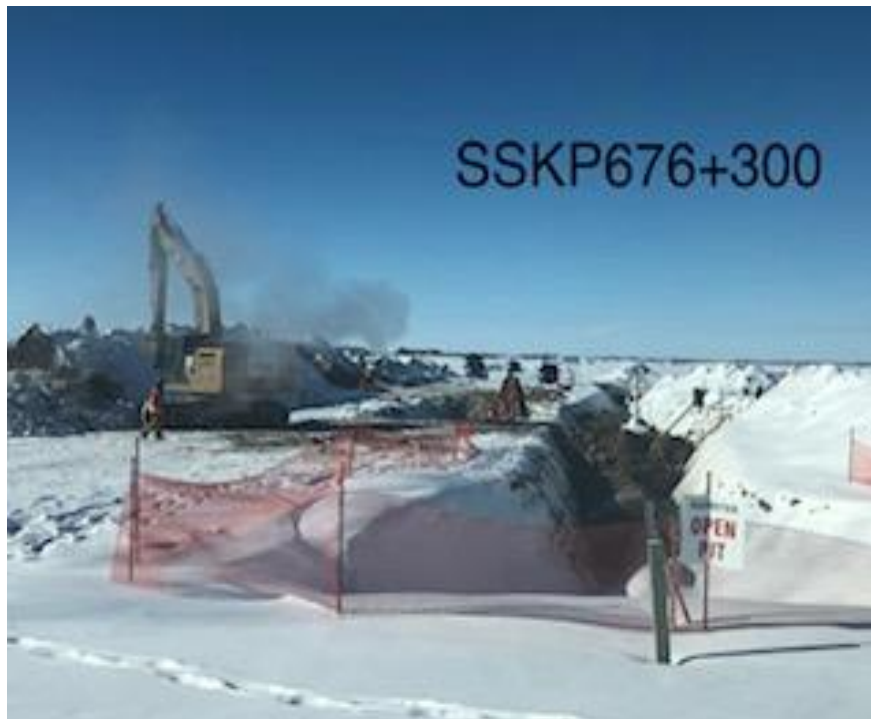
MLBV17 shade and backfill of upstream and downstream of valve site

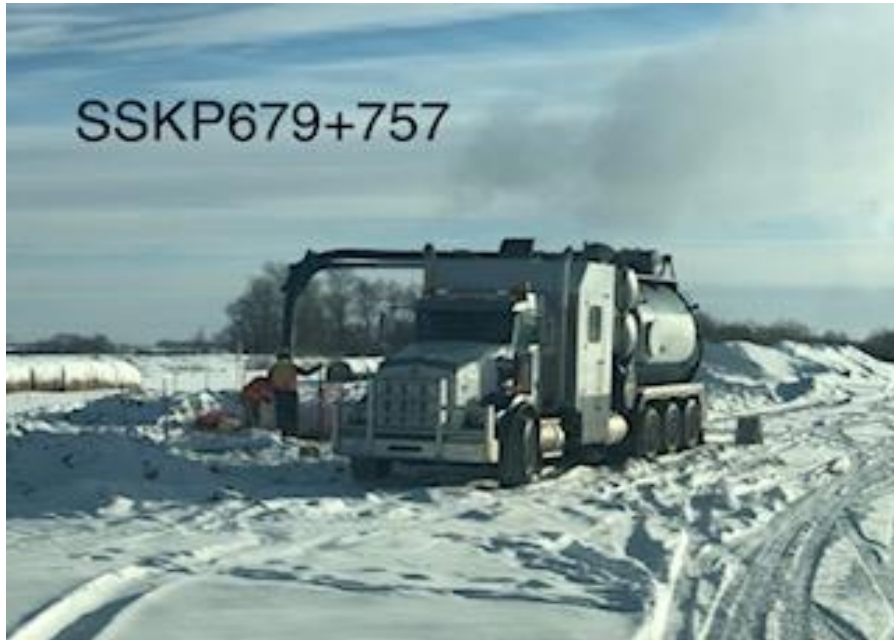
Hydro vac operator locating cathodic at Ovality S280 – SF81 east

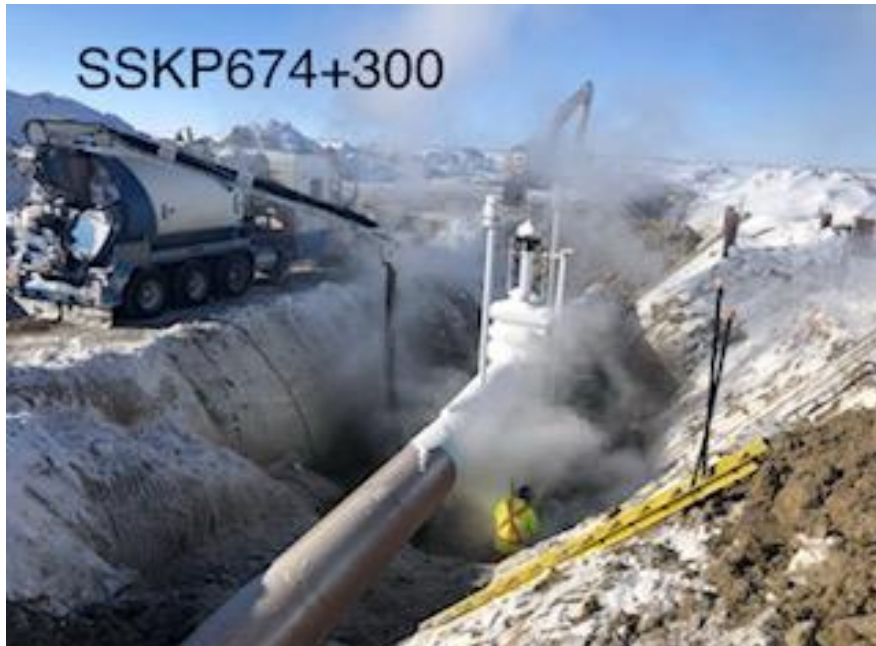
MLBV17 Hydro vac operator removing water from underneath pipeline before compaction

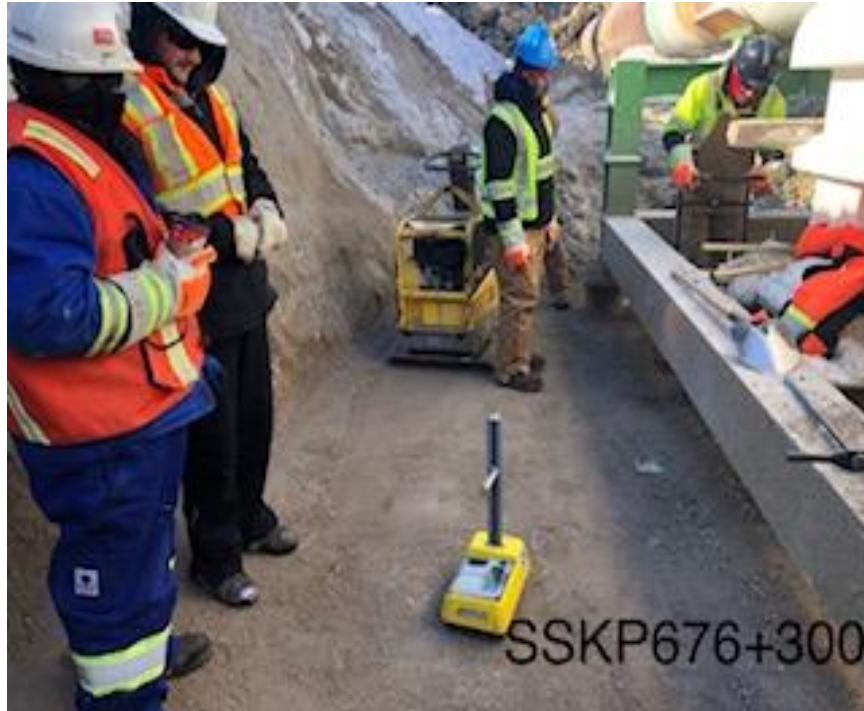
MLBV 17 compaction testing inside open pit area

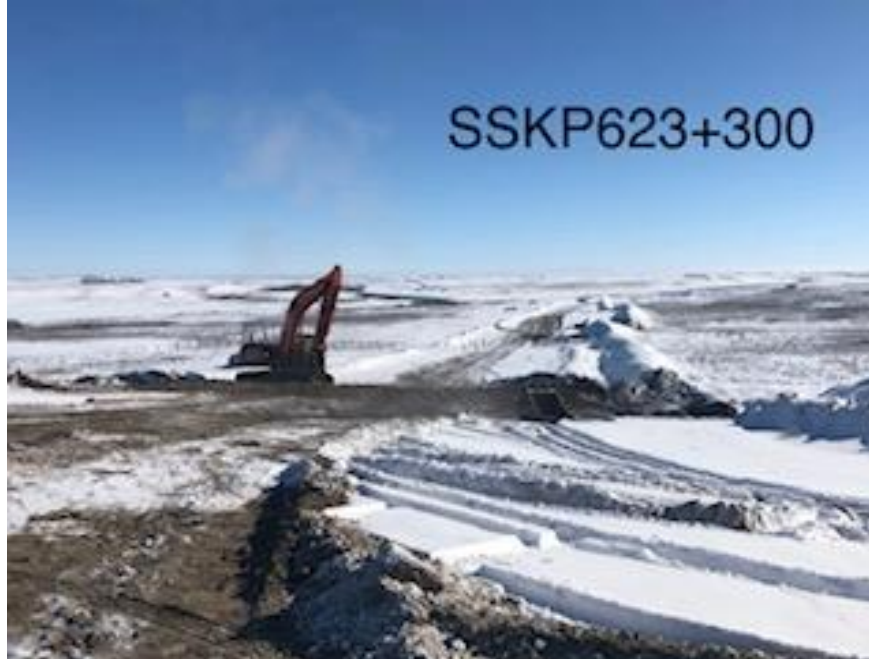
Diversion berms being installed at Chapleau Lake HER132

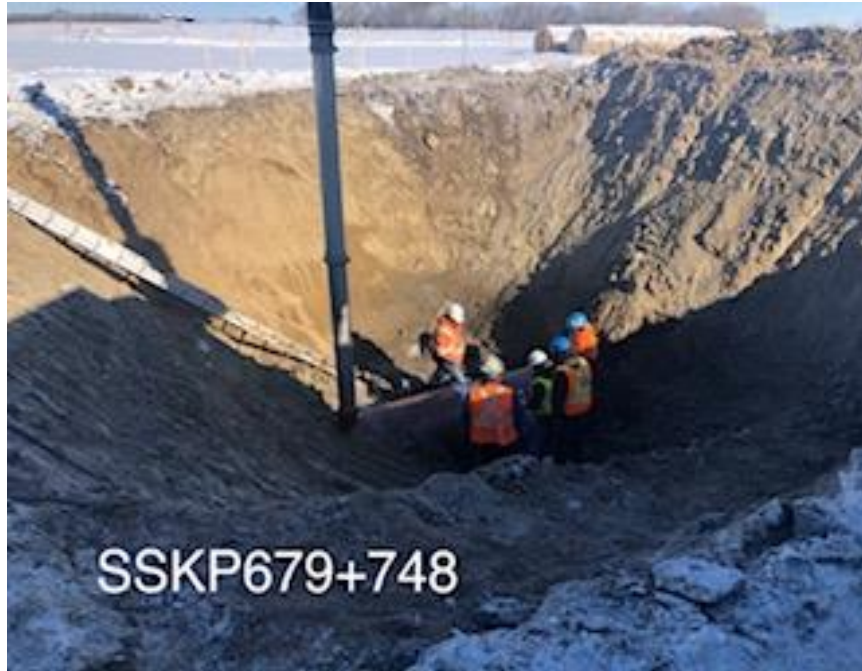
The last ovality S280 located at SSKP679+757 on spread 5 was relieved and in the process of being backfilled. Spring clean-up and removal of ramps near rare plant site VG57 SSKP624.02 west side of water course crossing Chapleau Lake SSKP624.04 was completed. It is anticipated clean-up will be carried out on the east side the following week.

Last ovality S280 was relieved on spread 5
