SGS MUSCOWPETUNG

ABORIGINAL CONSTRUCTION MONITORING

WEEKLY REPORT

DECEMBER 3RD TO DECEMBER 9TH, 2018

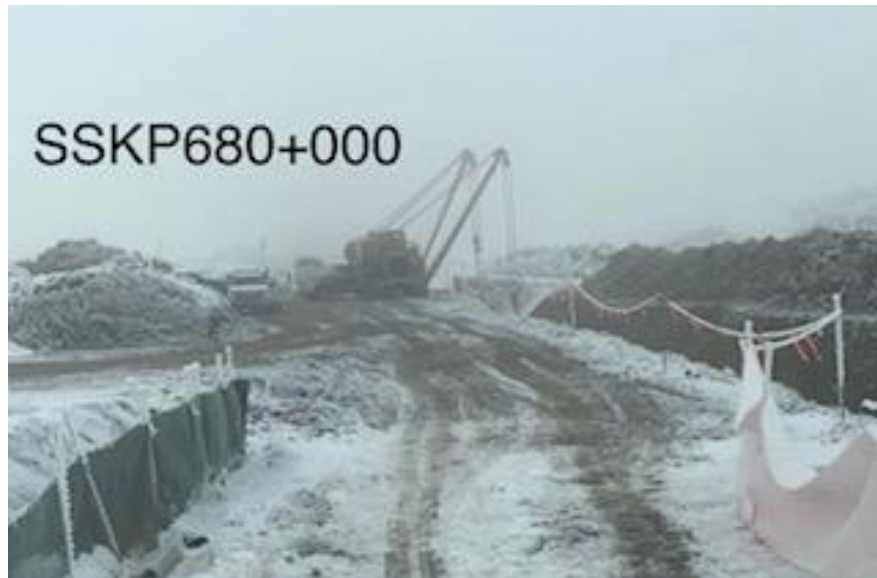
Lowered in a joint section and tie in – organic field

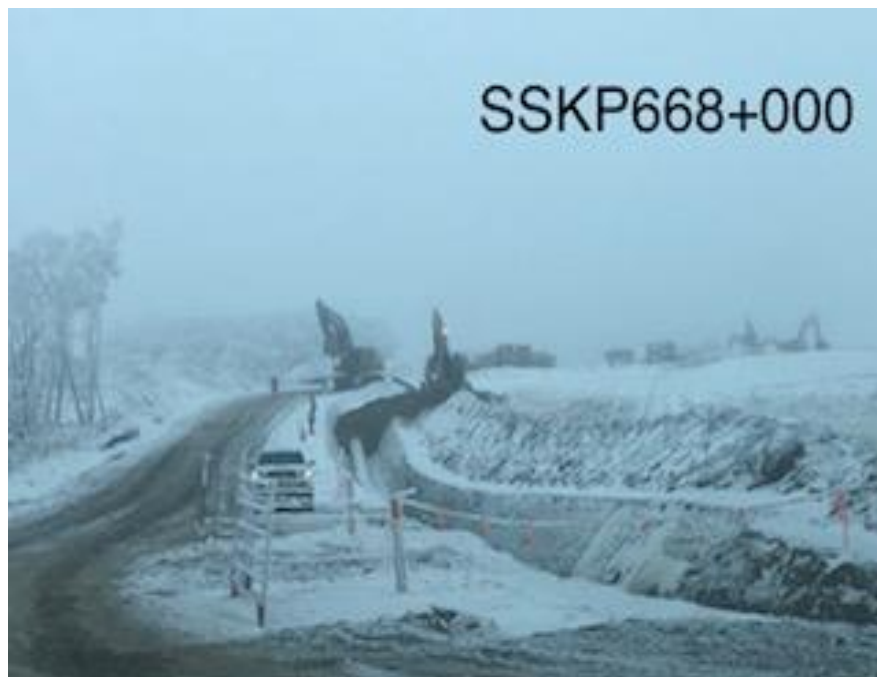
Backfill wet land crossing SK611

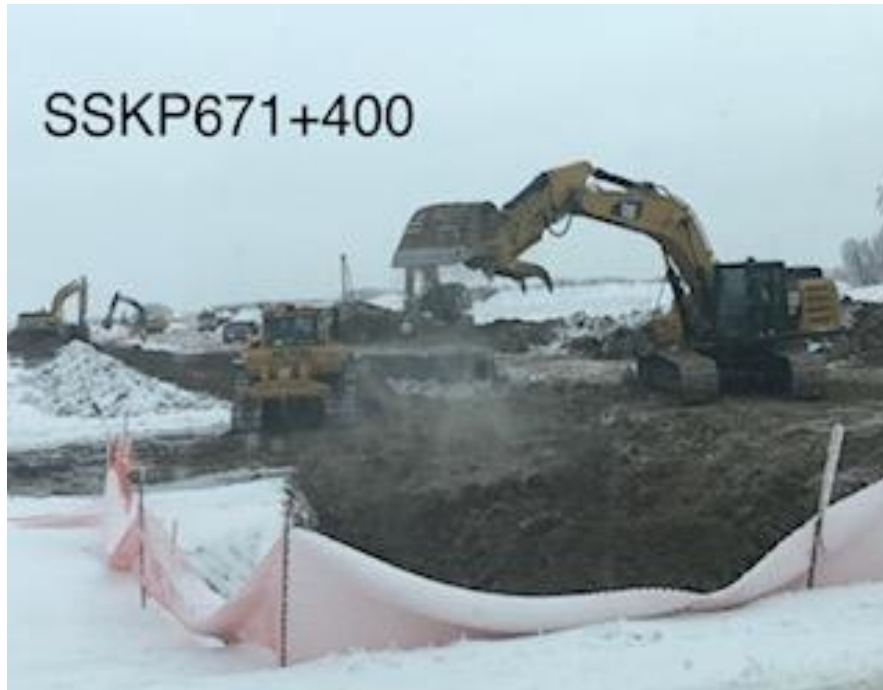
Bell hole backfill and wet land compaction

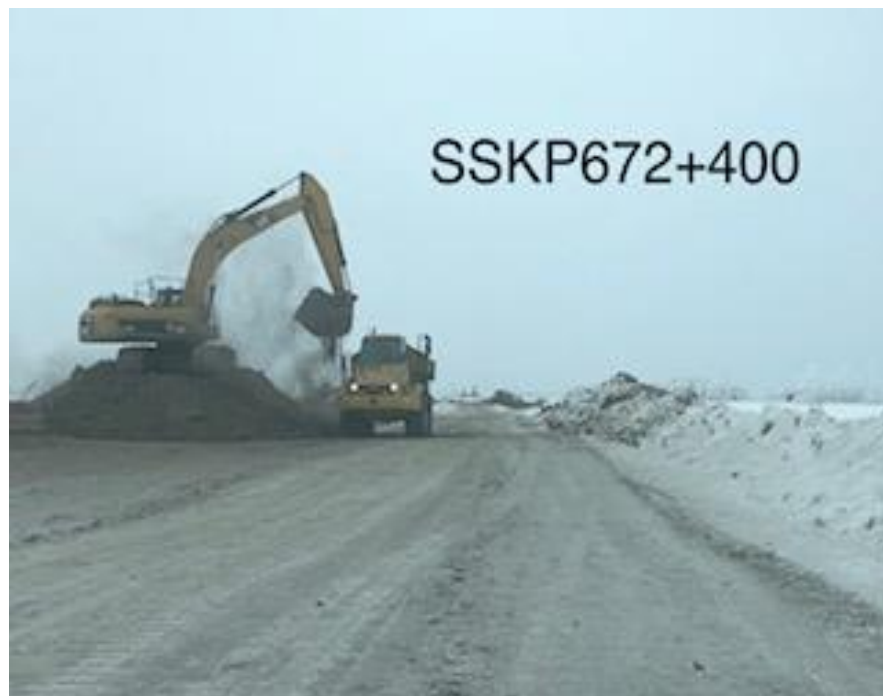
Backfill at Water Course Crossing SK WC74

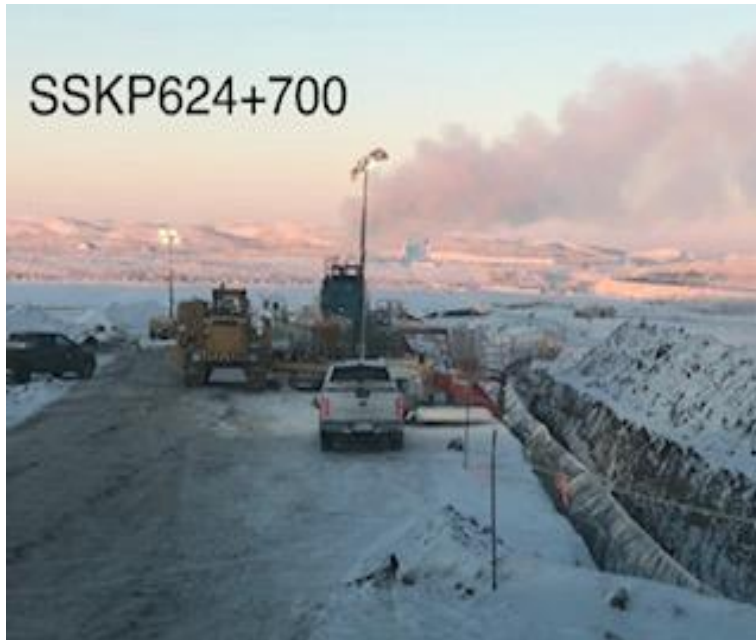
Chapleau Lake SK WC68 Test Site

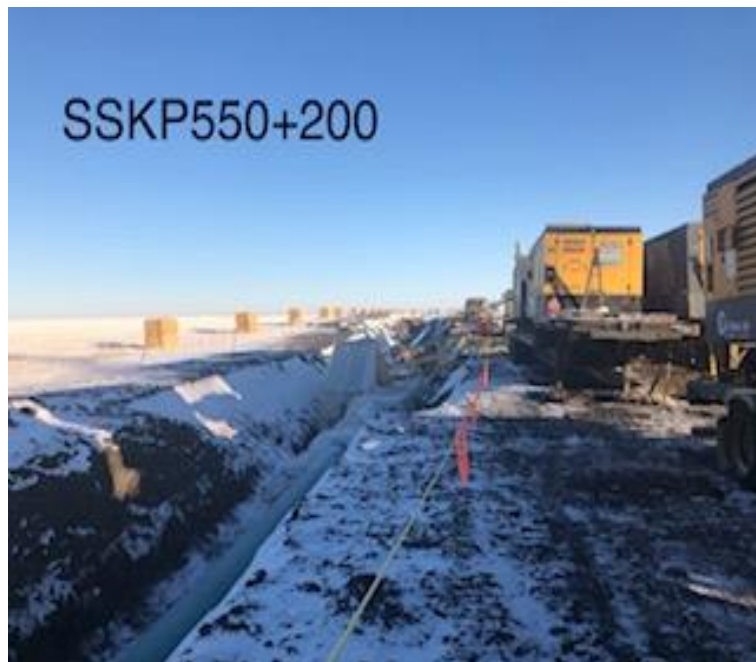
TS23 Banister labourers disassembling the hoarding area
