SGS MUSCOWPETUNG

ABORIGINAL CONSTRUCTION MONITORING

WEEKLY REPORT

JANUARY 14TH TO JANUARY 20TH, 2019

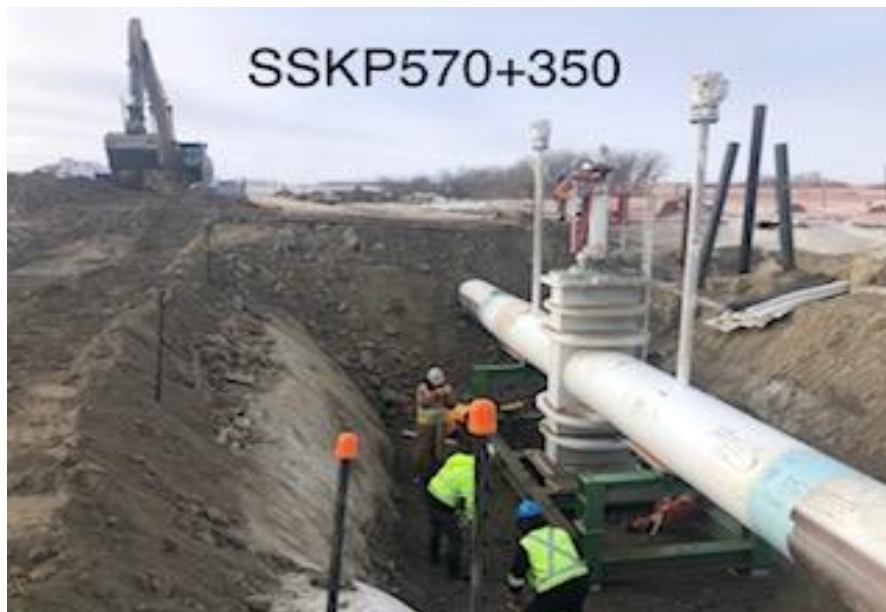
MLBV15 Compaction lift process- worker remove clay/ rocks from the excavation

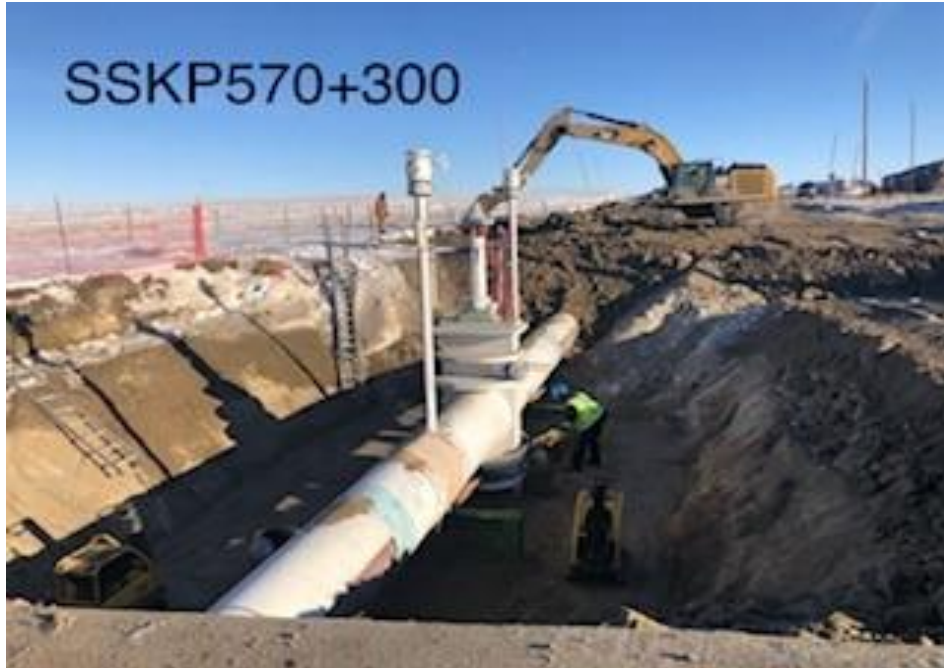
MLBV15 compaction in progress utilizing compaction plates

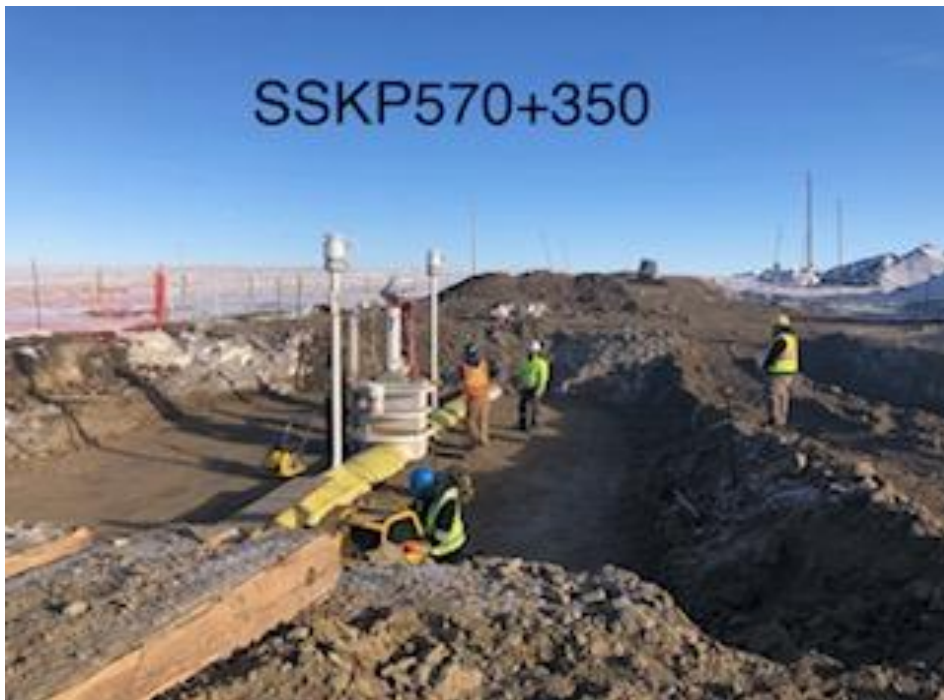
MLBV15 compaction in progress

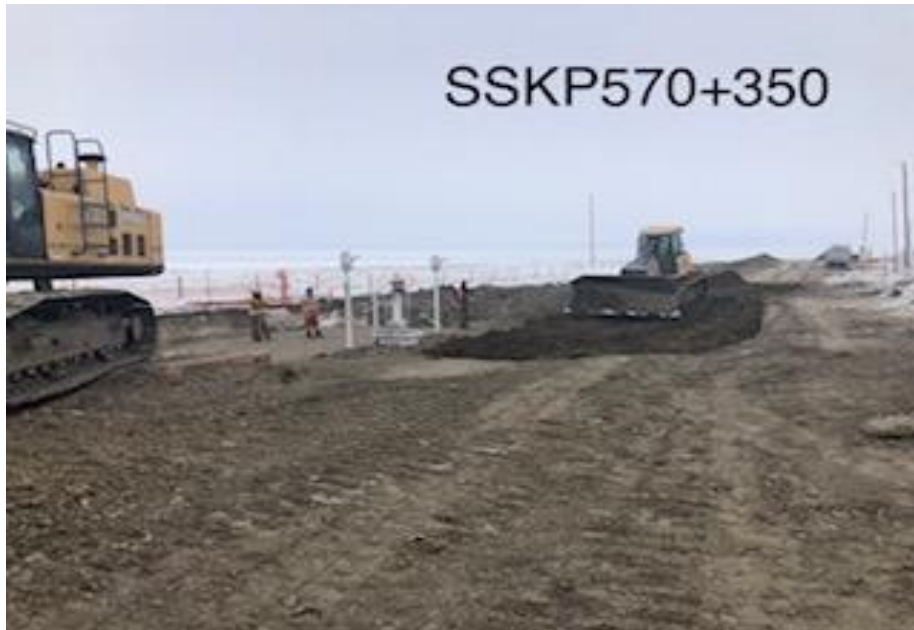
Compaction at MLBV15 continues

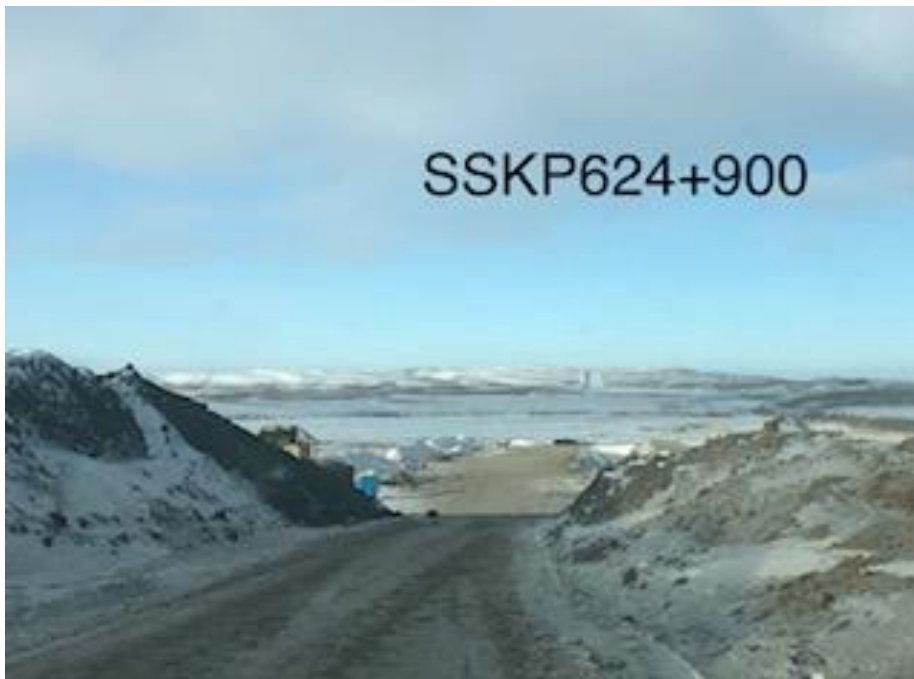
Site clean-up with machine begins on east side of Chapleau Lake

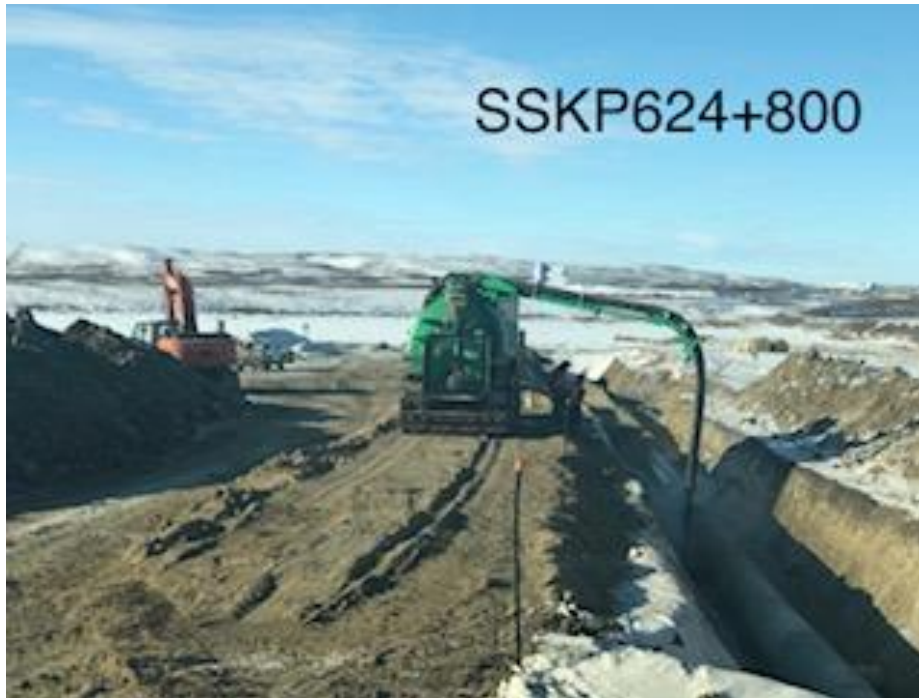
Hydro vac clearing ice from around the pipeline before shading in

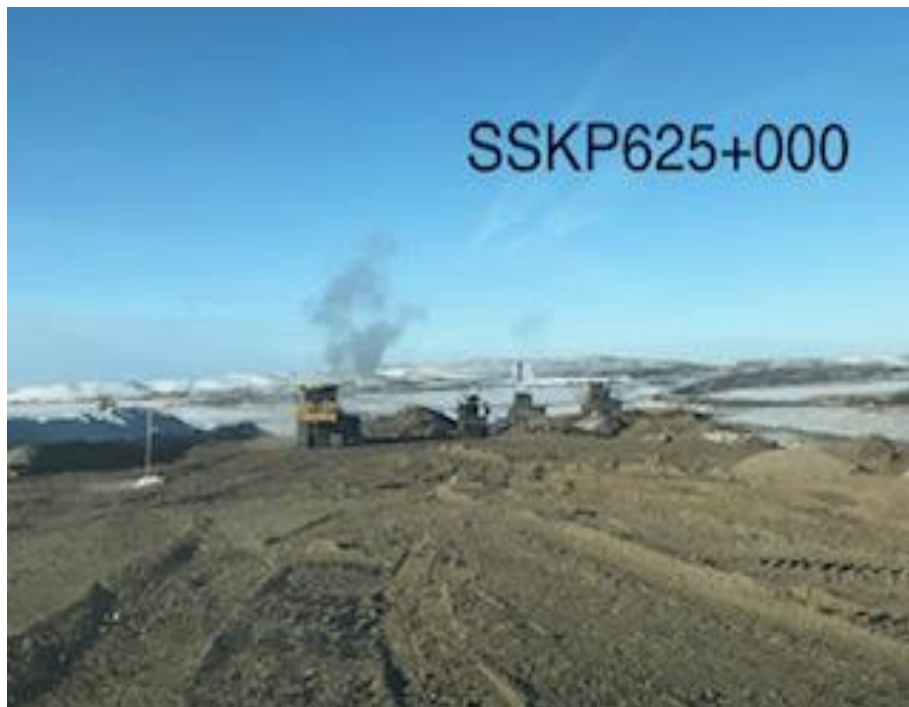
East side Chapleau Lake clean up in progress

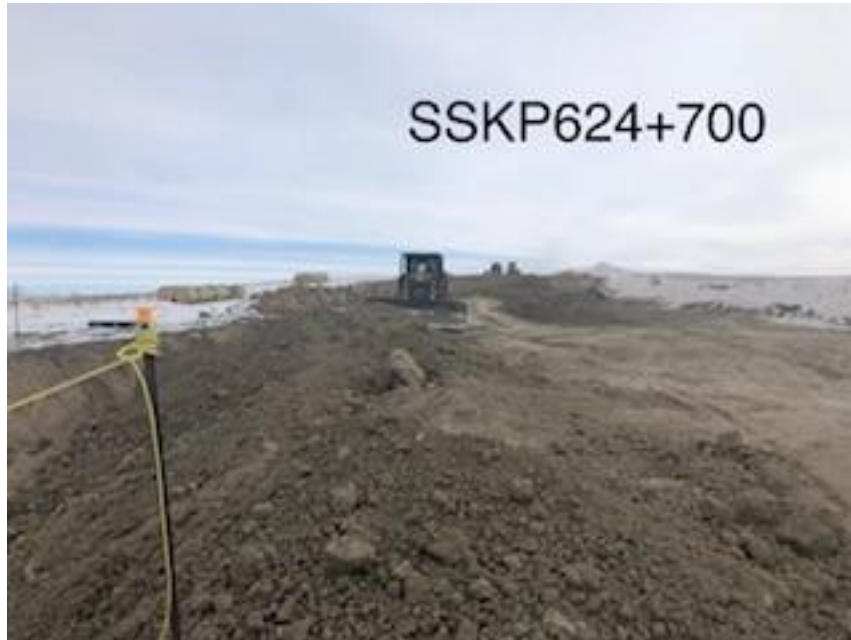
Shading in and backfill ongoing at east side of Chapleau Lake
