SGS MUSCOWPETUNG

ABORIGINAL CONSTRUCTION MONITORING

WEEKLY REPORT

JANUARY 21ST TO JANUARY 27TH, 2019

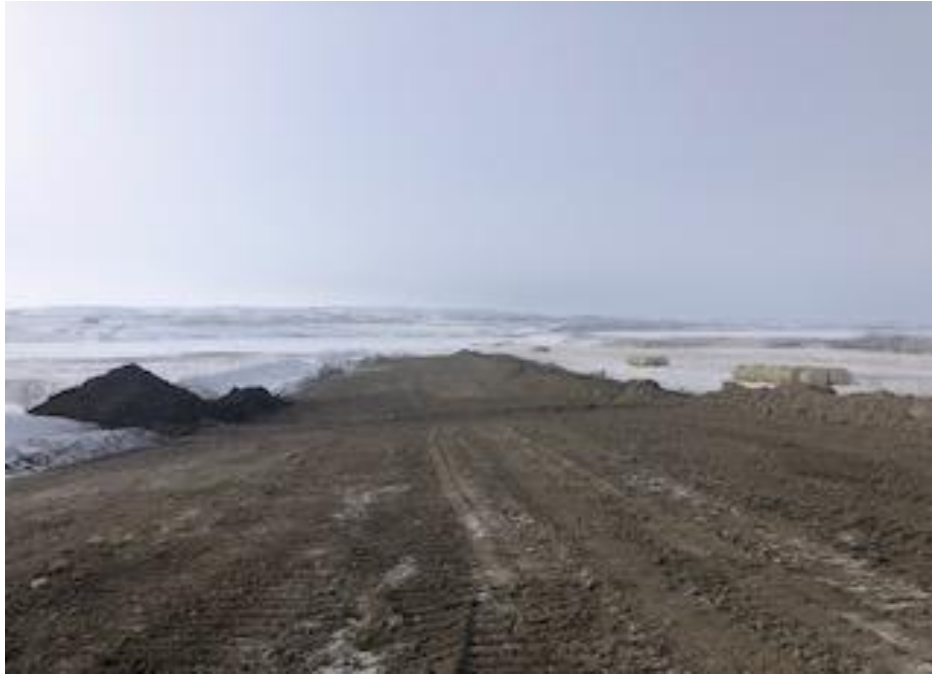
Machine clean completed at water course crossing Chapleau Lake SK WC86

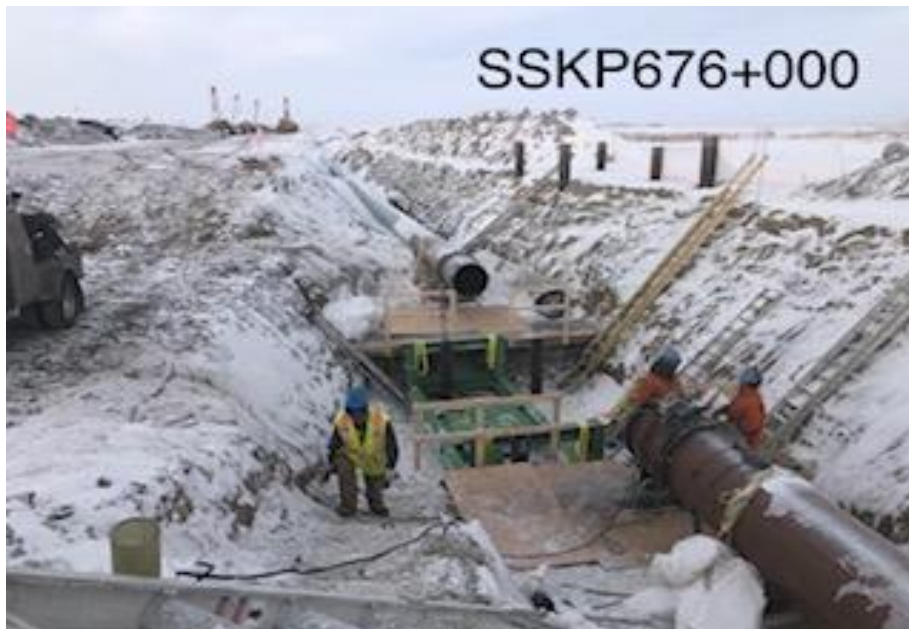
MLBV17 preparation for valve site

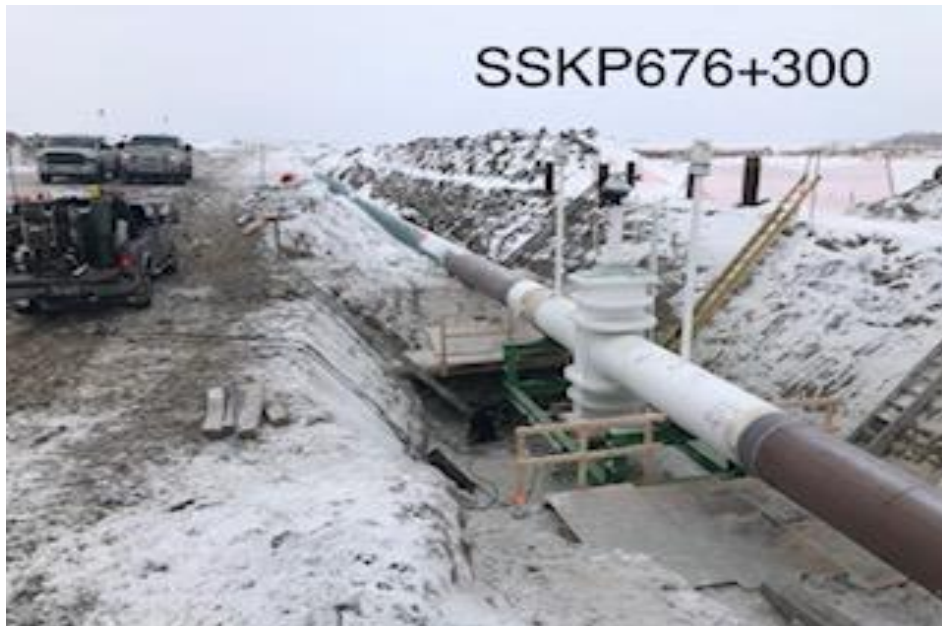
Structural weld MLBV17

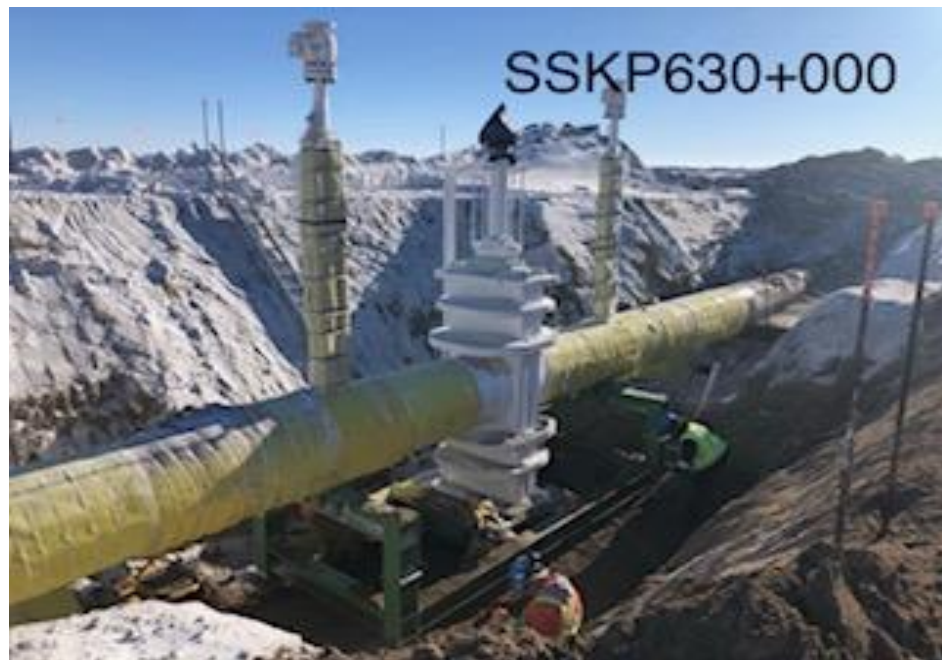
Compaction ongoing MLBV16

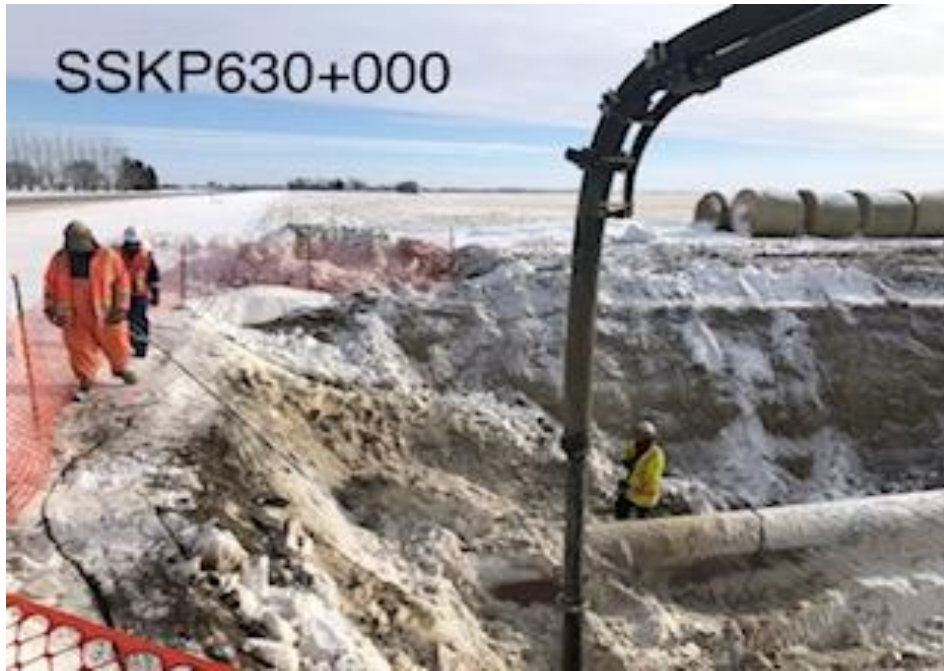
Hydro vac crew removing ice and snow from around MLBV16

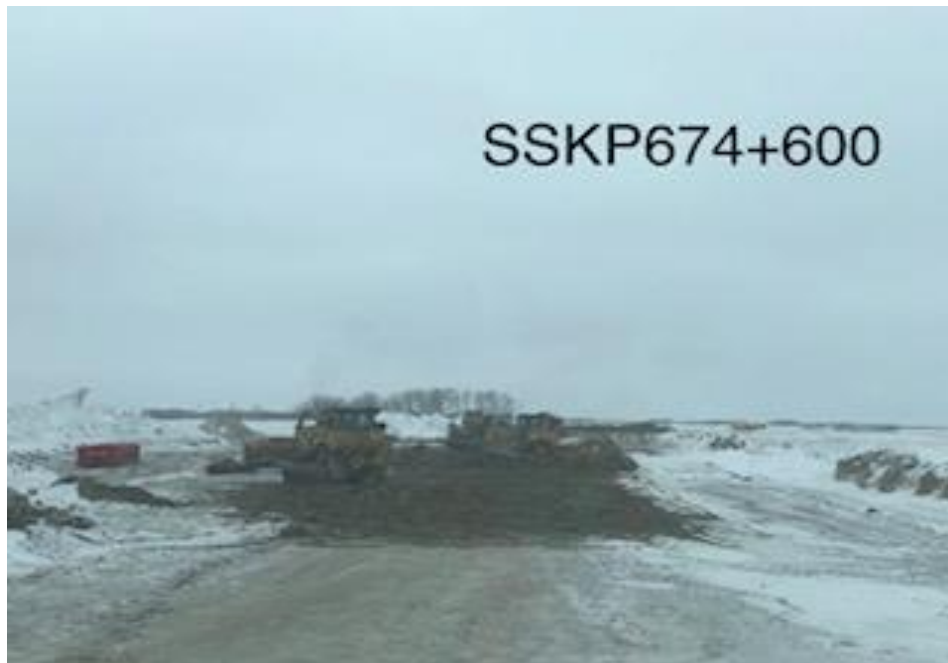
Machine clean up continues SF79 east
