SGS MUSCOWPETUNG

ABORIGINAL CONSTRUCTION MONITORING

WEEKLY REPORT

JANUARY 3RD TO JANUARY 6TH, 2019

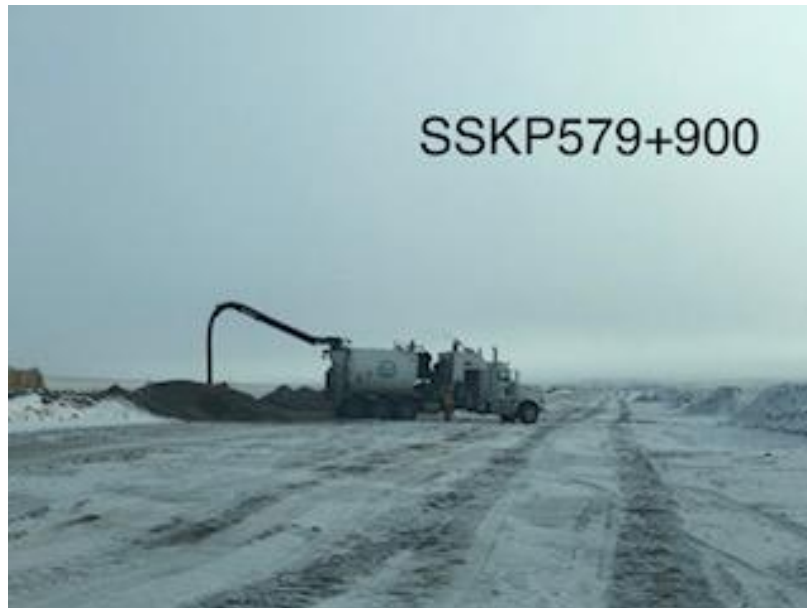
Hydro Vac daylighting SF24 east

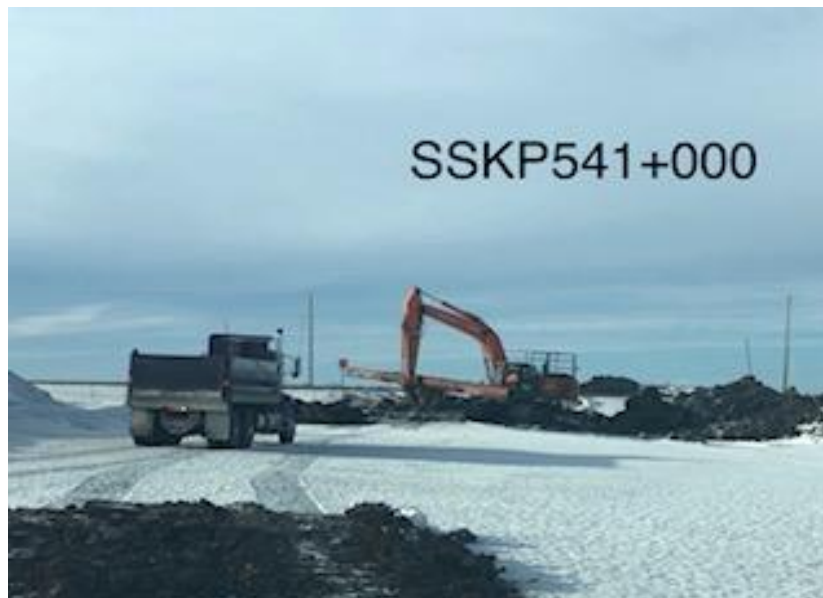
Ramp access removal SF6 east

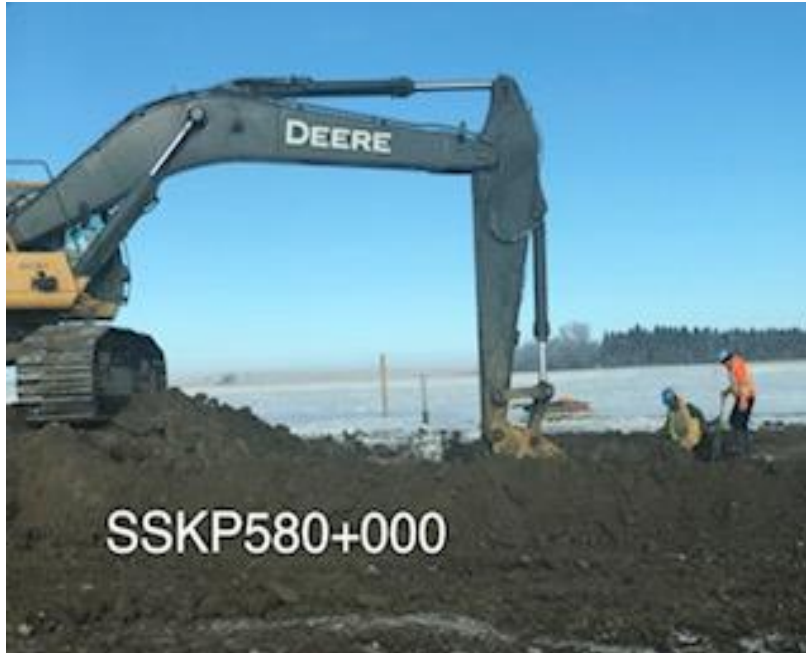
Ovality site – excavation

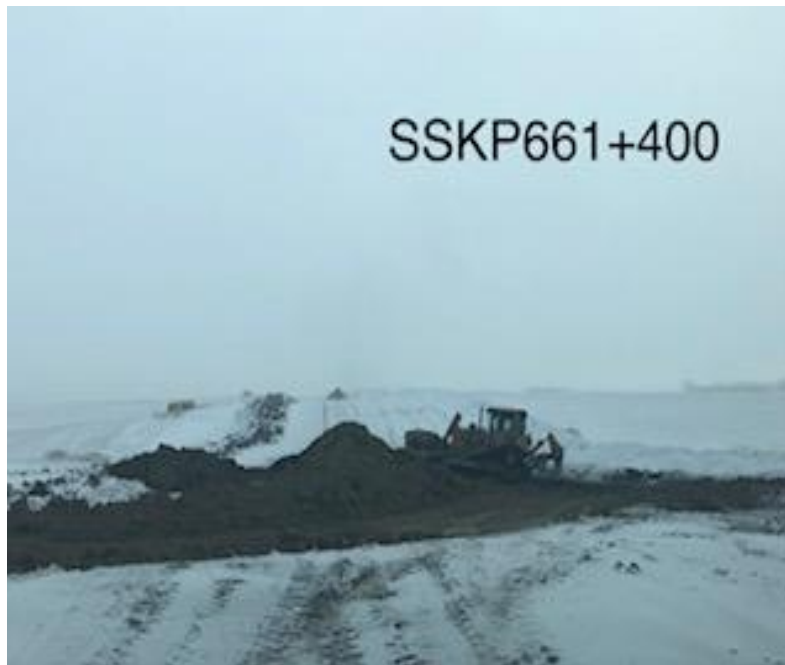
Machine clean up SF73 east
