**SGS MUSCOWPETUNG**

**ABORIGINAL CONSTRUCTION MONITORING**

**WEEKLY REPORT**

**JANUARY 7<sup>TH</sup> TO JANUARY 13<sup>TH</sup>, 2019**

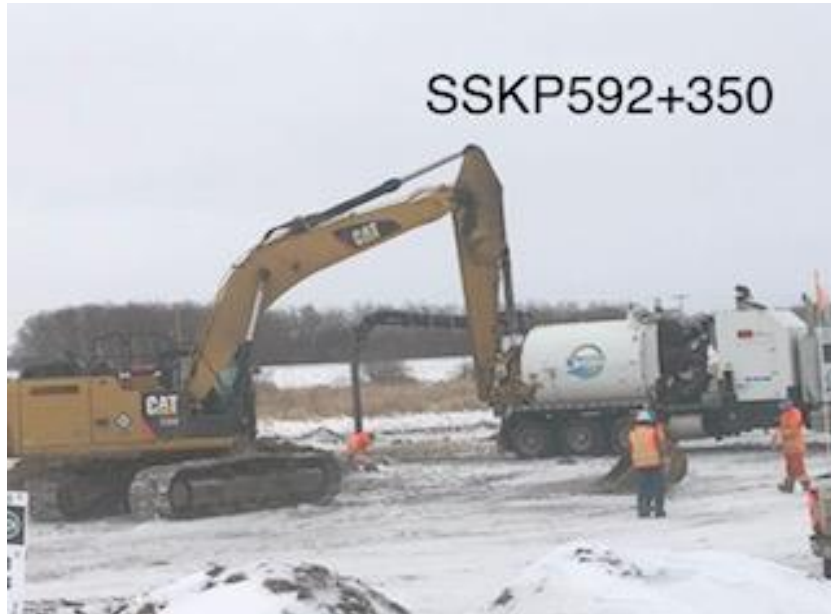
Ovality site SF33 east

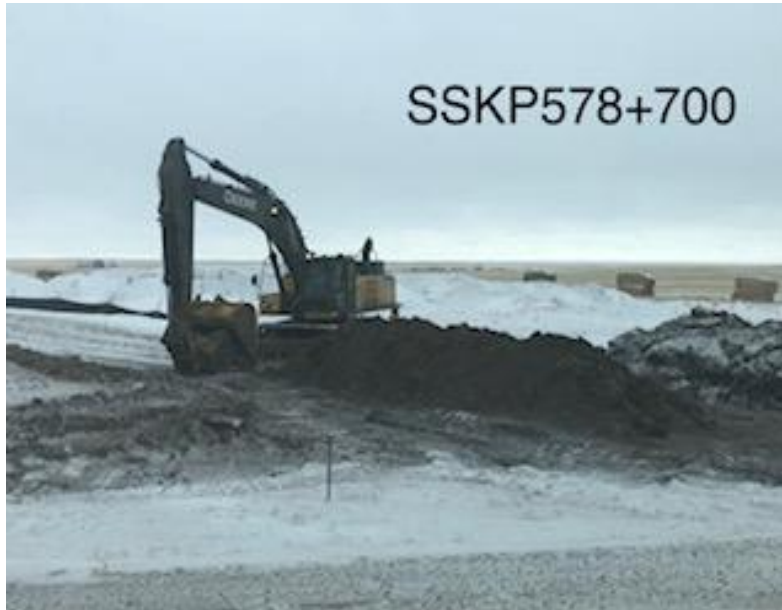
Ramp removal SF26 east

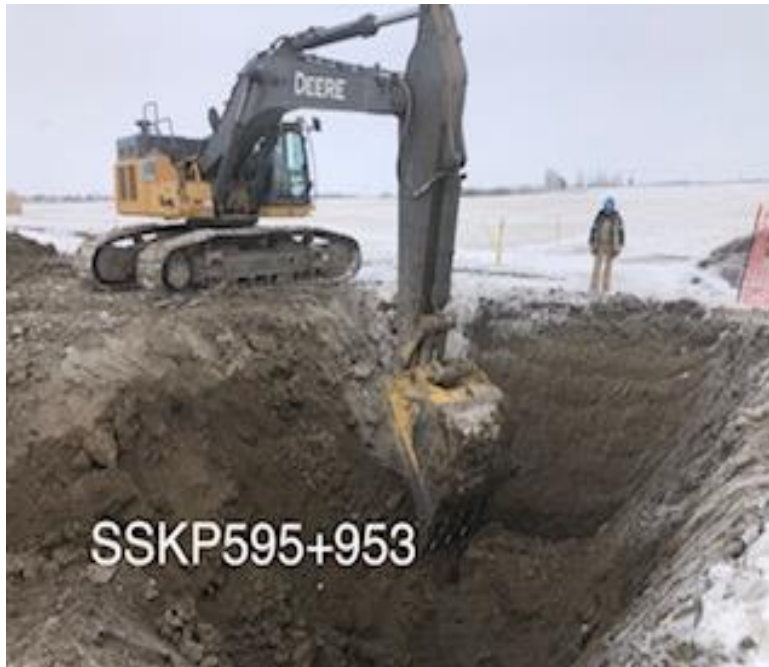
Ovality excavation

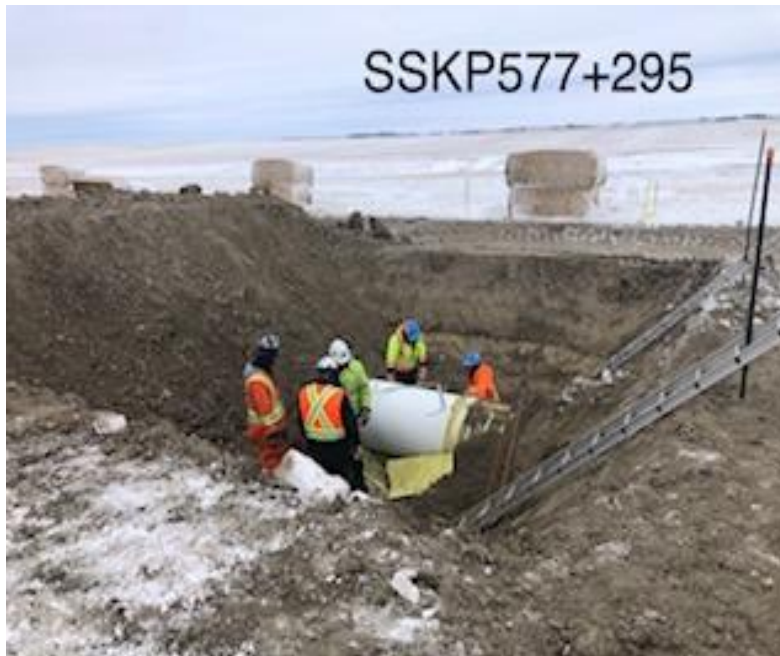
Ovality site Caliper tool used to measure the pipe

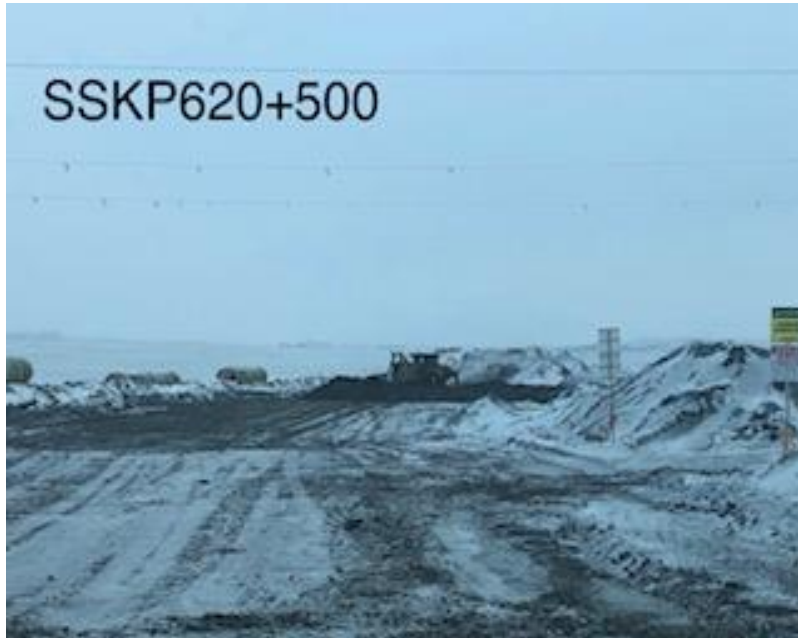
Machine clean-up continues which the operators break down the sub soil and spread it out levelling the right of way and has reached the border of Native prairie zone SSKP622.28 which leads to the west side of Chapleau Lake which includes Heritage Resource TLU HER132 & HER133. Follow up in the next week.

Machine Clean up continues

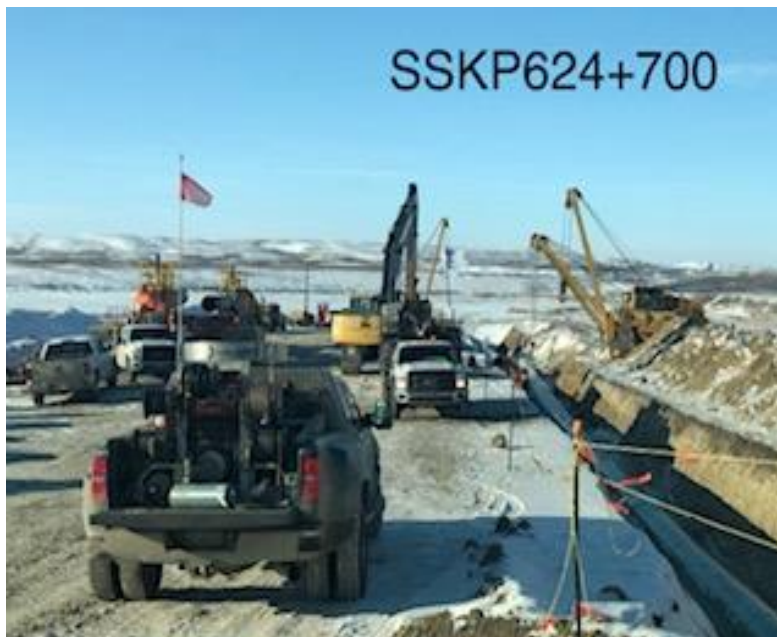
Returning to Water Course Crossing Chapleau Lake SK WC68, SSKP624.04 monitored the area when crews continued to clean up the de-watering site on right of way, removing geo tech and mats from the fill point. Labour crews removed the de watering pipe from the area cutting it into sections for transportation. There was a tie in by welding crews, so it was busy area by Saturdays end, clean up continues in this area.

Chapleau Lake East side – tie in section

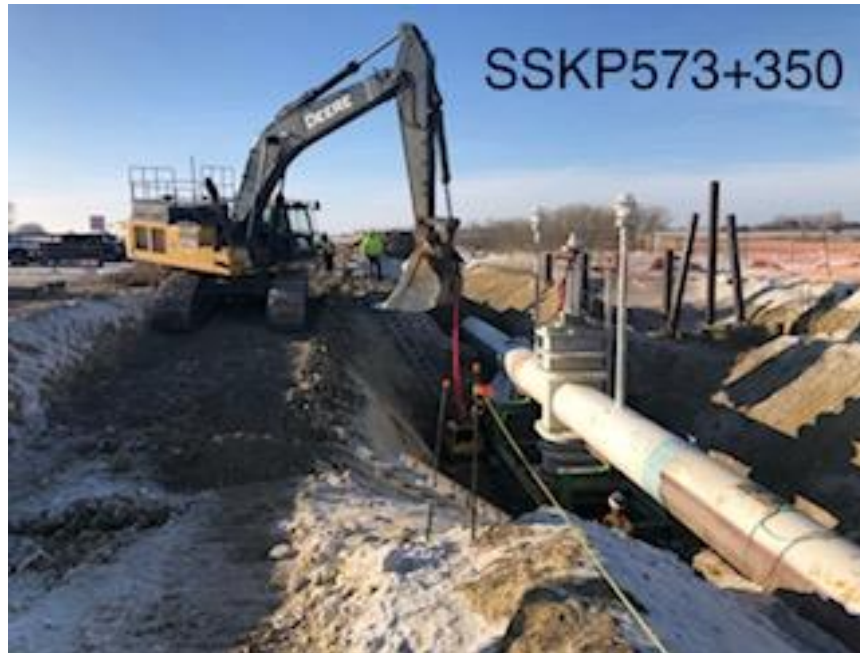
Beginning of MLBV15 compaction area requires 6inch grade to lift
