SGS MUSCOWPETUNG

ABORIGINAL CONSTRUCTION MONITORING

WEEKLY REPORT

NOVEMBER 12TH TO NOVEMBER 18TH, 2018

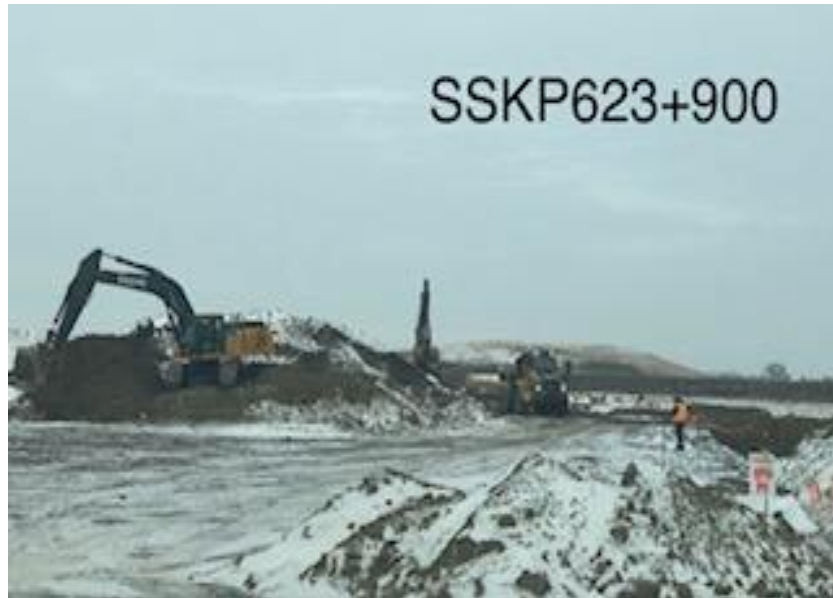
Backfill on west side of Chapleau Lake SK WC68

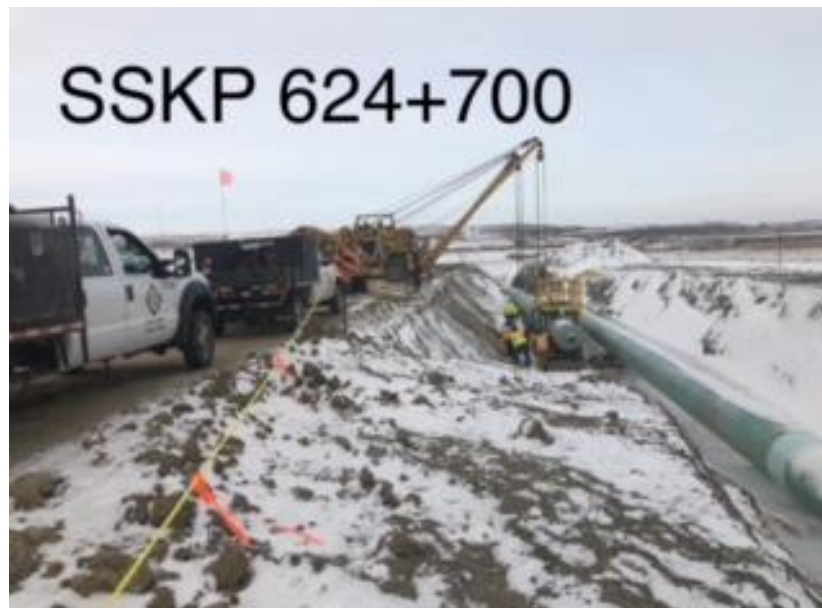
Test head in the main line ditch SSKP624+700

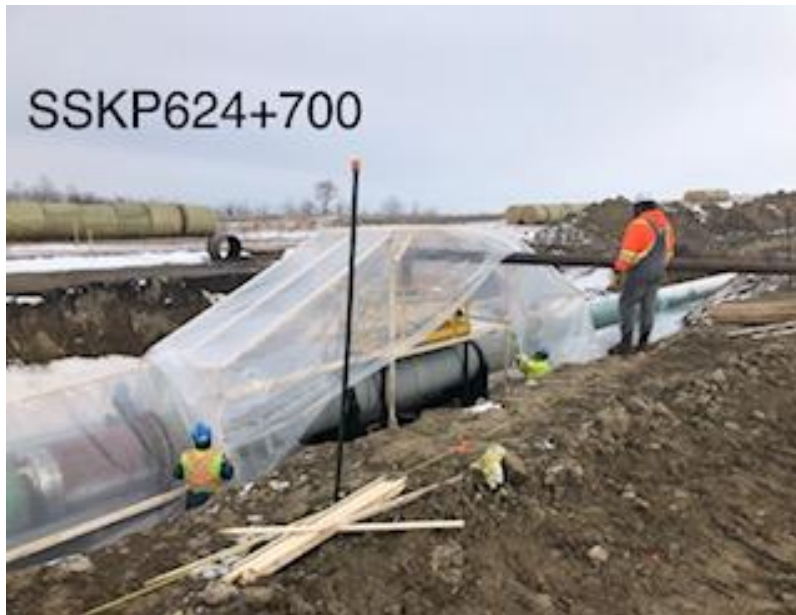
Banister crew members hoarding the test section

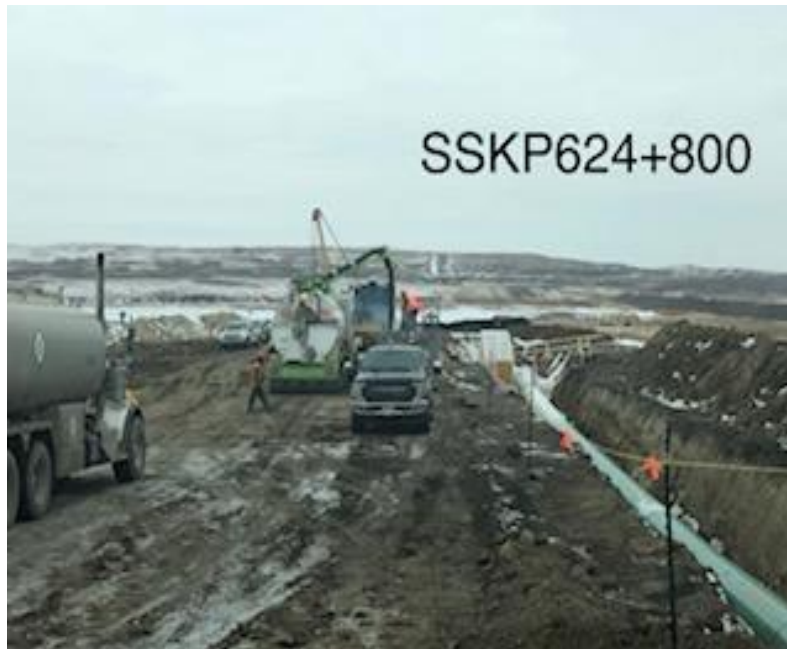
Setting up equipment at Chapleau Lake east

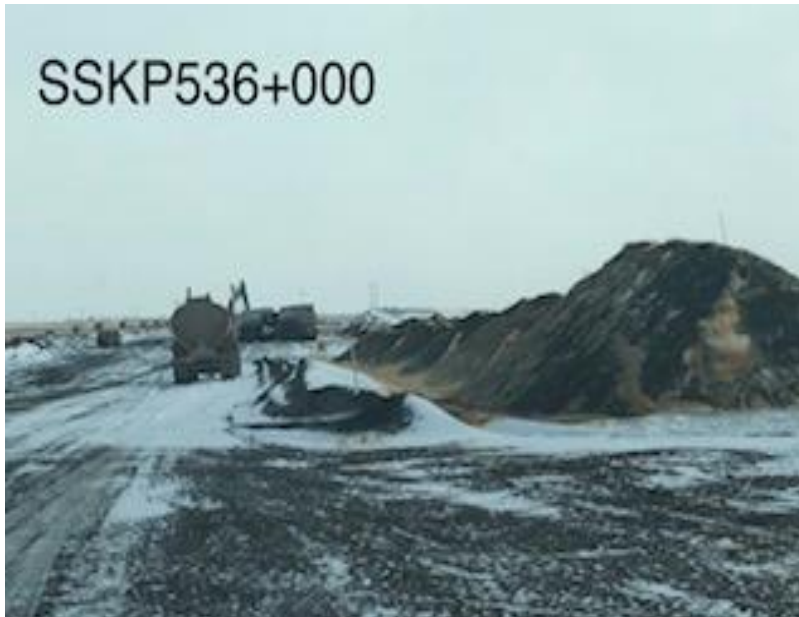
SSKP536+000

Soil separation layer SF4 East

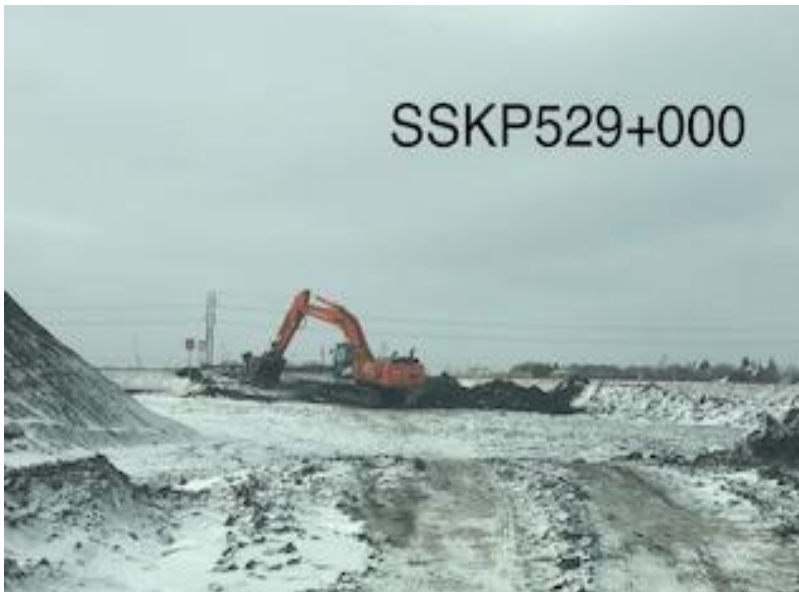
SSKP529+000

Road ramp removal kick off east
