SGS MUSCOWPETUNG

ABORIGINAL CONSTRUCTION MONITORING

WEEKLY REPORT

NOVEMBER 26TH TO DECEMBER 2ND, 2018

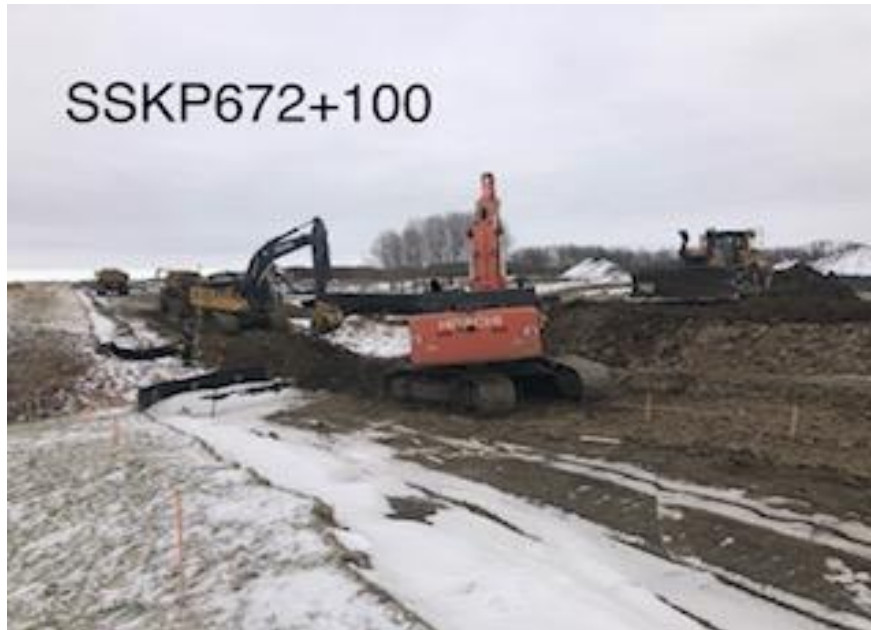
Water Course Unnamed drainage SK WC74 SSKP672.1 Excavation

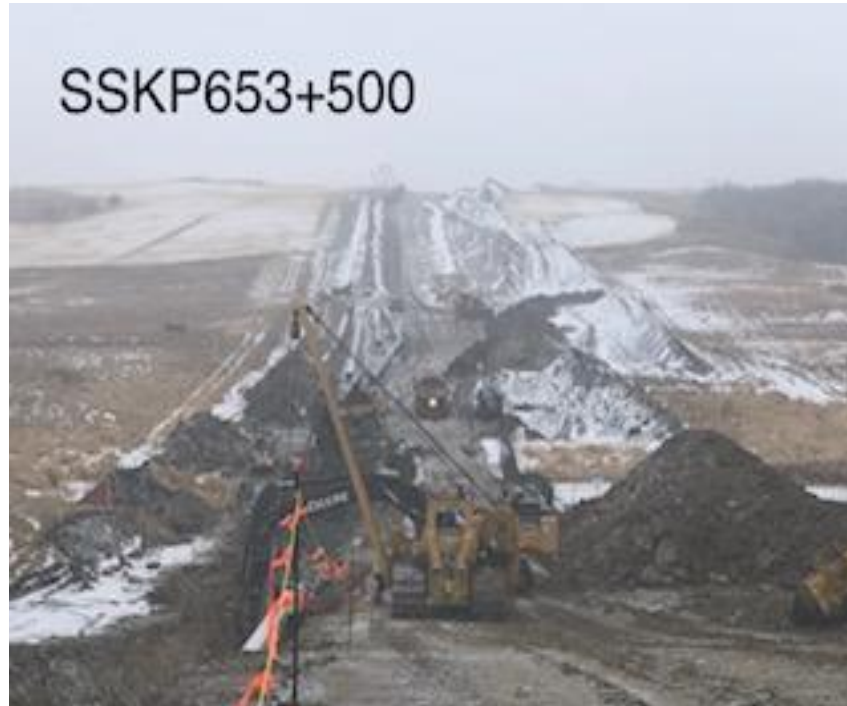
Water Course Vipond Creek SK WC72 SSKP653.52 Excavation

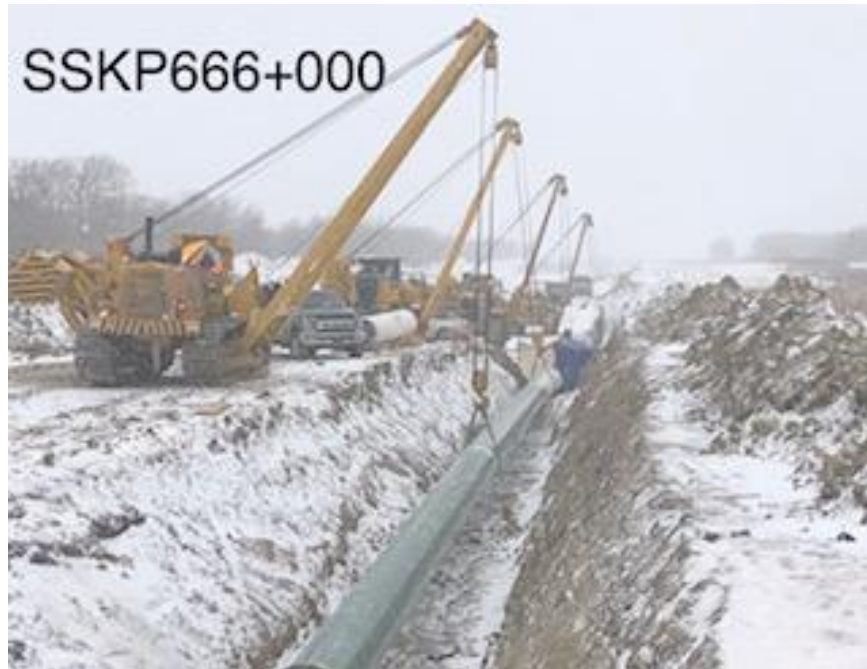
Lowered in section and tie in at wet land crossing SK597

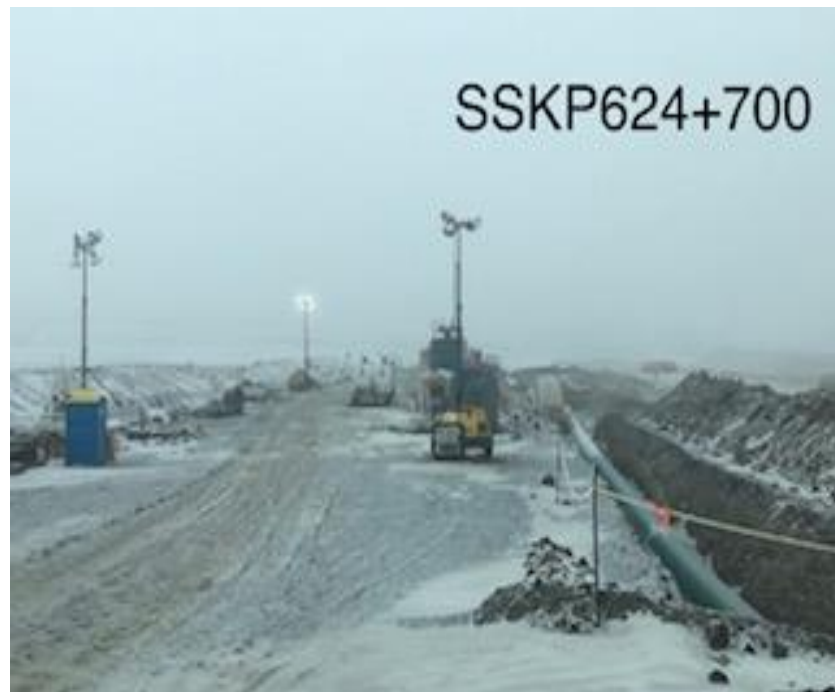
Chapleau Lake SK WC68 – high pressure test area

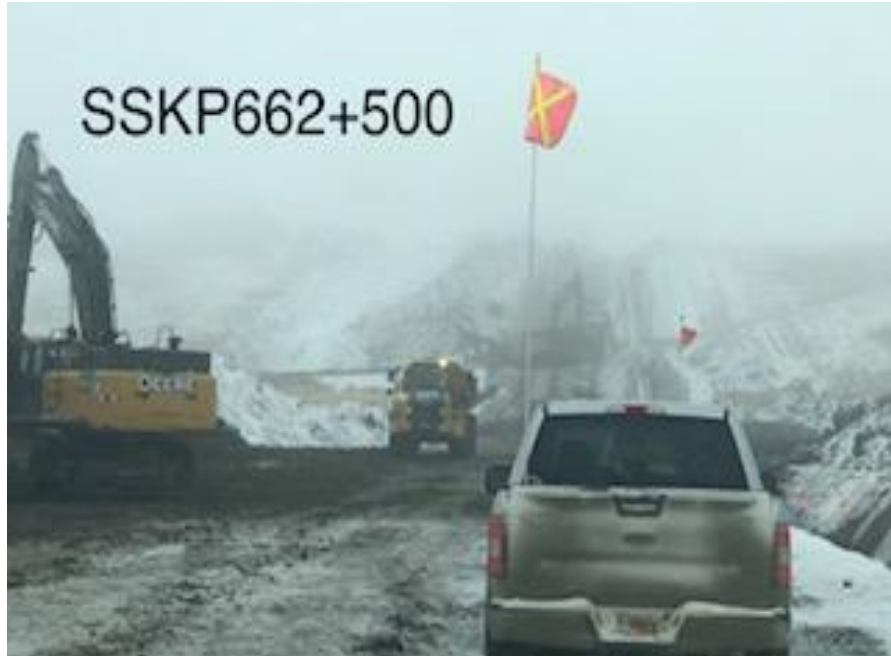
Backfill at Vipond Creek SK WC72

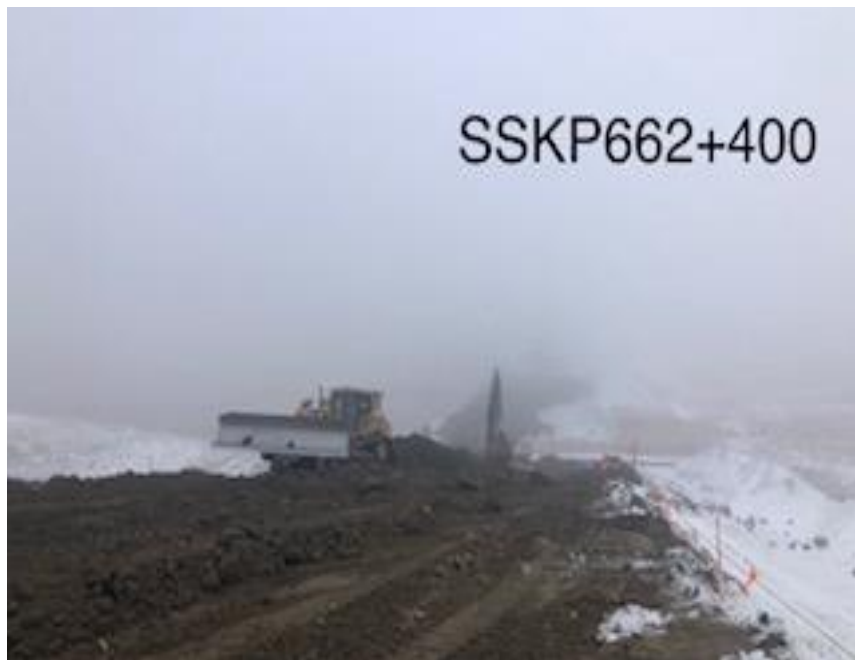
Backfill continues at Vipond creek SK WC72

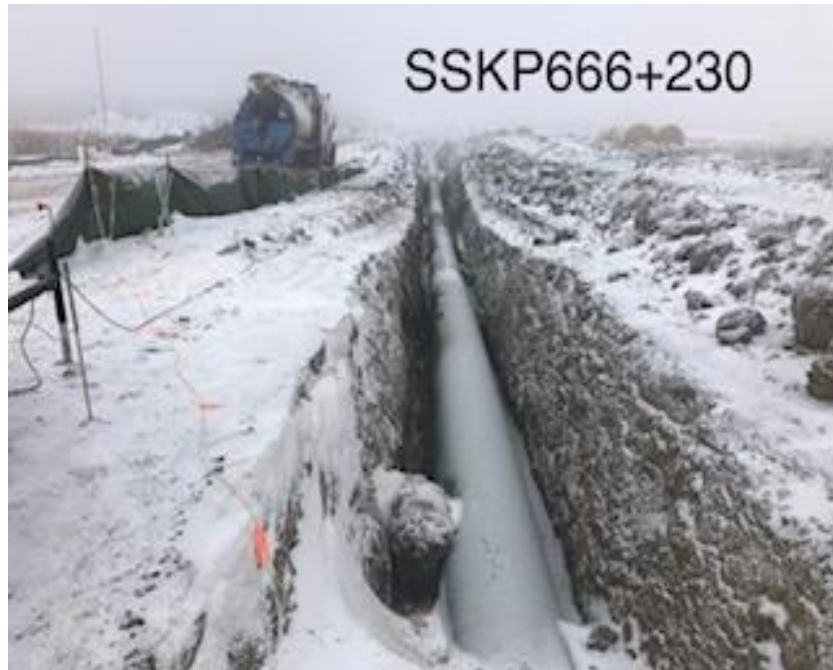
Hydro Vac truck de-icing and draining mainline section before backfill

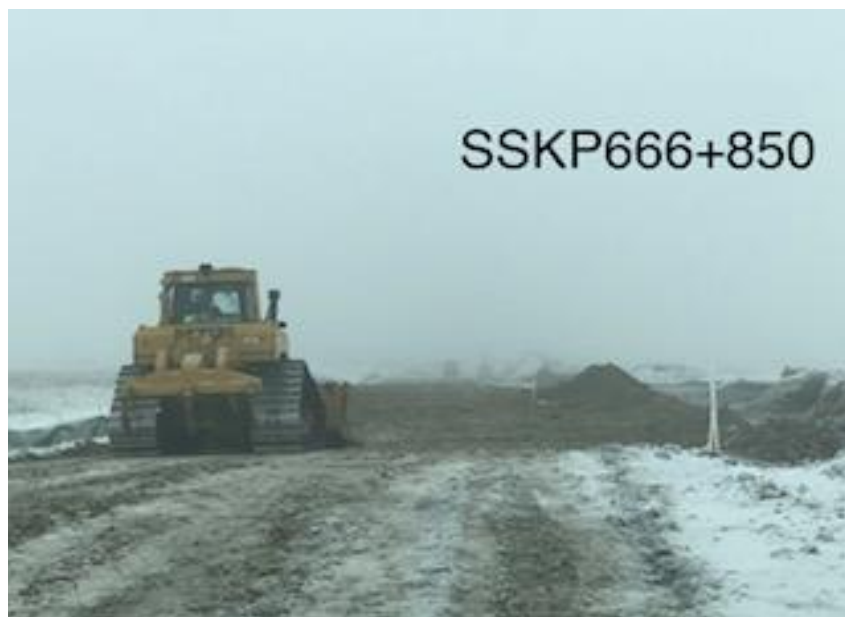
D6 levelling the right of way making accessible for pipeline equipment and trucks
