SGS MUSCOWPETUNG

ABORIGINAL CONSTRUCTION MONITORING

WEEKLY REPORT

NOVEMBER 5TH TO NOVEMBER 11TH, 2018

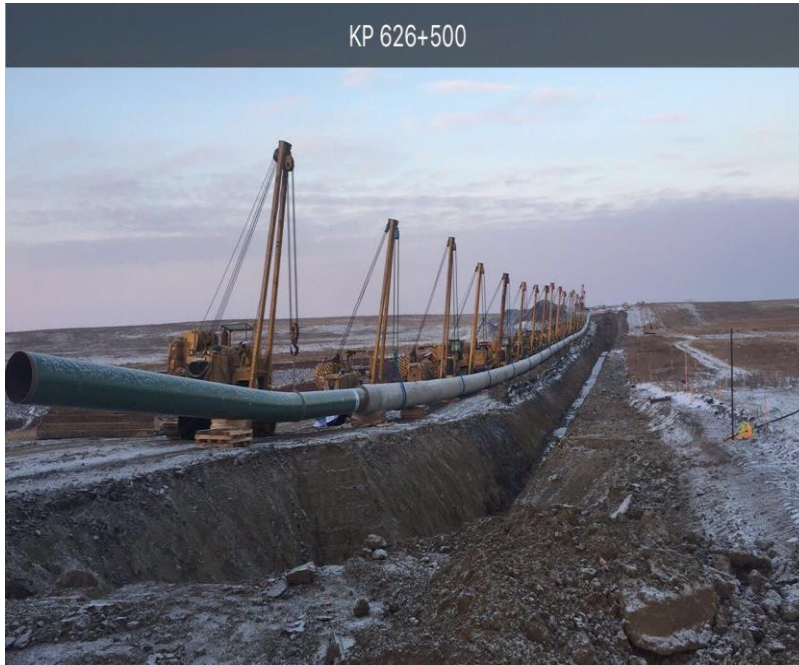
Prepping to lower in gunite section

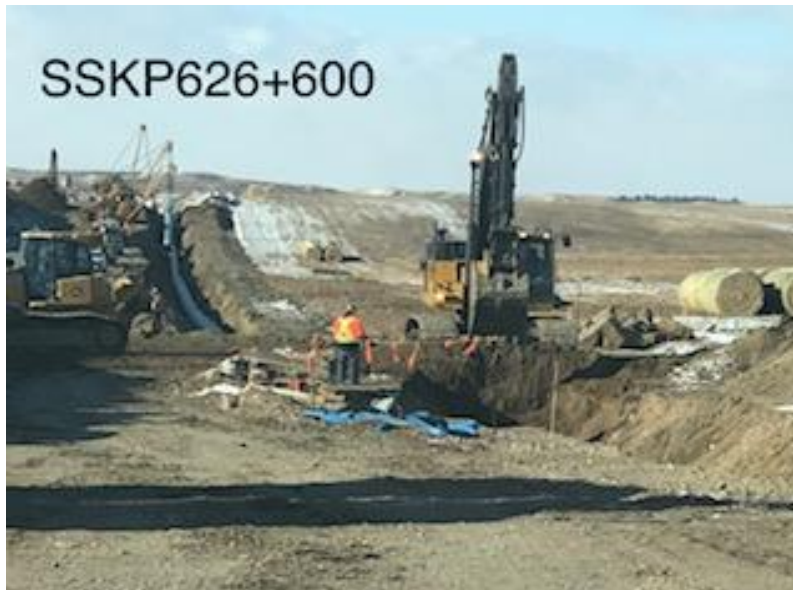
Lowered in gunite section at SF53 East

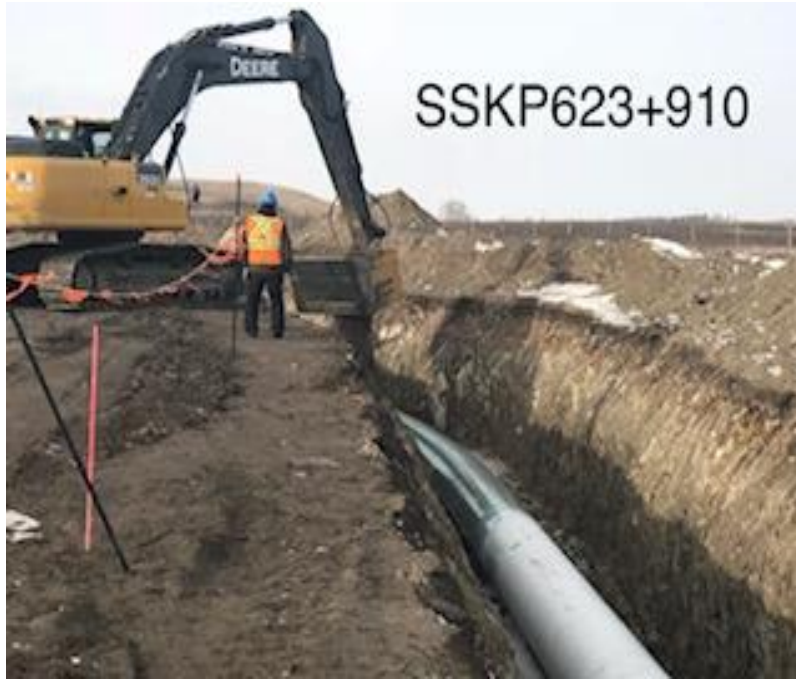
Shading in mainline ditch rock removal bucket

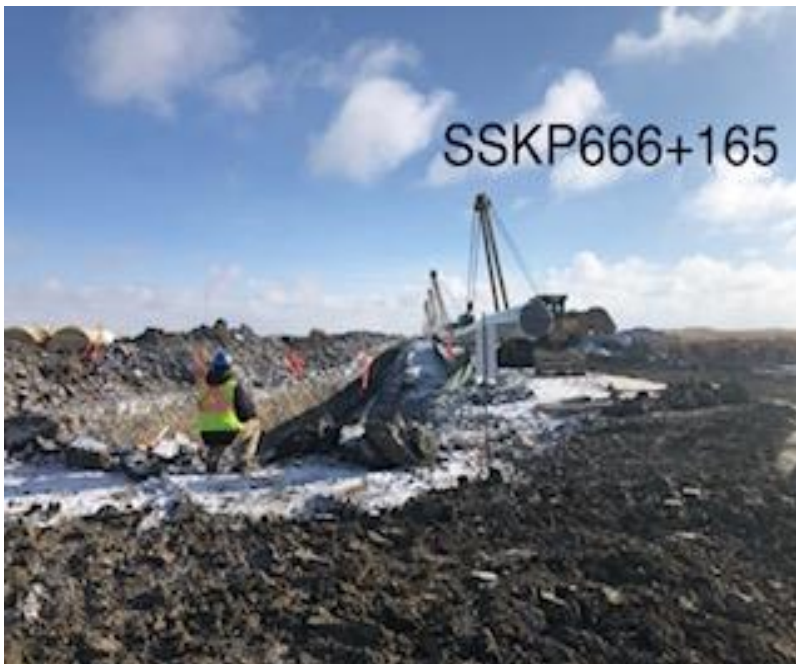
Lowering at SF75 East

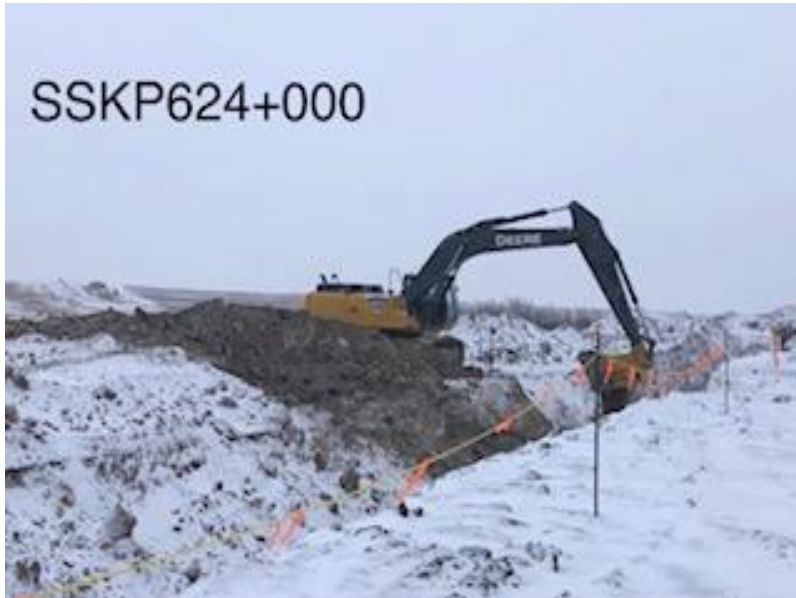
Shading in at Chapleau Lake west

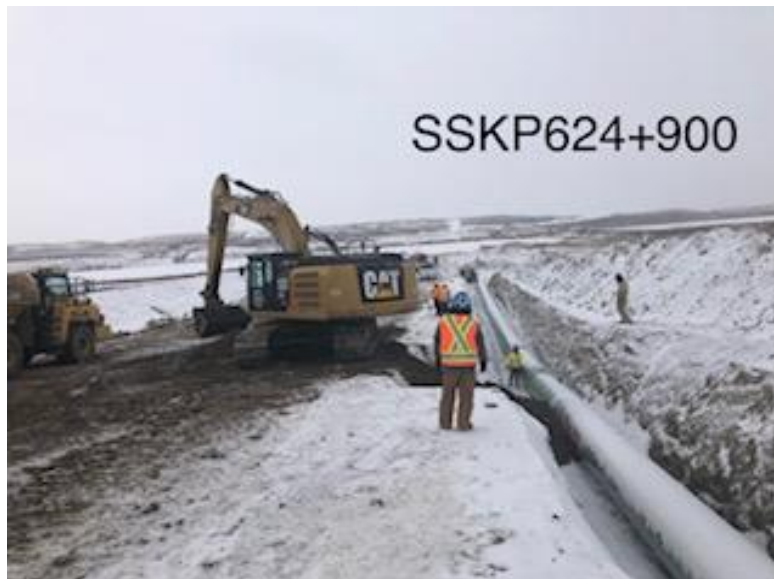
Backfill bellhole Chapleau Lake East
