SGS MUSCOWPETUNG

ABORIGINAL CONSTRUCTION MONITORING

WEEKLY REPORT

OCTOBER 28TH TO NOVEMBER 4TH, 2018

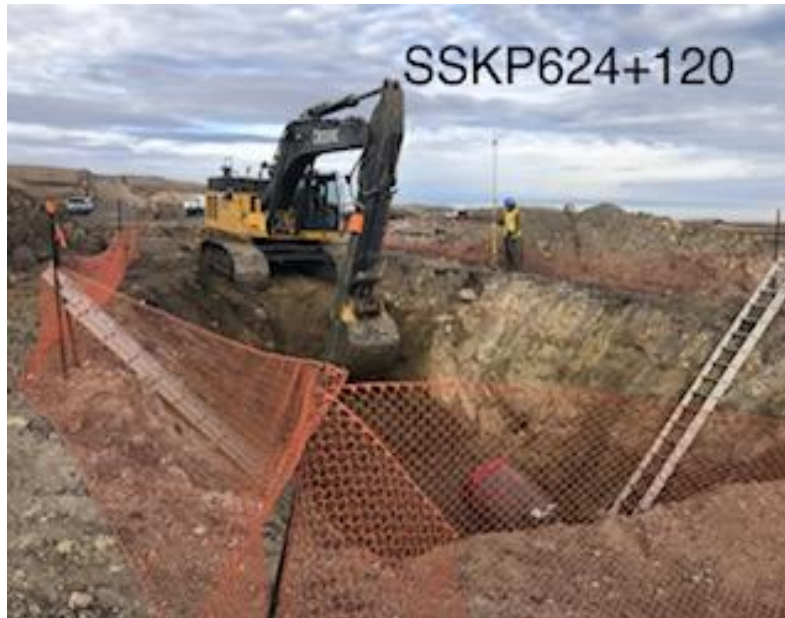
Bellhole excavation HDD exit SSKP624+100

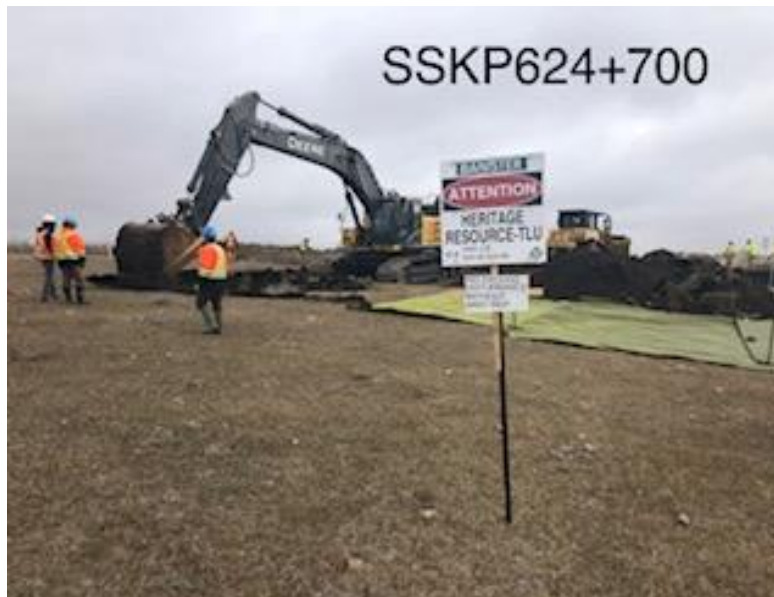
Topsoil excavation HDD entry point SSKP624+700

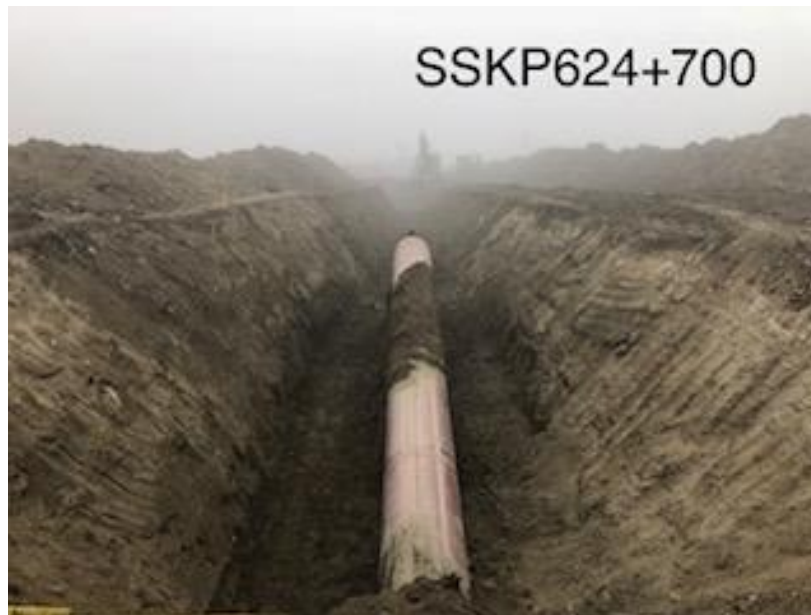
Mainline ditch at SSKP624+700

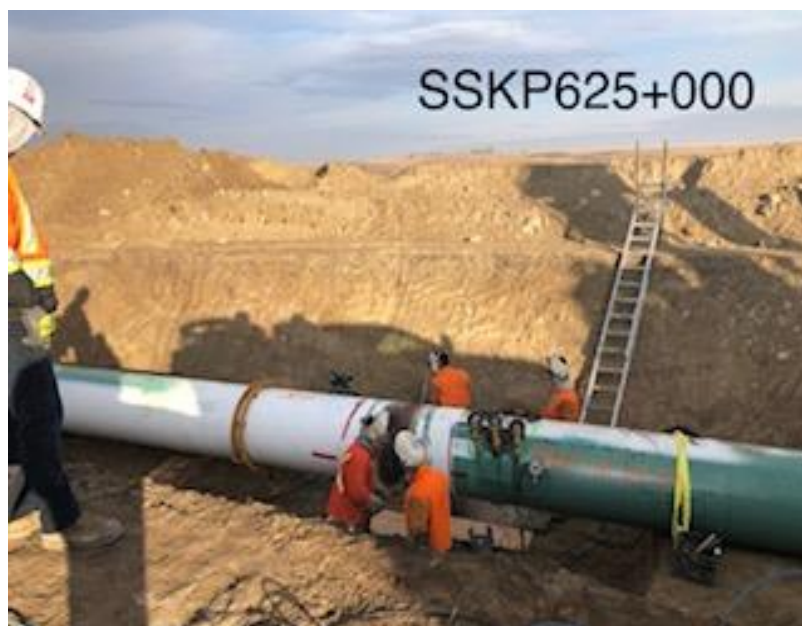
Welding a joint section main line

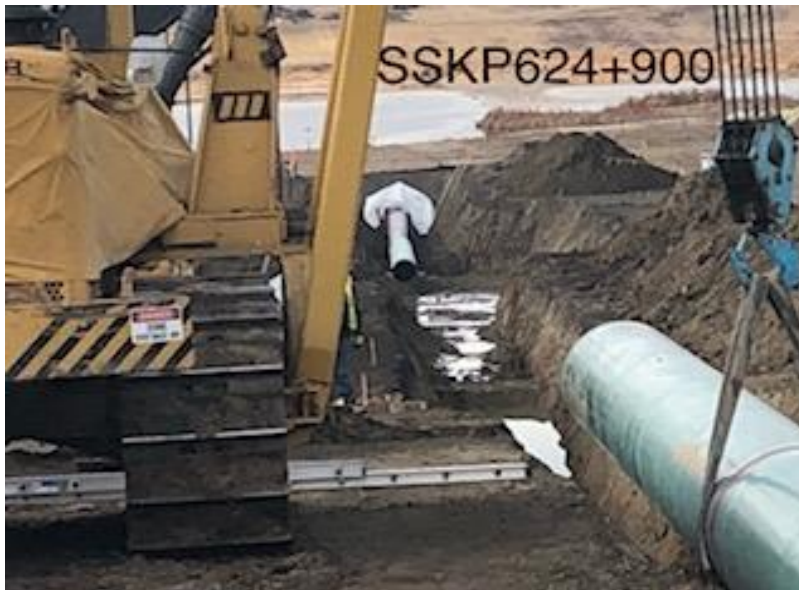
Lowered in sections at Chapleau Lake

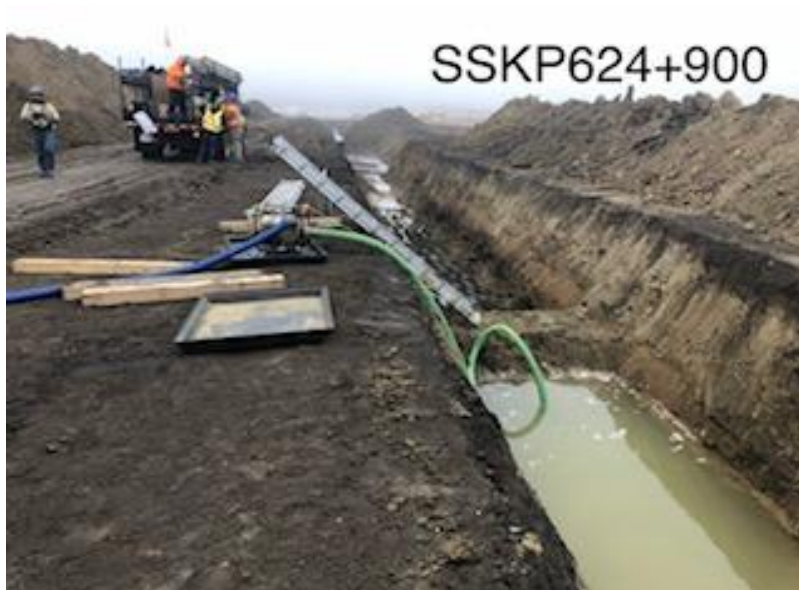
Pump out east side of Chapleau Lake

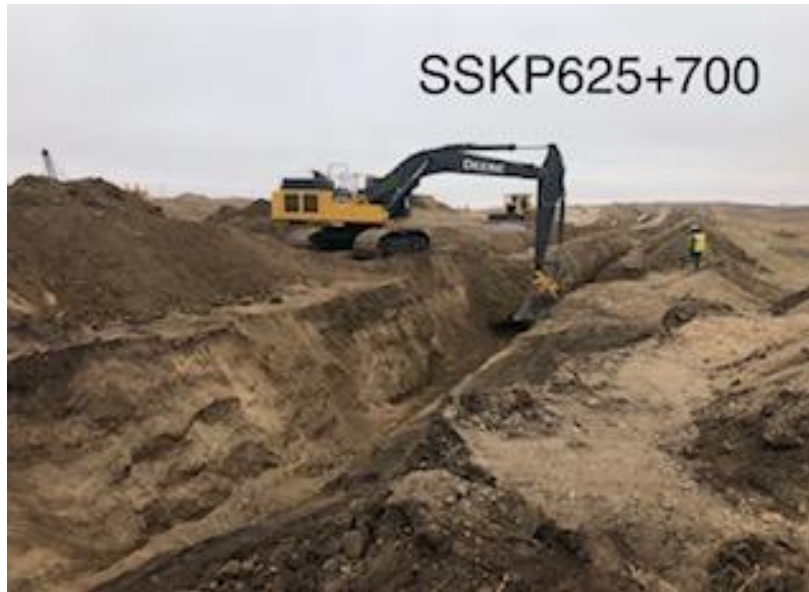
Main line ditch at SF53

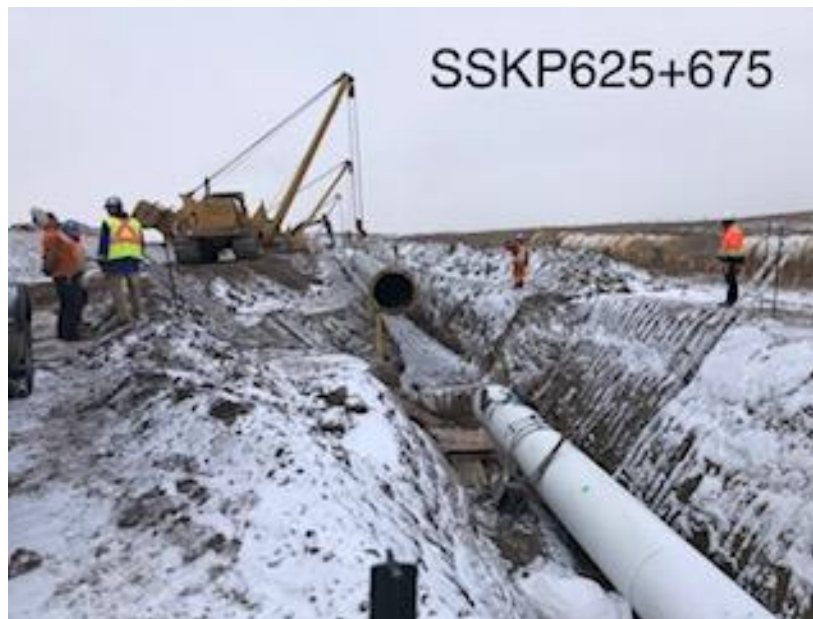
Tie in at SF53 east side
