SGS MUSCOWPETUNG

ABORIGINAL CONSTRUCTION MONITORING

WEEKLY REPORT

FEBRUARY 11TH TO FEBRUARY 17TH, 2019

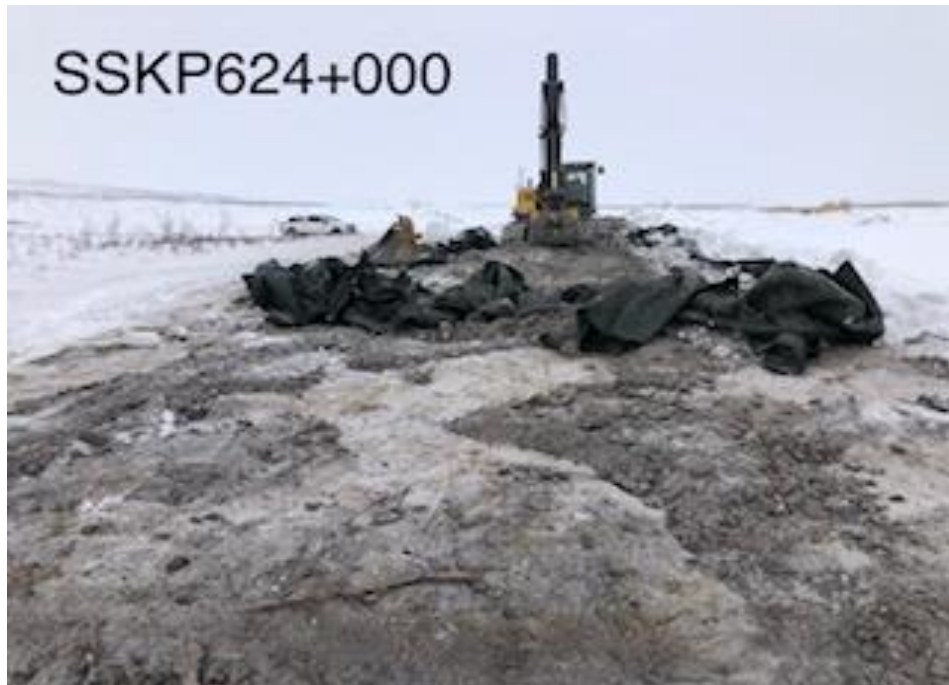
Ramp removal at a rare plant area VG57

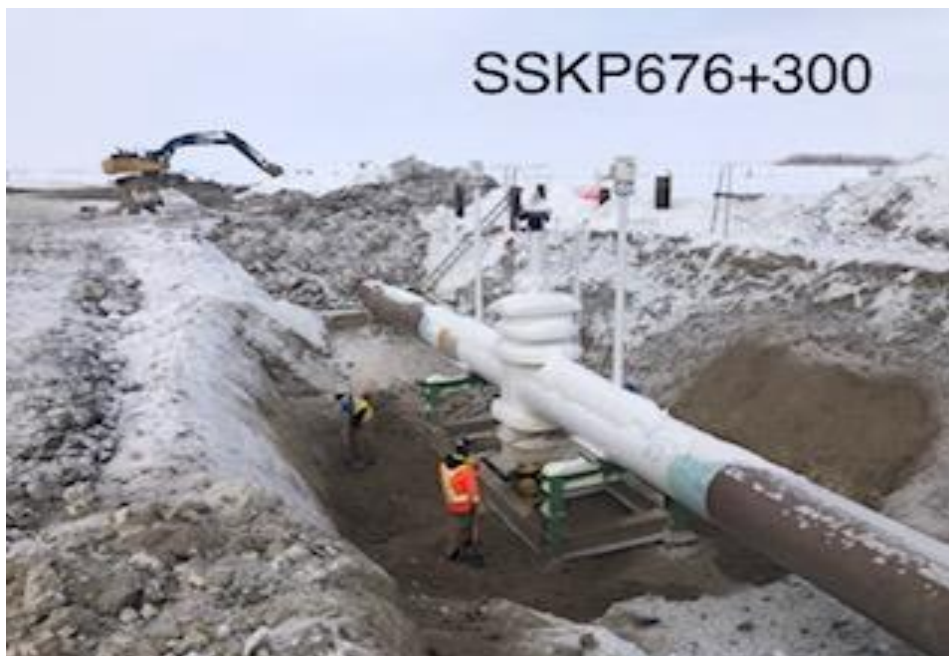
Compaction started at MLBV17 – sand fill worker breaking down hard clay with hand shovel before use of compaction plates.

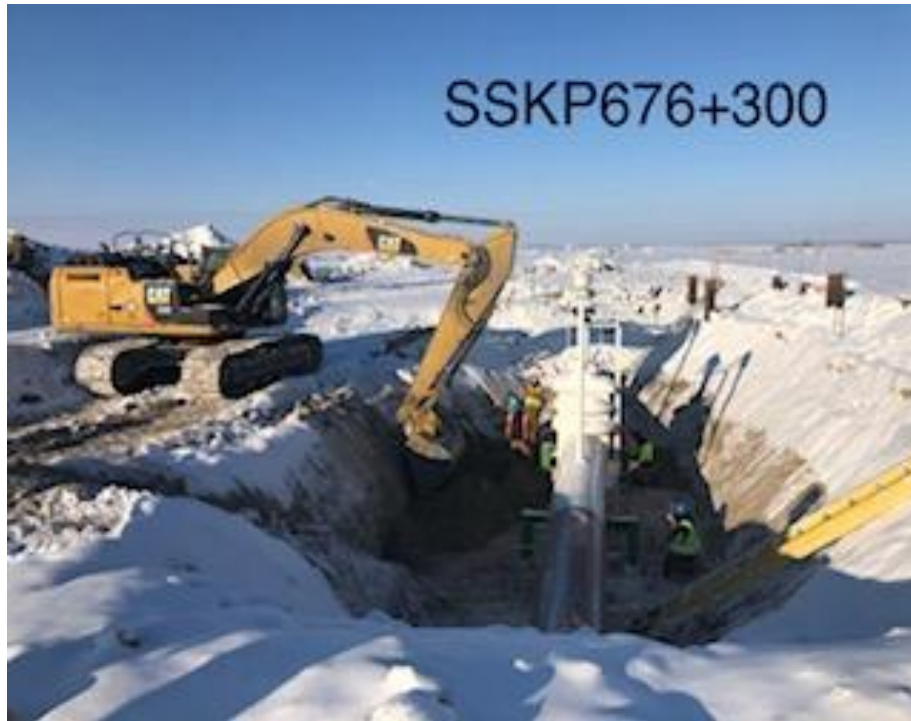
Sand fill being shaded in by bucket – spotter inside trench area used whistle to alert other workers during the backfill process. (Safety feature)

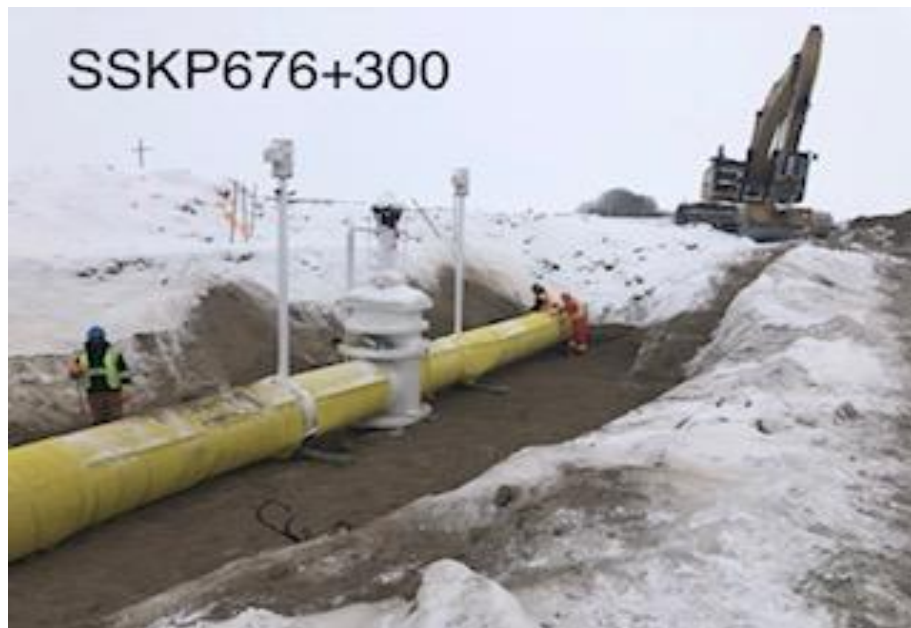
Workers applied rock shield - rock shield is a plastic mesh used as pipe guard to protect pipeline from rocks when backfilled. Rocks can easily damage the pipes protective coatings and the rock shield mesh helps to cushion any impact during the backfilling.

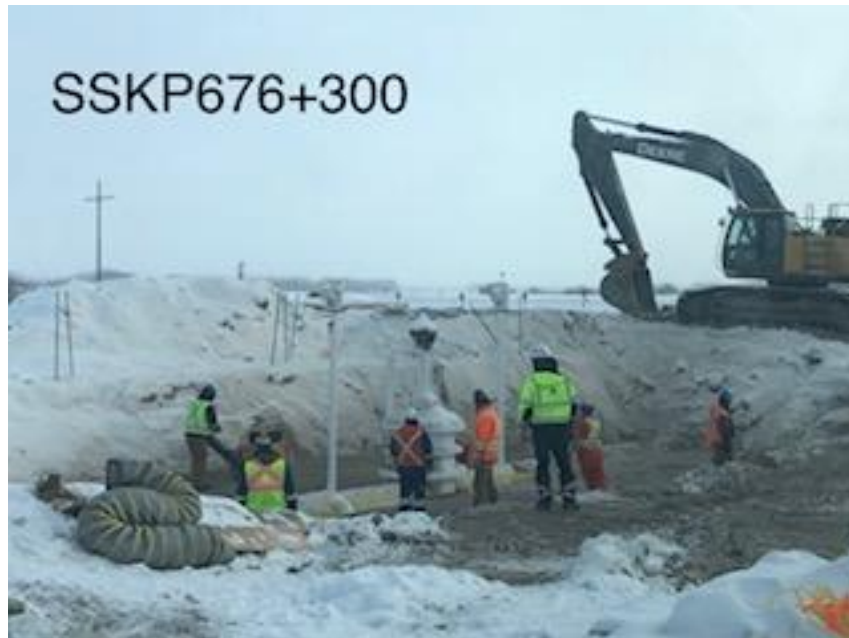
Pinter & Associates LTD employee conducting compaction test testing 5 areas in the pad area after each lift

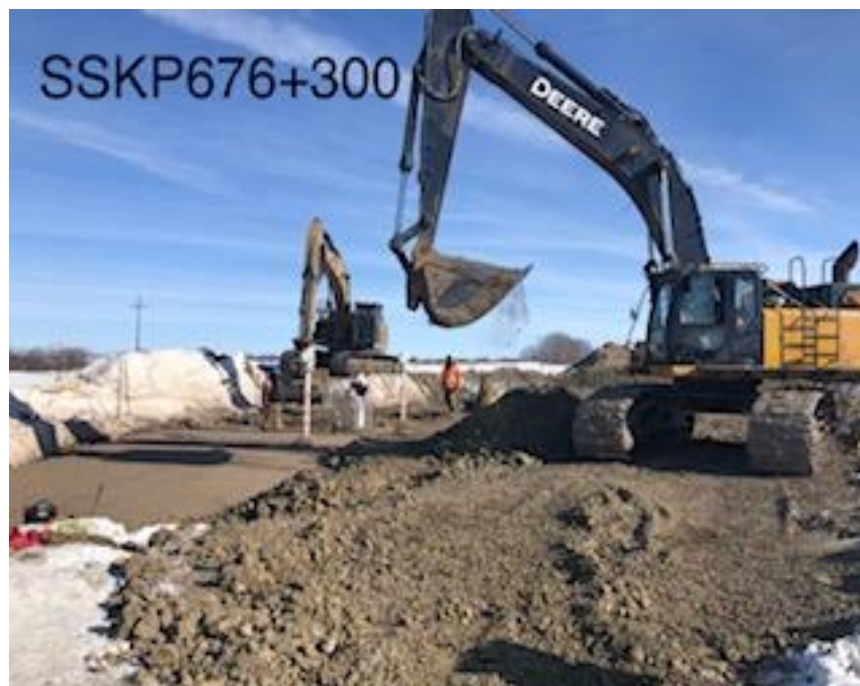
Sand compaction completed, backfilling MLBV 17 valve station with subsoil from trench area - Final lift reached!
