SGS MUSCOWPETUNG

ABORIGINAL CONSTRUCTION MONITORING

WEEKLY REPORT

SPREAD # 5

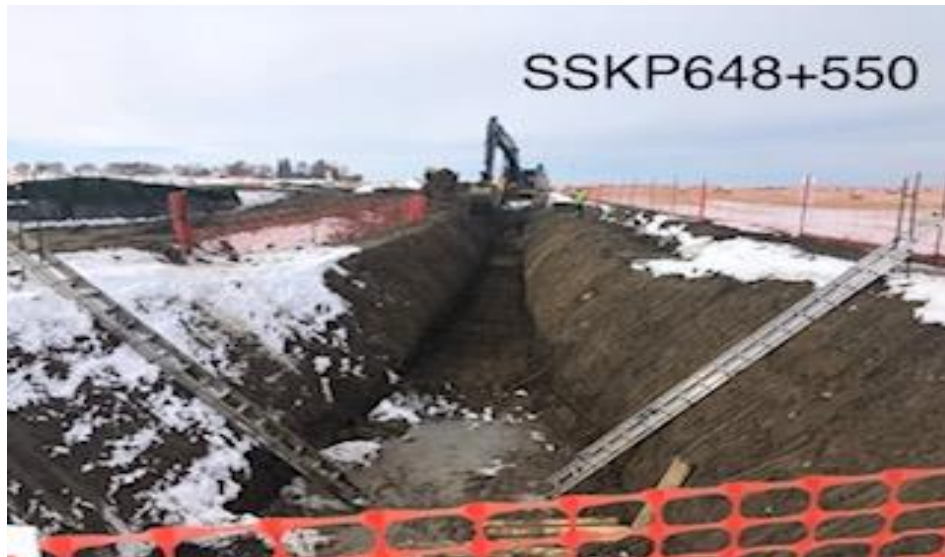
Bell Hole excavation

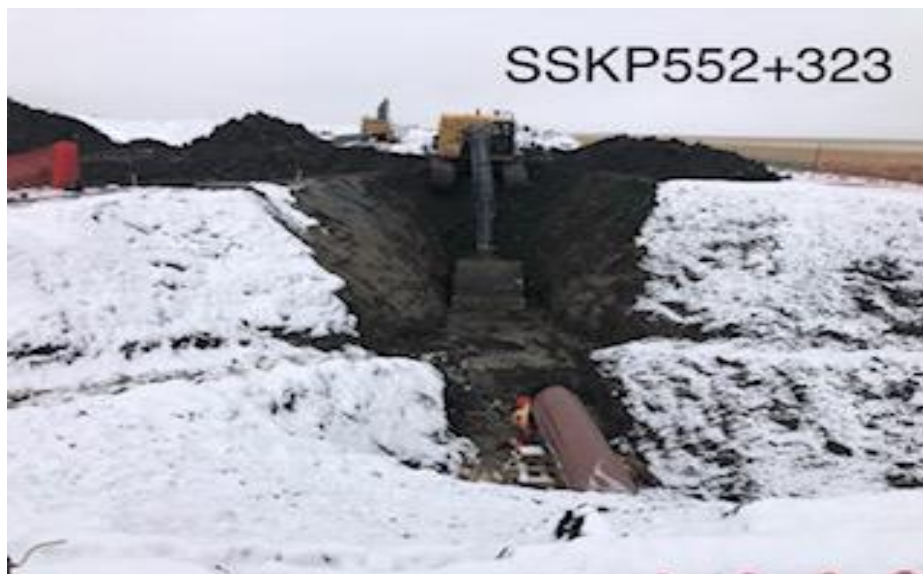
Excavating for tie in

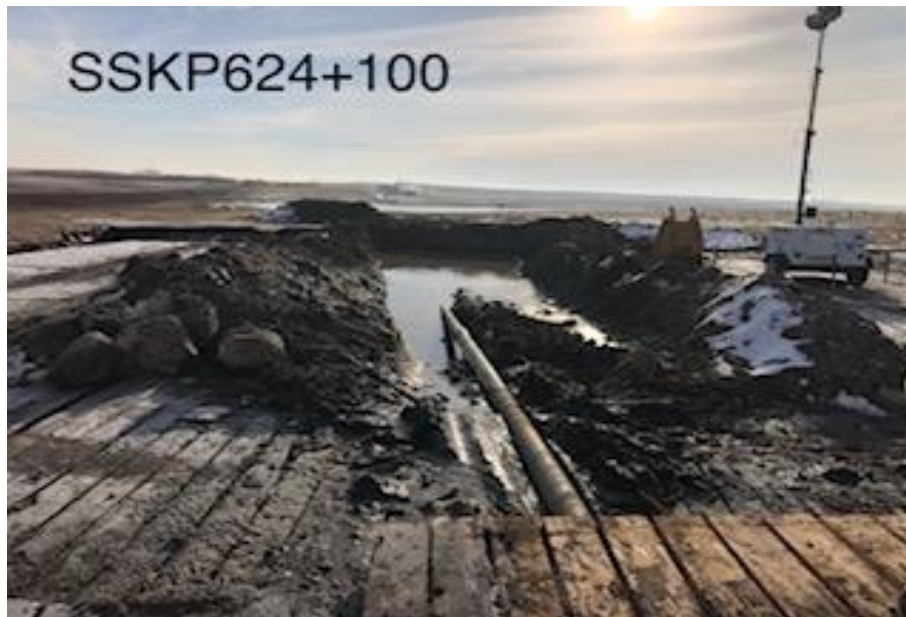
HDD exit site

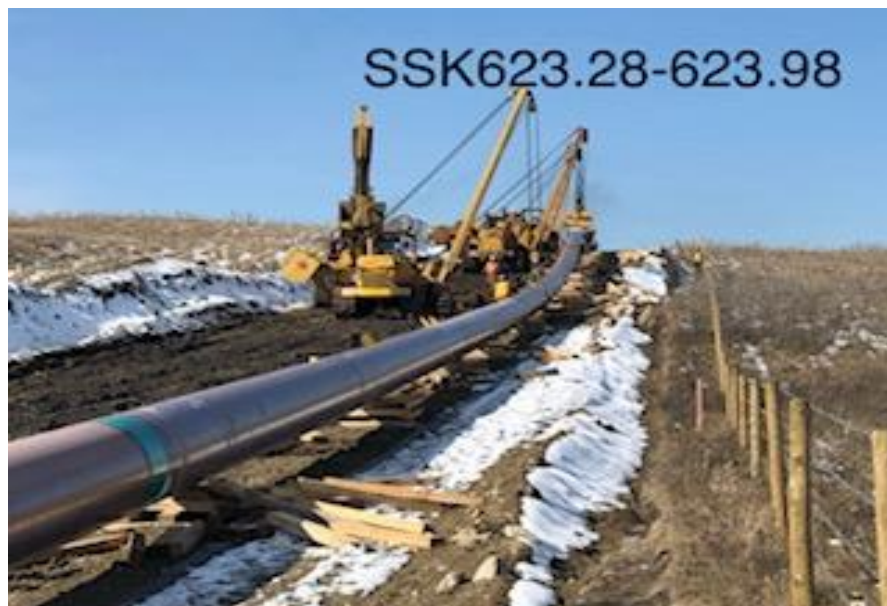
Side booms used to put Section onto rollers in preparation for pull
