**SGS MUSCOWPETUNG**

**ABORIGINAL CONSTRUCTION MONITORING**

**WEEKLY REPORT**

**SPREAD 5**

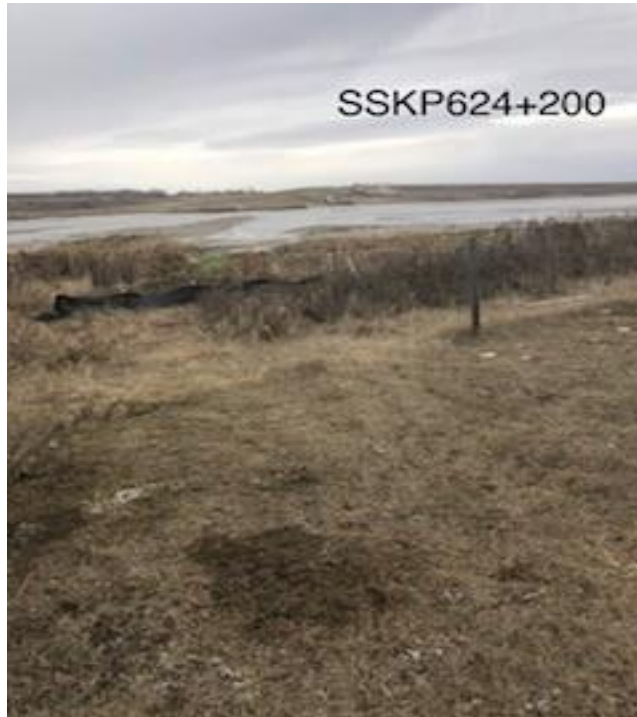
Beginning of the week, following up at Chapleau Lake SK WC68 SSKP624.3 on the frac-out clean up area in the Native Prairie Zone SSKP622.28, HER132 SSKP623.23-623.47 & HER133 SSKP623.87-624.13 near the fence line a diesel spill on the ground near the frac-out containment site - notified environment. Clean up requires ground disturbance and archaeologist on site as it is on vegetation and soaked into the soil about 5-10cm. Beveling crews which is commonly used to prepare the ends for welding were coming into the Heritage areas HER129 & HER130. Monitoring the area, the crews come through and picked up any debris from the process as they went through, another crew truck following behind was the crew to make sure the area was left as it was before they entered. Michels continues to demobilize in the HDD area taking equipment out of the area and removing the rig mats from the area.

Diesel spill west on Chapleau Lake

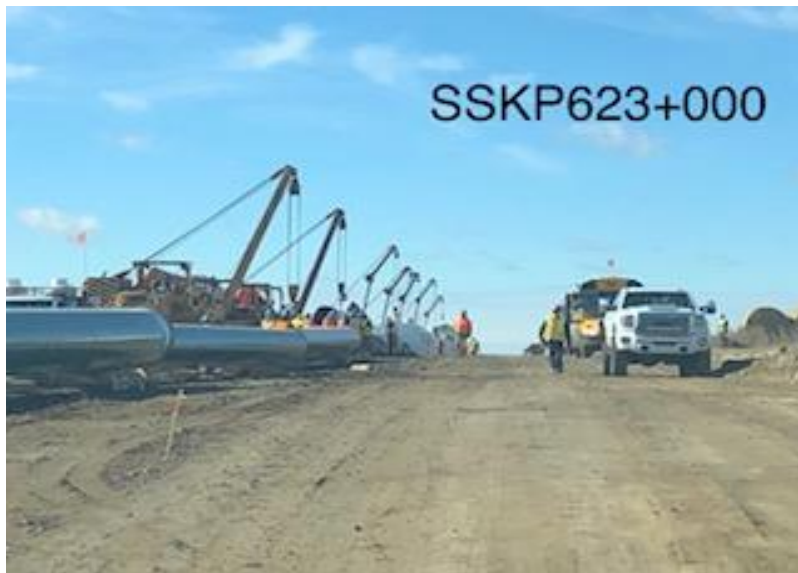
Midweek, at the Chapleau Lake area, poor boy welding crews arrived welding each pipe section together entering through Native Prairie zone SSKP622.28 right up to the SSKP624+000, using a goose which conducts the welds then followed by a hot pass in the shacks, RTD Applus following behind testing by UT scan on the welds. Following them was the coating crews which coat and seal the pipe sections after the weld and test process is complete.

Poor boy welding crew

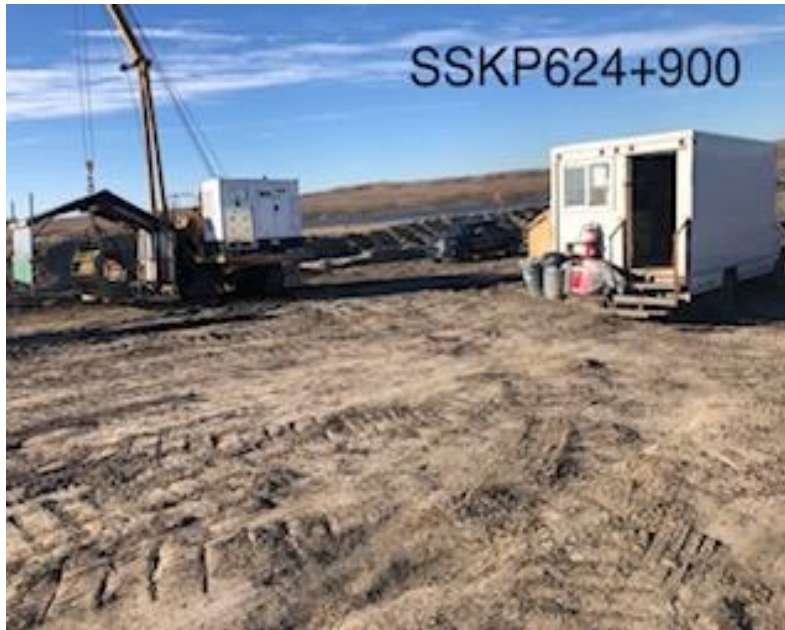
Coating crew mix shack and heater coil shack

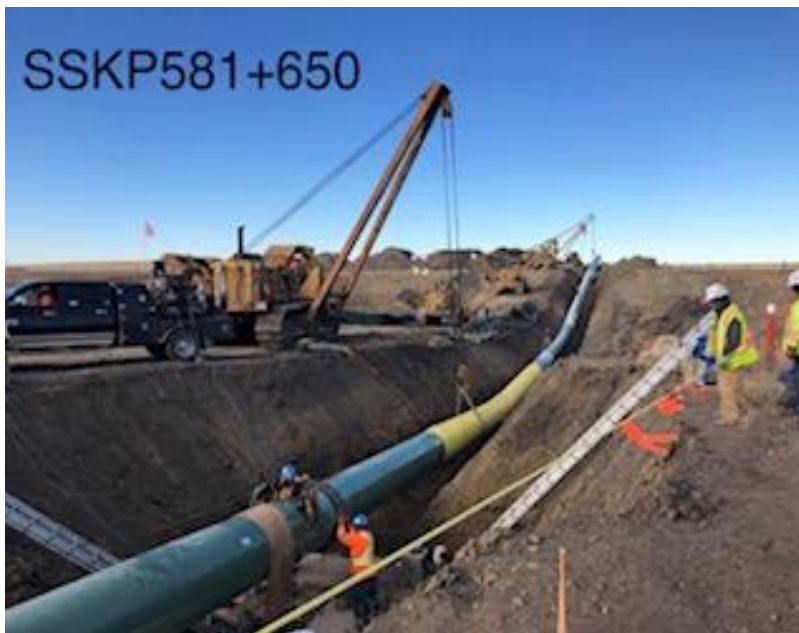
Ending my week monitoring west side of SF27 Water Course crossing Many bones creek SK WC64 SSKP581.58 Crews continued to excavate the bell hole in preparation for lowering in a section and tie in, crews were also pumping out the trench into two different containment areas just off the ROW on ditch side, rock trucks transported the excavated dirt to another area and a dozer pushed it off the road. A semi-truck off loaded a side boom off the road, spotters and flaggers were used to direct traffic during the offloading process, busy road with gravel trucks passing through the area. On the east side of the road, welders were on standby for the tie ins once lowering in the sections was complete and another crew was excavating just off the road, an oiler was used during the process, snow fence and signs were put up in the area. Crews completed the tie-in section in the creek area and continued welding a tie-in off the road with the use of a weld shack, meridian surveyors arrived to map the pipe in the trench area before backfill proceeded. welding crews moving equipment out of the trench area by the creek, Equipment operators and crew were prepping the area for backfill process, operators breaking up the topsoil piles, dozer pushing the soil to the trench area and oilers clearing equipment wheels while waiting for the surveyors to complete the pipe section area. Monitored the Many bones creek SK WC64 SSKP581.81. during excavation, lowering in and tie in process on ending my work week on Saturday.

Manybones Creek lowering in a section
