SGS MUSCOWPETUNG

ABORIGINAL CONSTRUCTION MONITORING

WEEKLY REPORT

OCTOBER 22ND TO OCTOBER 28TH, 2018

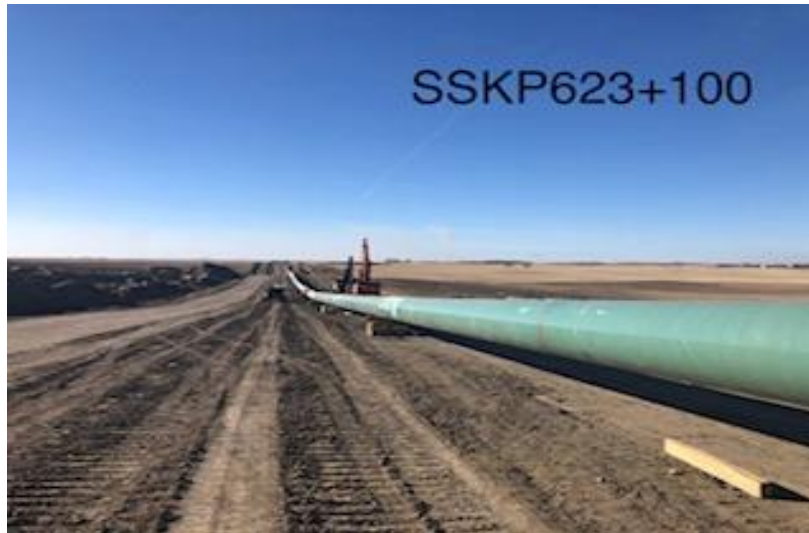
Beginning of the ditch process

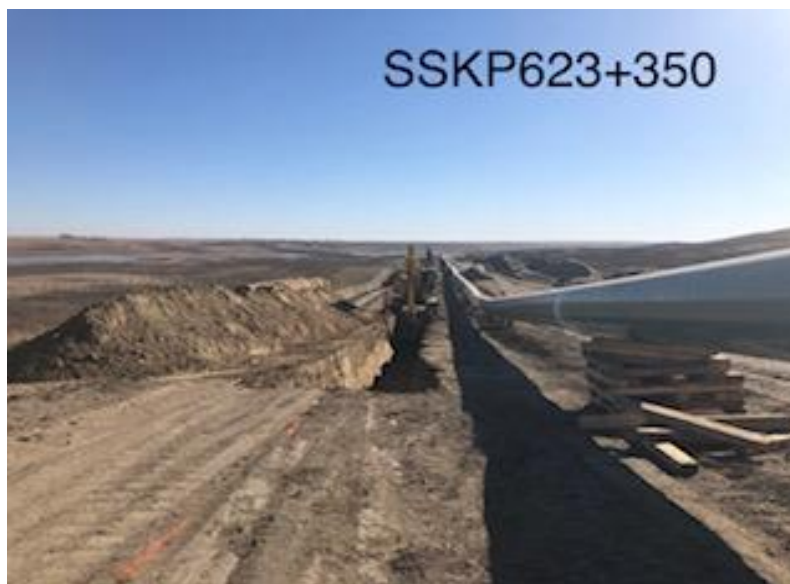
Ditching continues HER132 & HER133

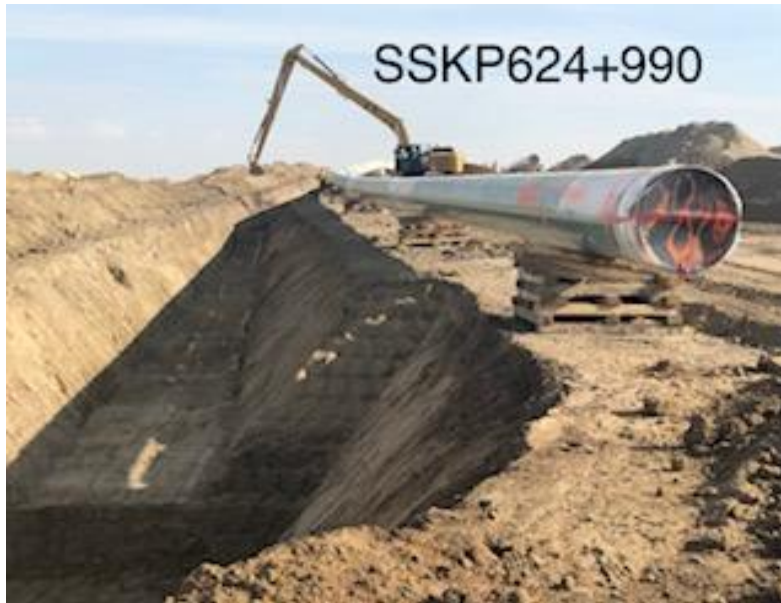
Crews using excavators to create sand bed before lowering

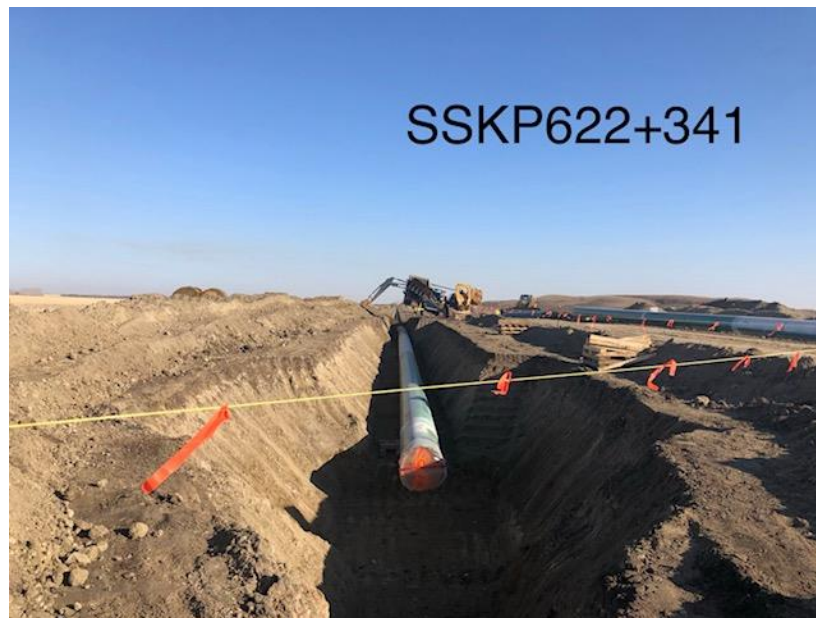
Lowered in mainline section

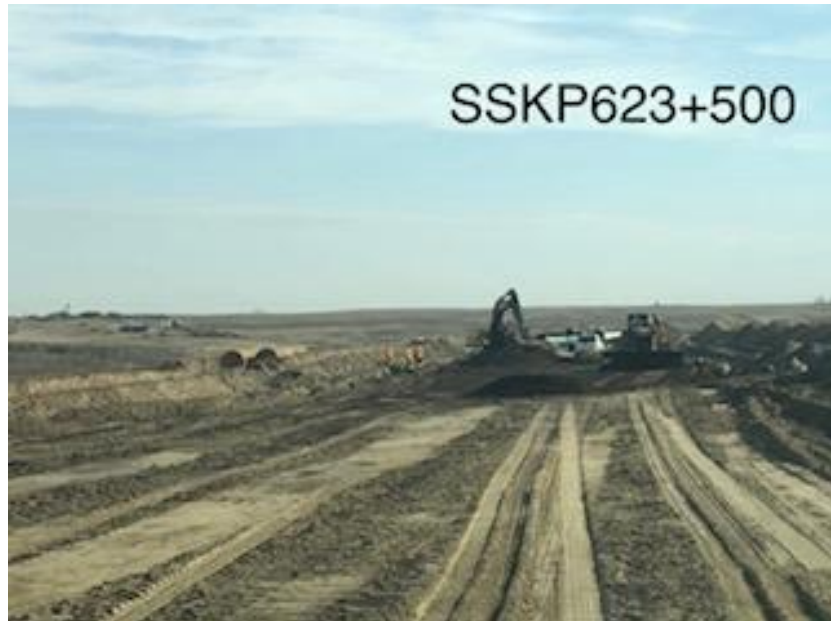
Backfill process on west of Chapleau Lake

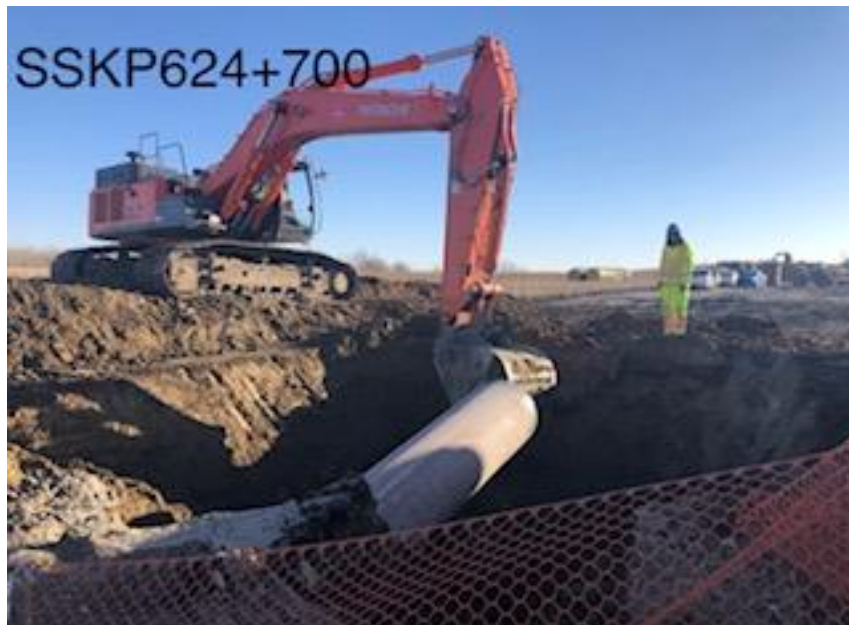
Excavating around pipe in preparation for hydro test

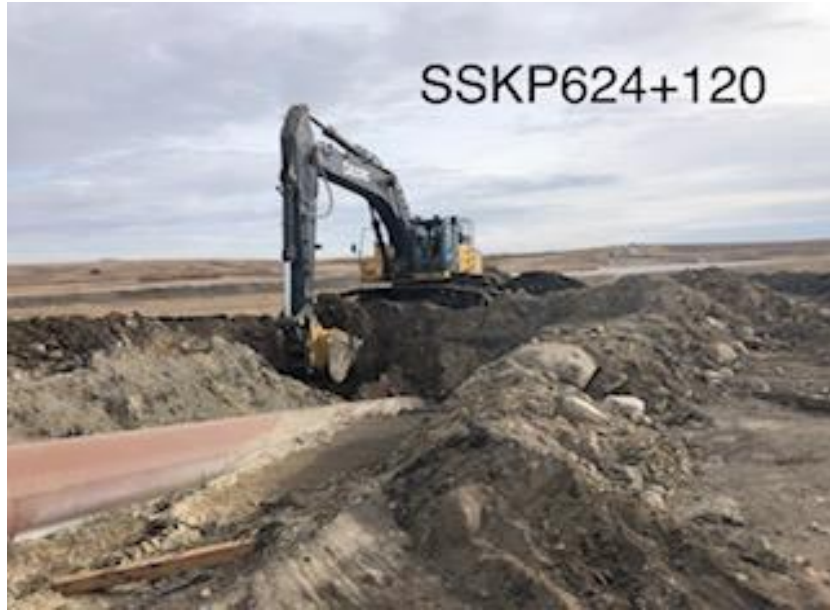
Excavating around HDD area for cut out
