SGS MUSCOWPETUNG

ABORIGINAL CONSTRUCTION MONITORING

WEEKLY REPORT

SPREAD # 5

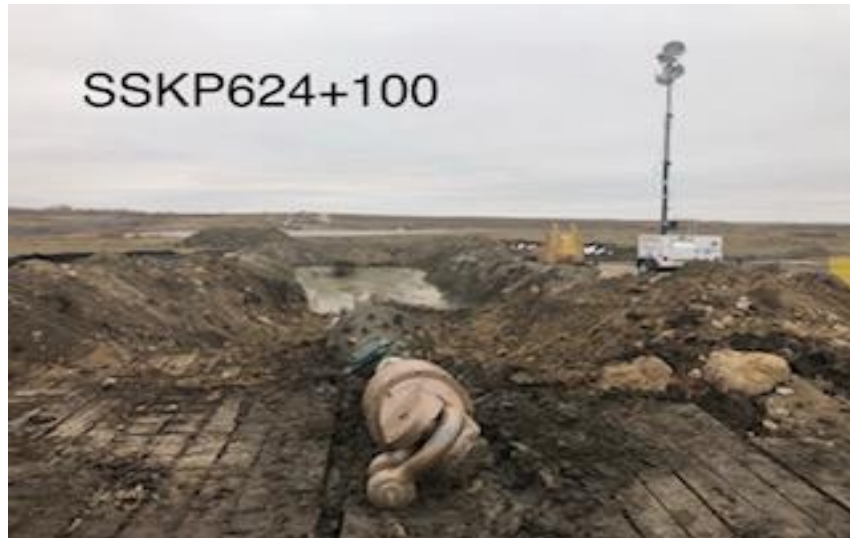
Prepping to pull the drag section at Chapleau Lake

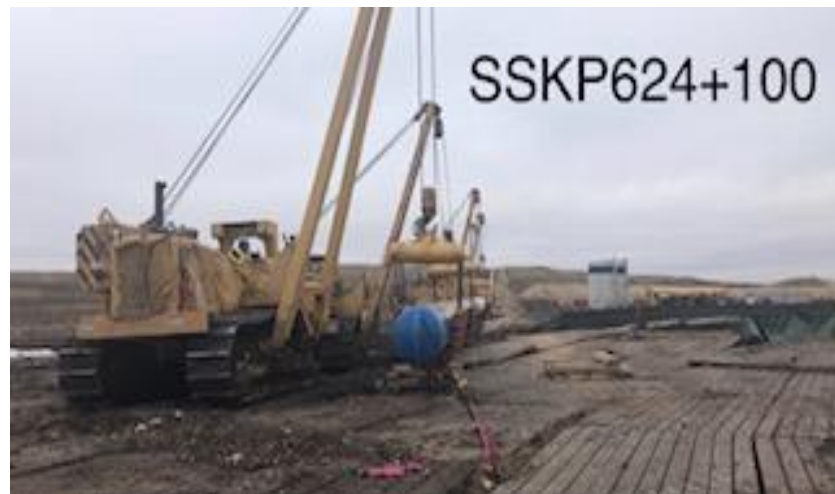
Prepping to pull drag section through Chapleau Lake

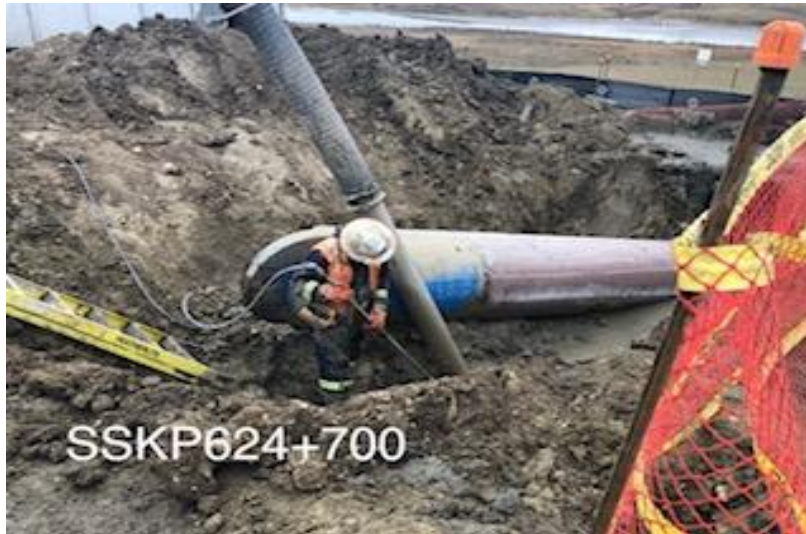
HDD pipe section reaching east side of chapleau

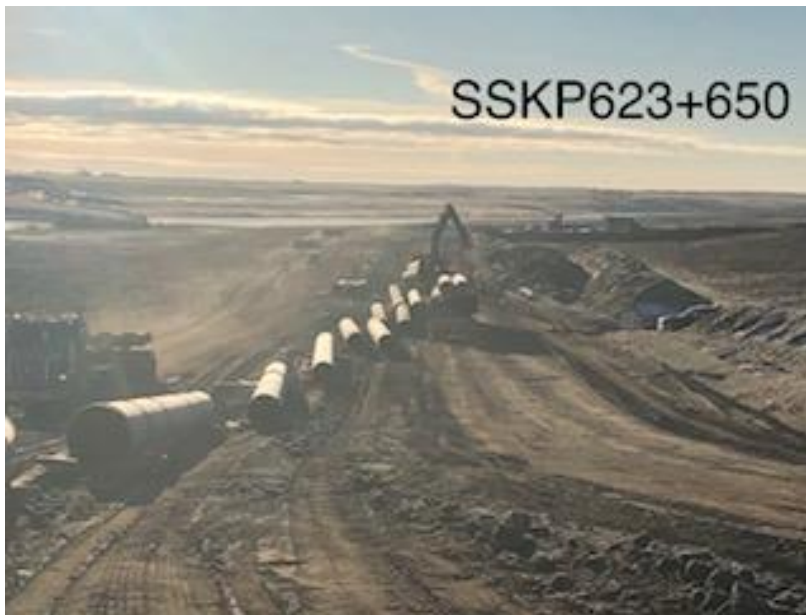
Stringing Crew West of Chapleau Lake

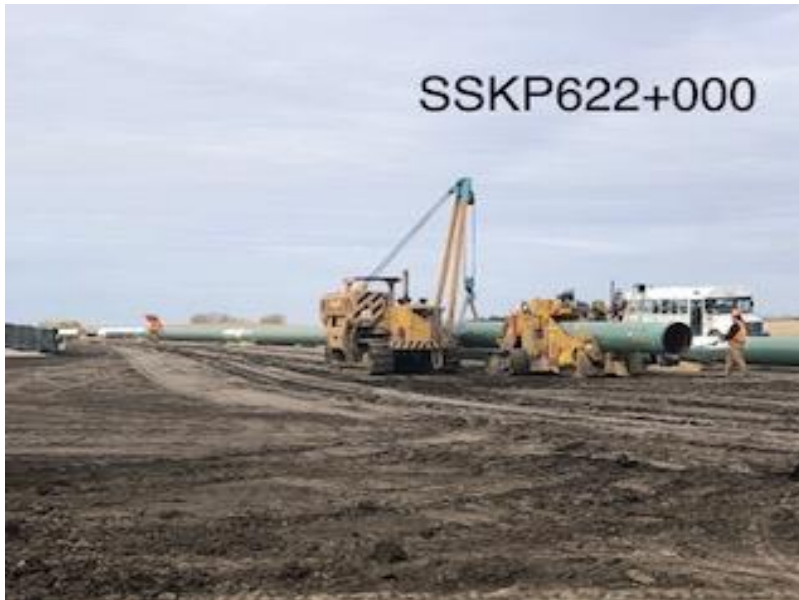
Bending crews reaching Native Prairie Zone SSKP622.28

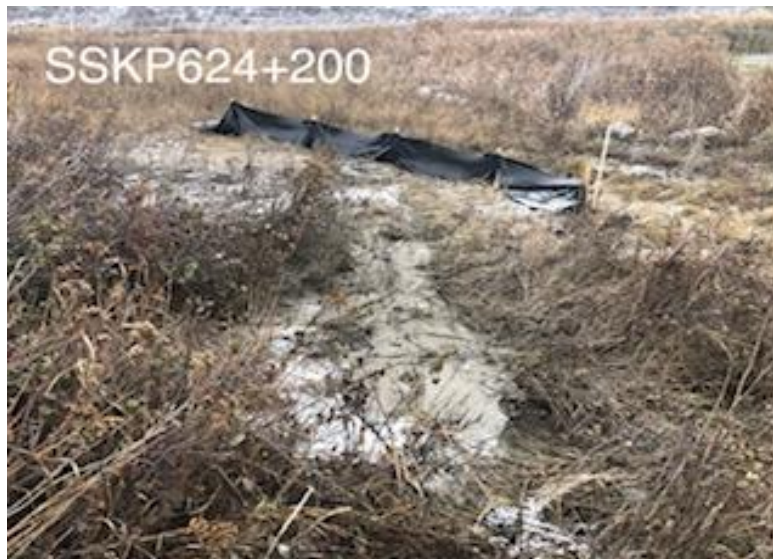
Finishing my week at Chapleau Lake, entering Native Prairie Zone SSKP622.28 going down to the west side of Chapleau Lake SK WC-68 Michels crews went down by the lake where frac-out occurred, hydro vac truck was brought in to help contain the frac-out the truck was out of gas and one truck broke down and another equipment was not working properly so had to wait till they returned. The area where frac-out occurred was new crew members put sand bags around the containment site and silt fence and swept up what they could into the hydro vac truck near the HER134 SSKP624.50-SSKP624.71. In that same area west of ROW bending crews started the bending process finishing up bends at the Rare plant area VG57 SSKP624.02 leading to the native prairie zone SSKP622.28, HER132 SSKP623.23-623.47, HER133 SSKP623.87-624.13. taking equipment back to the boneyard to demobilize and transport over the east side of Chapleau and continue the bends.

Frac-out west side of Chapleau Lake SK WC-68
