SGS MUSCOWPETUNG

ABORIGINAL CONSTRUCTION MONITORING

WEEKLY REPORT

APRIL 29TH TO MAY 5TH, 2019

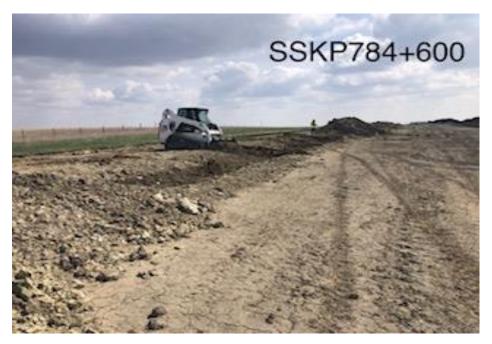
Work on spread 6 continued, starting off with correcting access plug crossings at location SSKP785+500 – a skid steer was used to push roach line soil into areas where the mainline pipe back fill had settled and had caused the ground to concave at several crossings. The settled areas were built up with roach line soil then compacted with the skid steer equipment, in the following locations; SSKP786+800 784+375, SSKP783+900, SSKP783+800, SSKP760+000, SSKP735+000. One area of interest at SSKP789+200 was located near a Heritage Resource area – The operator used the roach line soil to fill the sunken area and compact the area. SSKP692+000 operator cleared and filled in the area in preparation for the mat installation at request of land owner. The operator moved 3 access mats over to the area and made the crossing accessible for farm equipment to cross without damaging pipeline or land area.

Sunken Access plug

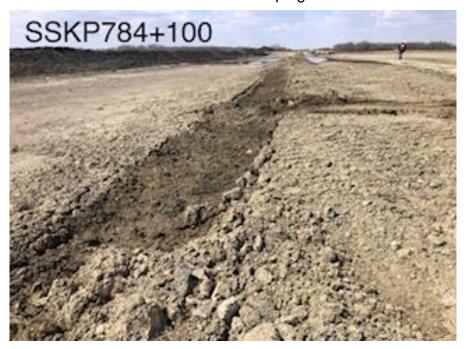
Working on access plug

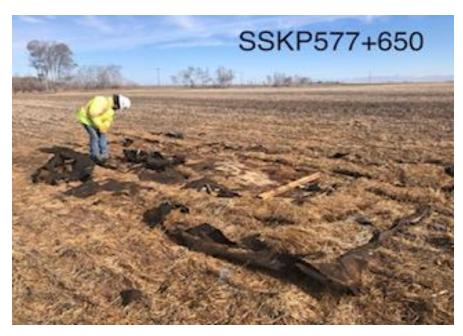
Filter bag being removed from dewatering site

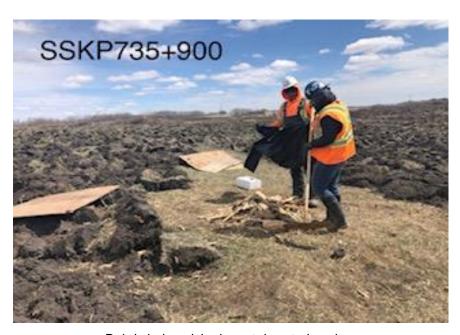
Debris being picked up at dewatering site

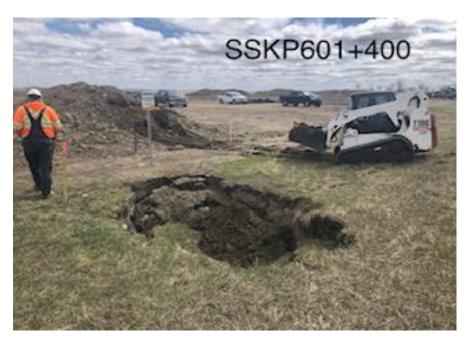
Sinkhole restoration

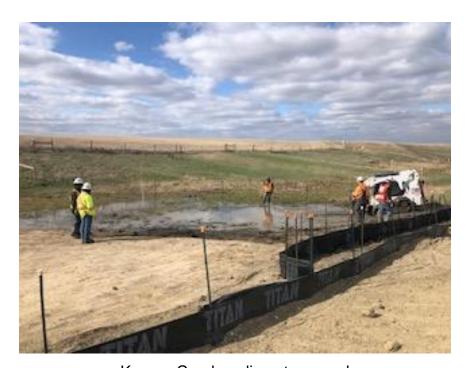
Kronau Creek sediment removal
