**SGS MUSCOWPETUNG**

**ABORIGINAL CONSTRUCTION MONITORING**

**WEEKLY REPORT**

**SPREADS 5 & 6**

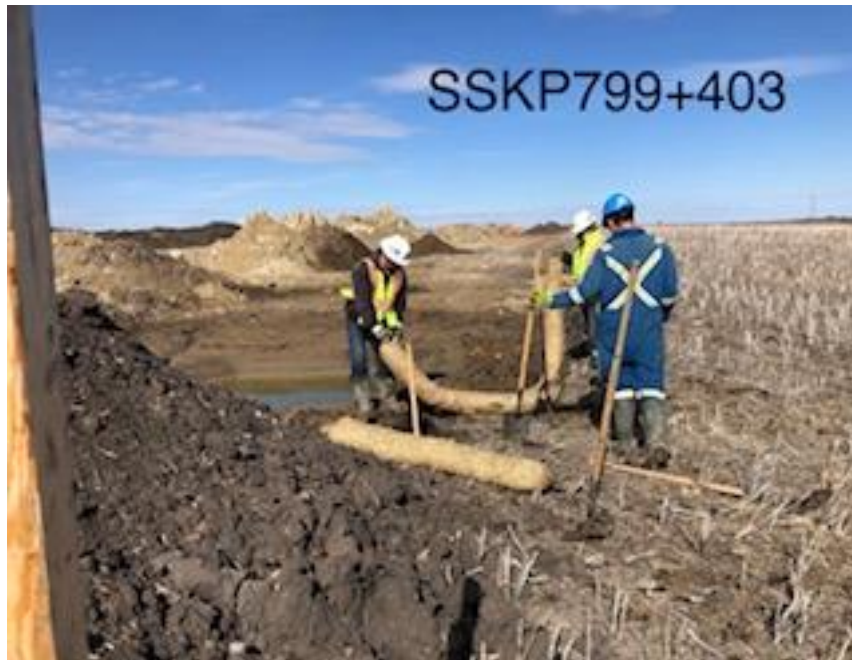
Erosion control devices – straw wattle being installed

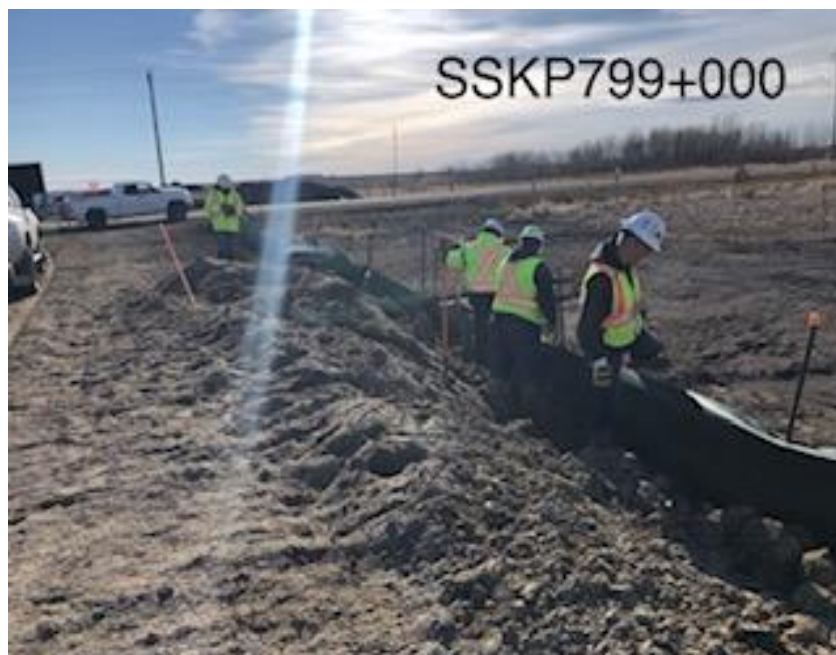
Wing wall that was down was being repaired

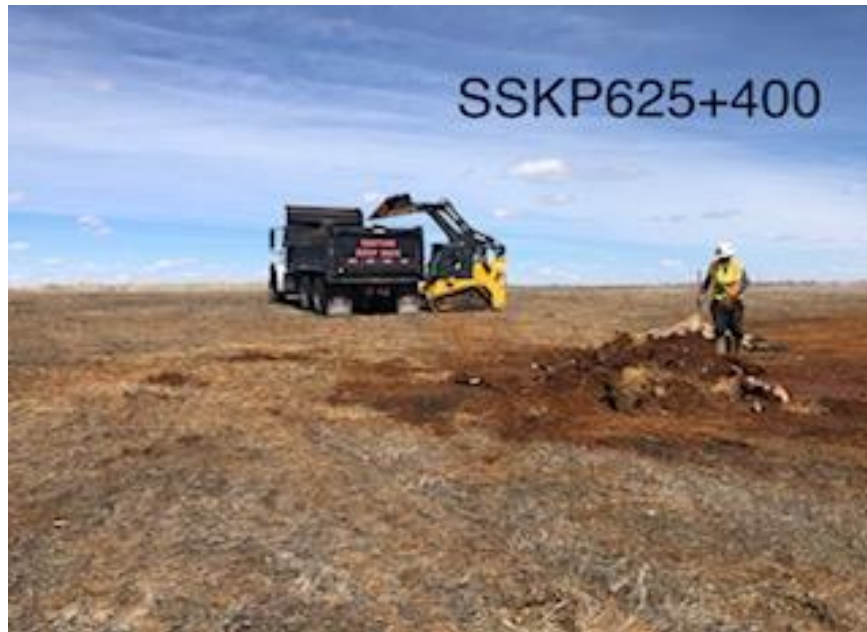
Environmental clean-up at dewatering site

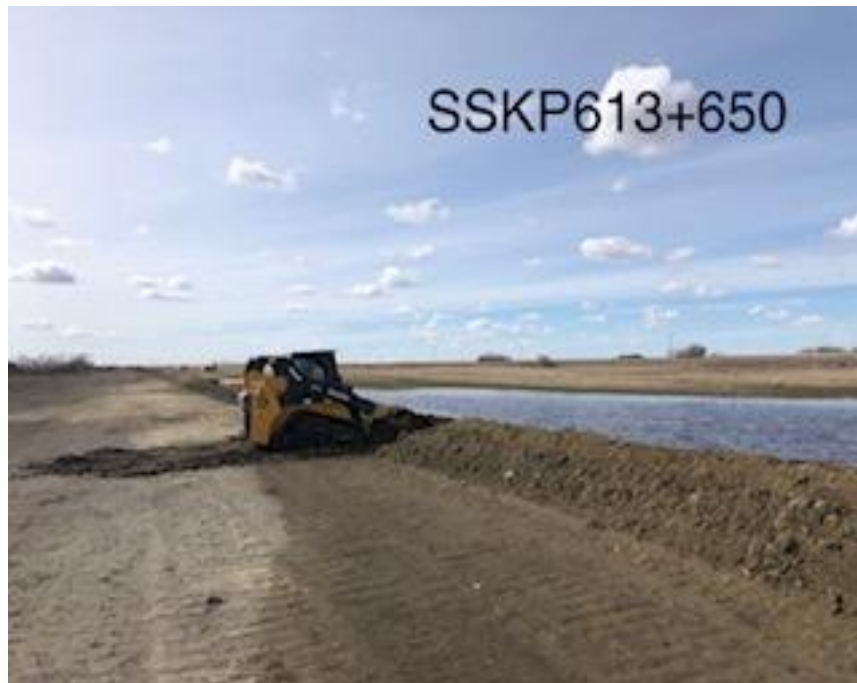
Skid steer used to create a break in roach line to alleviate the water to dry quicker
