SGS MUSCOWPETUNG

ABORIGINAL CONSTRUCTION MONITORING

WEEKLY REPORT

SEPTEMBER 24TH TO SEPTEMBER 30TH, 2018

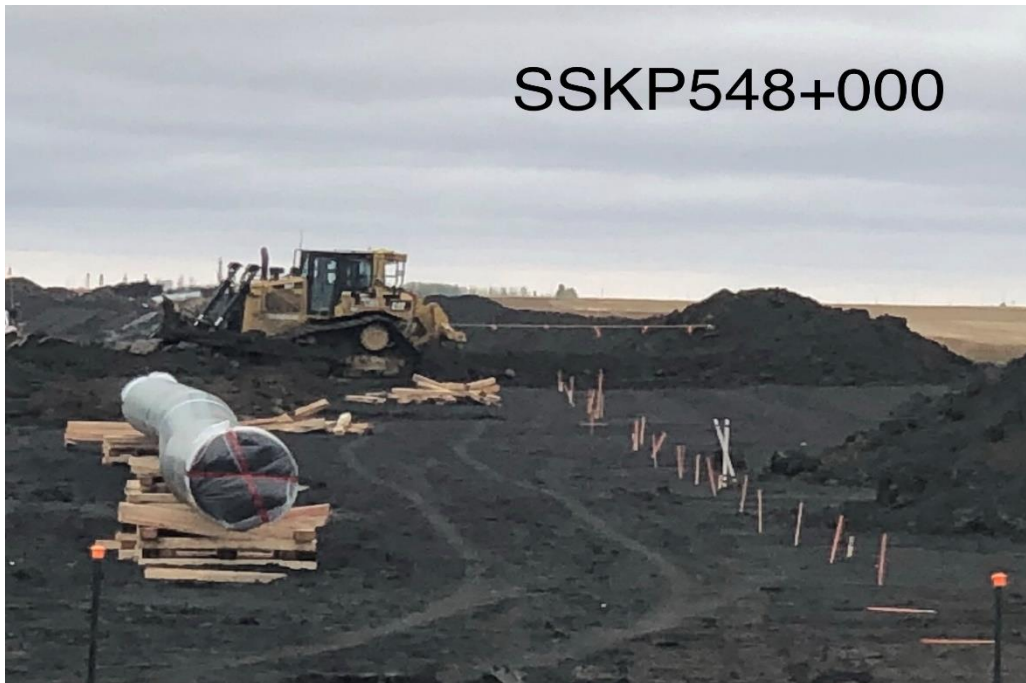
Backfill process

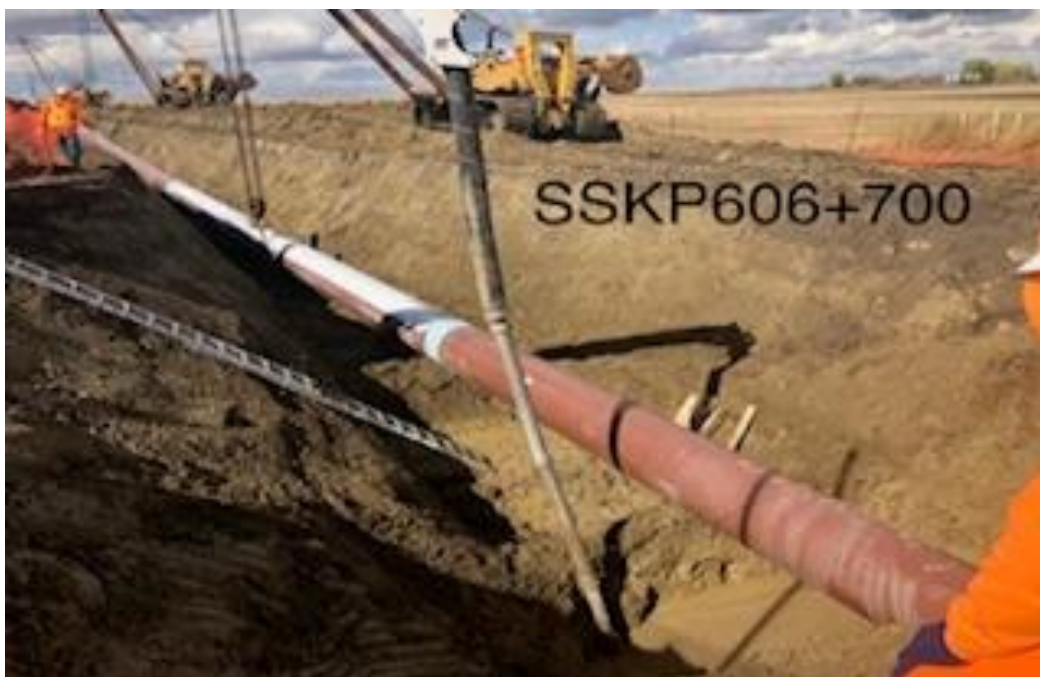
Bore Process

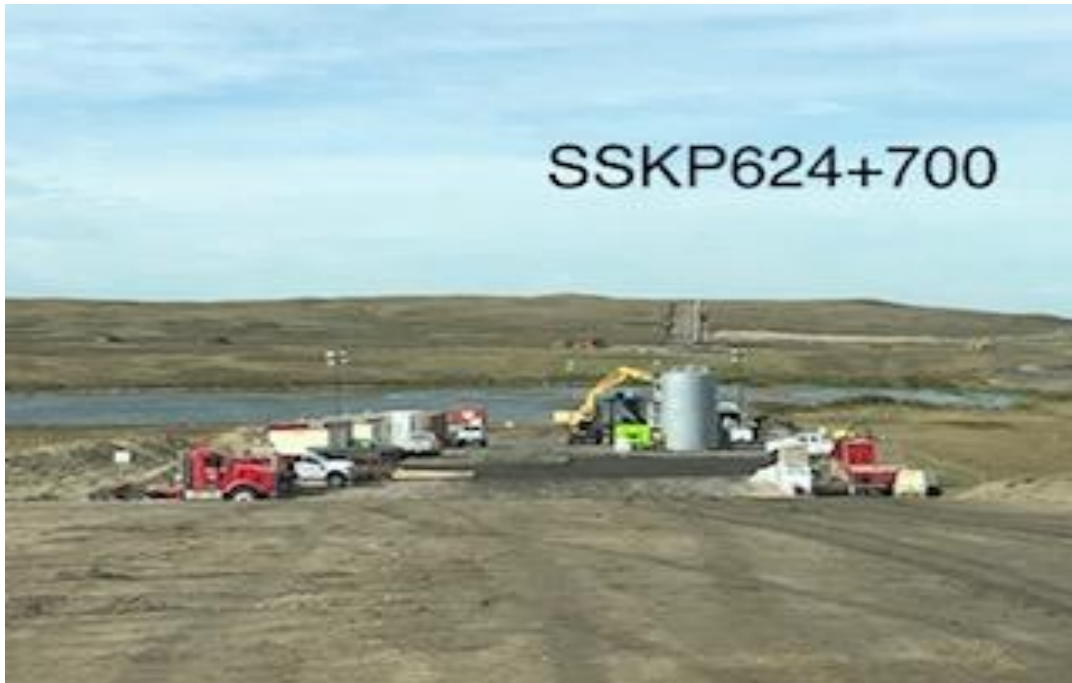
HDD Entry Point East Chapleau Lake

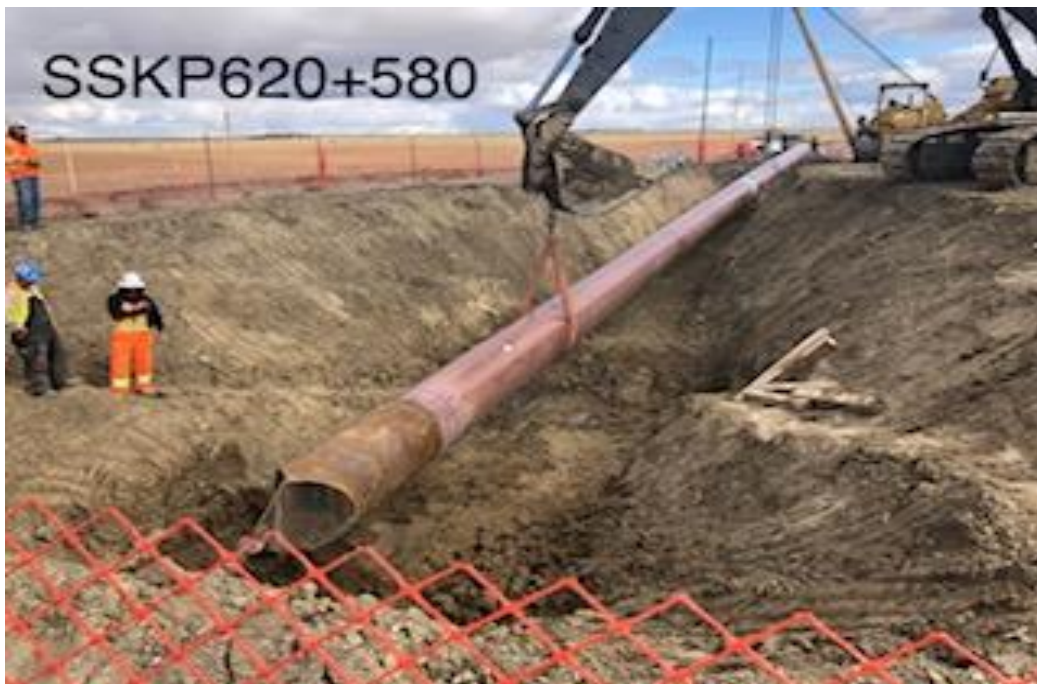
Bore process SF49

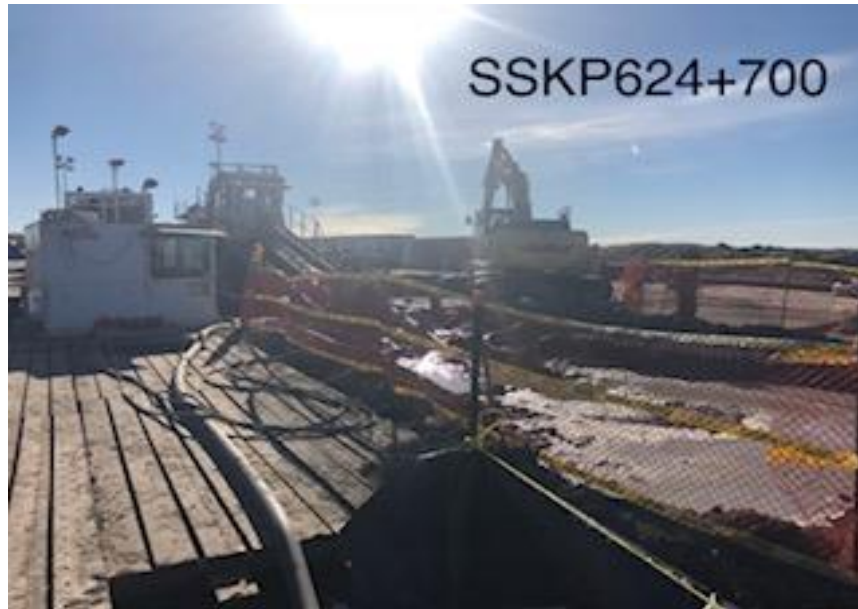
HDD Equipment at entry point

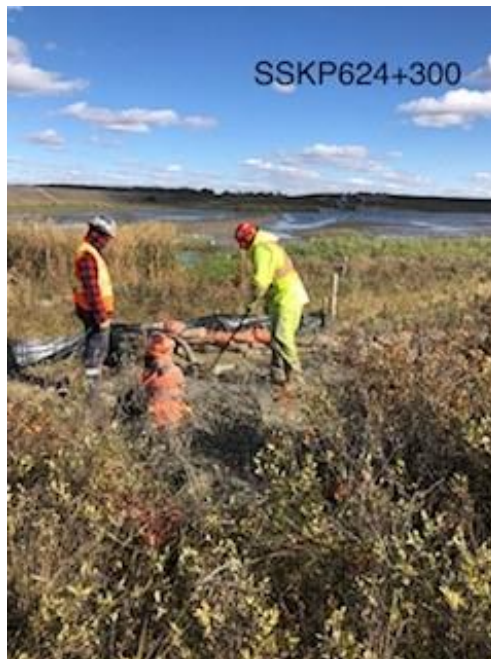
End of the week, west side of Chapleau Water Course Crossing Chapleau Lake SK-WC68 SSKP624.3 frac-out occurred due to the drilling process, a hydro vac was on site to assist in containing the spill, crew members sweeping the frac-out into the vac truck hose, silt fence and sand bags were around the affected area. Frac-out is the unintentional return of drilling fluids to the surface during horizontal directional drilling. The drilling fluid itself may not be toxic, but the fine particles can smother plants and animals, particularly in an aquatic environment. Many landowners do not appreciate frac-outs on their land. The potential concern is when the HDD is used under sensitive habitats, waterways, and areas of concern for cultural resources. AAE Tech services Inc was monitoring the lakeside conducting readings every 2 hours from instruments placed in the lake along the HDD path. AAE Tech Services is a Canadian environment consultant, specialized in aquatic ecology, agricultural development, environmental monitoring programs and land survey.

Frac-out clean up
