SGS MUSCOWPETUNG

ABORIGINAL CONSTRUCTION MONITORING

WEEKLY REPORT

DECEMBER 17TH TO DECEMBER 23RD, 2018

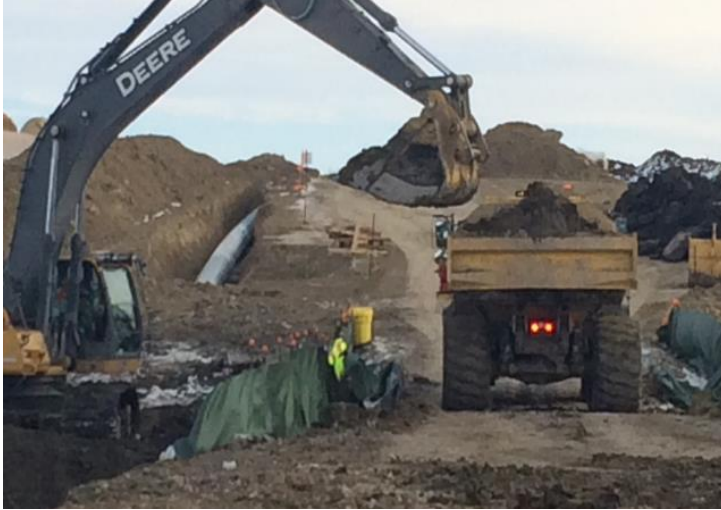
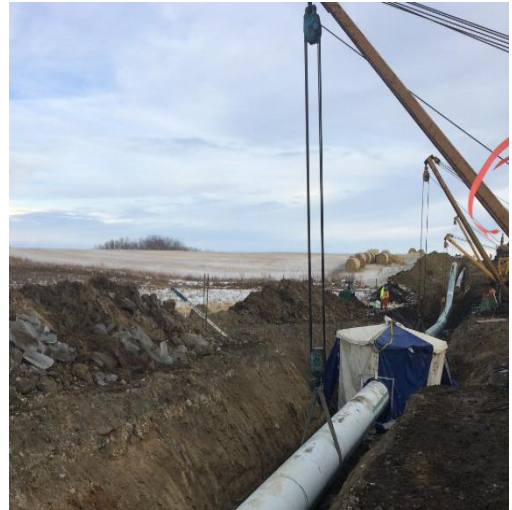
Montgomery Creek Tributary was monitored at 716 + 600 SK WC-79. At the beginning of the week the track hoe stripped/excavated south side ditch line. The Sk WC 79 soil was separated and placed on the work side. Seconds and clay were excavated and loaded in rock trucks then placed on the south side, pushed into piles with the dozer. Product pipe was prepared and strung along right of way ready for tie in. The ditch line was excavated up to the tributary. A steel plate was placed across the creek for isolation. The area isolated was then excavated. The pipe was lowered and tied in. Sand shading was completed with inspection of rock mitigation. The ditch line was completely backfilled before seed mix and erosion blanket were placed on top.

Montgomery Creek SK WC 79 excavating ditch and tying in pipe.

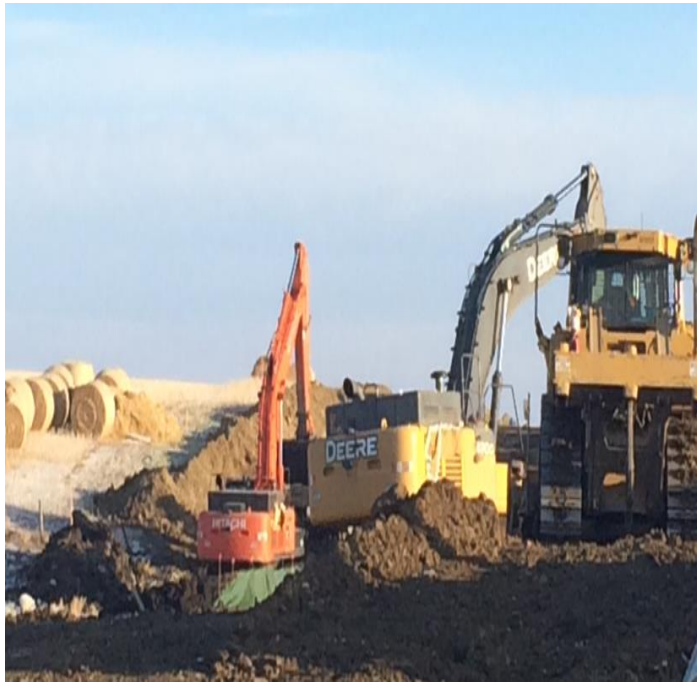
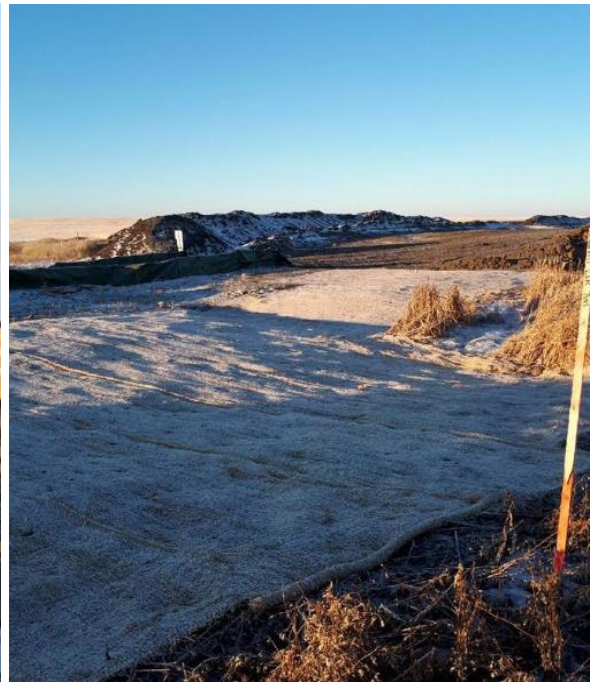
Field Observation	# of occurrences	Description and Mitigation Measures	Mitigation Status	Further Action Required (Yes/No)
Medicinal or Cultural Plants				
Aquatic Life				
Animal Observations or Burrows				
Bird Nests				
Trees (Red Willow)				
Wetlands				
Watercourse Crossing	1	Montgomery Creek tributary SK WC 79 (FB) Open cut and isolated for pipe installation. Backfilled, Seed mix and Erosion blanket installed	Completed (EPP)	No

Montgomery Creek SK WC 79 backfilling ditch line and erosion blanket placed over seed mix.

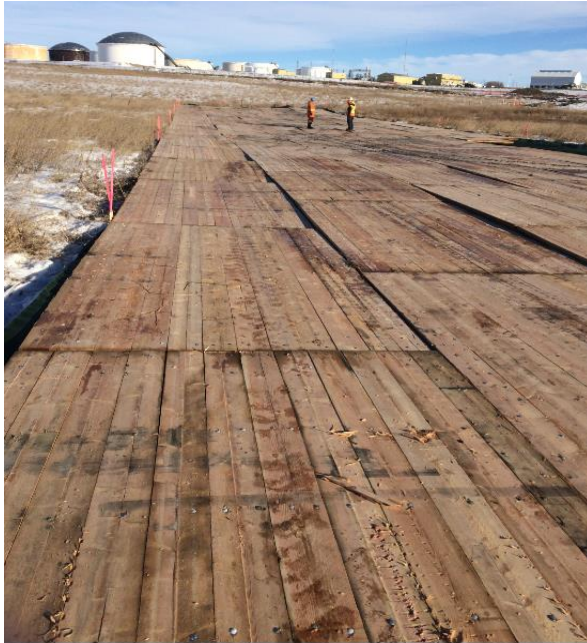
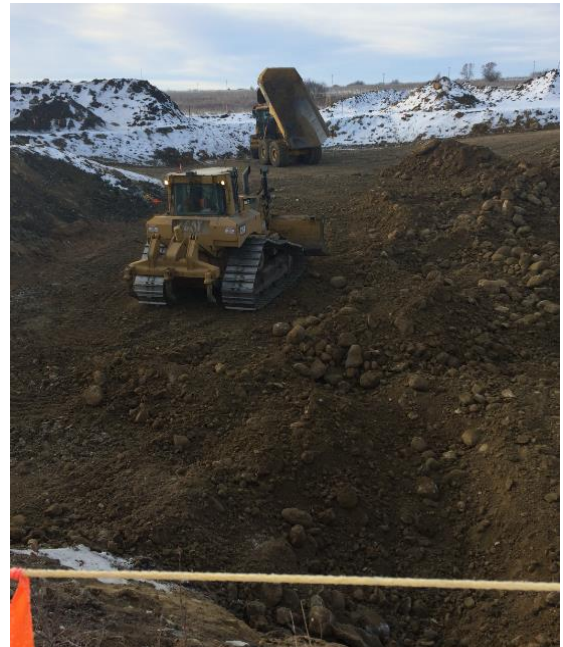
Our team followed up monitoring 803 + 494 – Heritage resource TLU area 805.63 – 805 .93 East side of Pipestone Creek. At the extra work space geo tech fabric was laid out, and matting was hauled in and unloaded at the site. To eliminate stripping of the area Geo tech fabric and over two hundred mats were placed on the ground for the extra equipment laydown area. Pipe strung along the right was prepared and ready for lowering in. On the west side of the Creek the track bore bay was backfilled. At the laydown area product pipe was prepared, coated and ultrasonic testing completed. Archaeologist and ICM's were on site throughout the week.

Pipe Stone Creek - Geo tech fabric and matting laid over area for equipment workspace & Track bore bay backfilled.

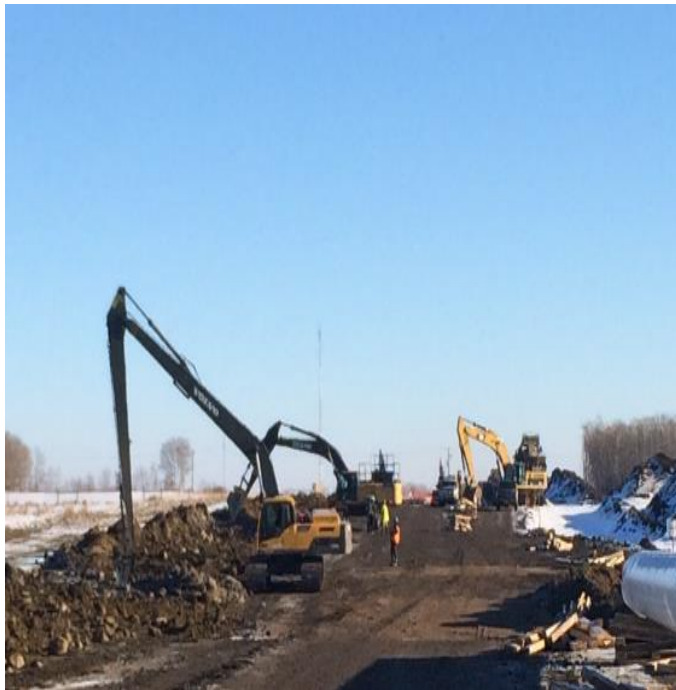
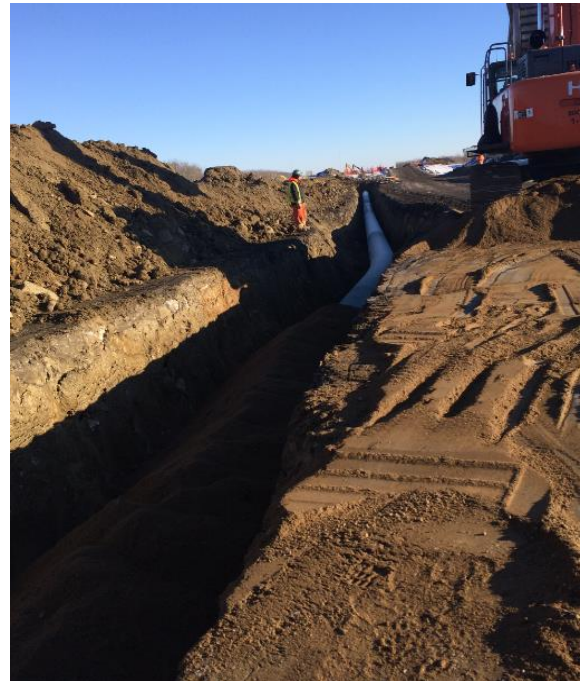
Additional monitoring included observing the ditch wheel and ten track hoes excavate ditch line through 776 + 022 – 779 + 495 Jackson Creek area. Our team monitored the ditching and preparation of the pipe early in the week. By mid-week lowering in the pipe and tie in was completed. The week ended monitoring shading, rock mitigation and mainline backfilling.

777 + 900 Jackson Creek area Mainline backfill and pipe shading.
