SGS MUSCOWPETUNG

ABORIGINAL CONSTRUCTION MONITORING

WEEKLY REPORT

FEBRUARY 4TH TO FEBRUARY 10TH, 2019

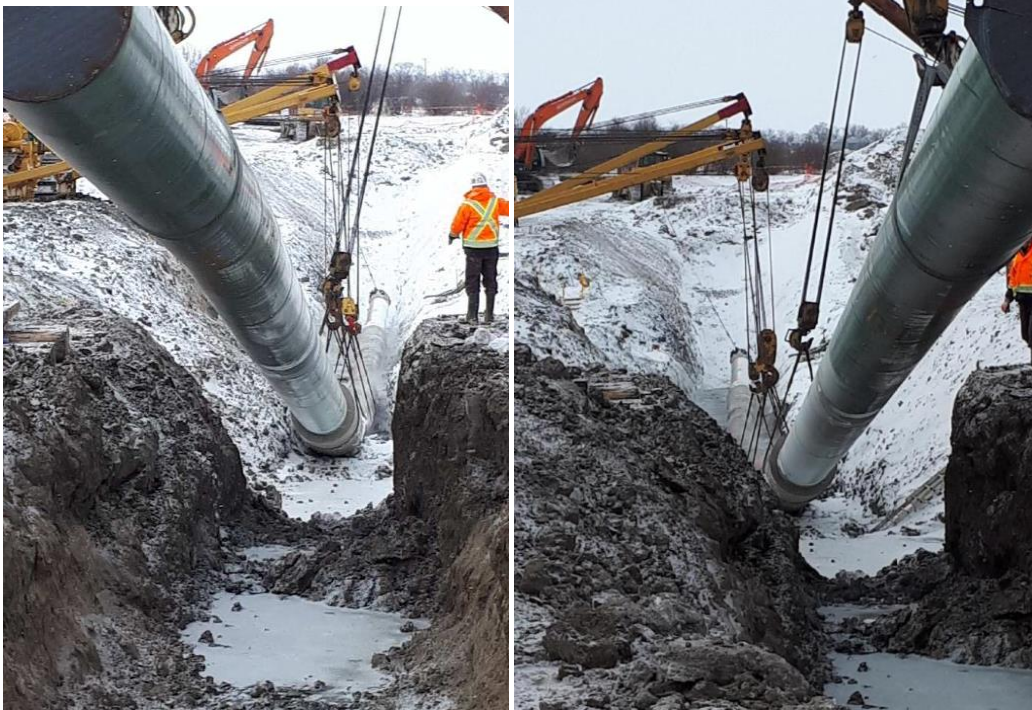
805 + 700 Lowering pipe across the Pipestone Creek MB 1010

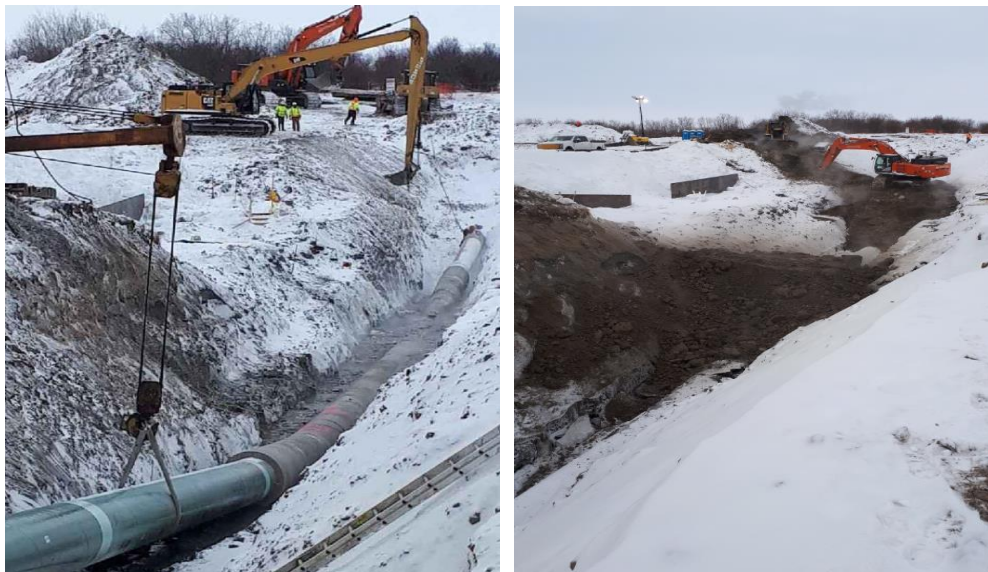
805 + 720 Track hoes backfilling open ditch at the Pipestone

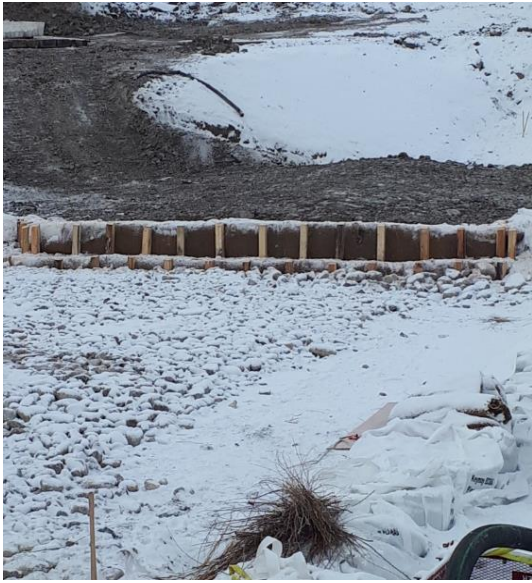
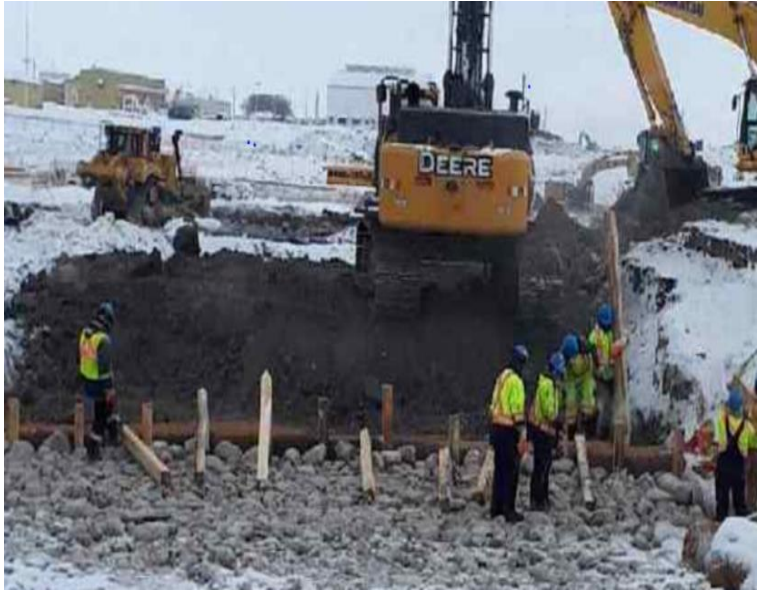
Restoration of the Pipestone Creek MB 1010

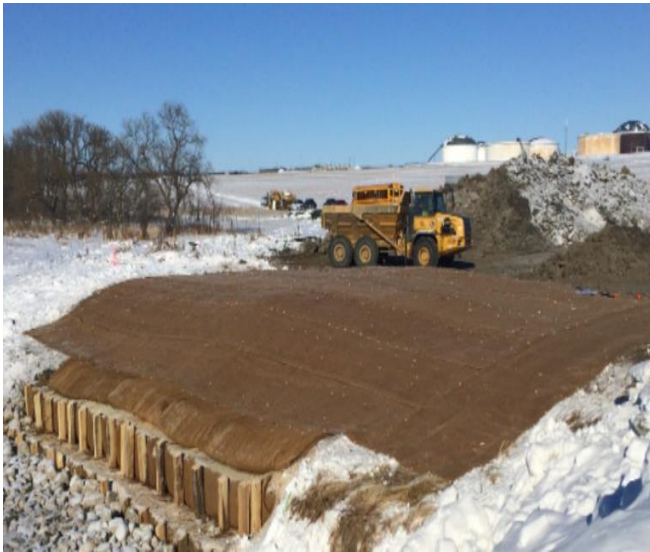
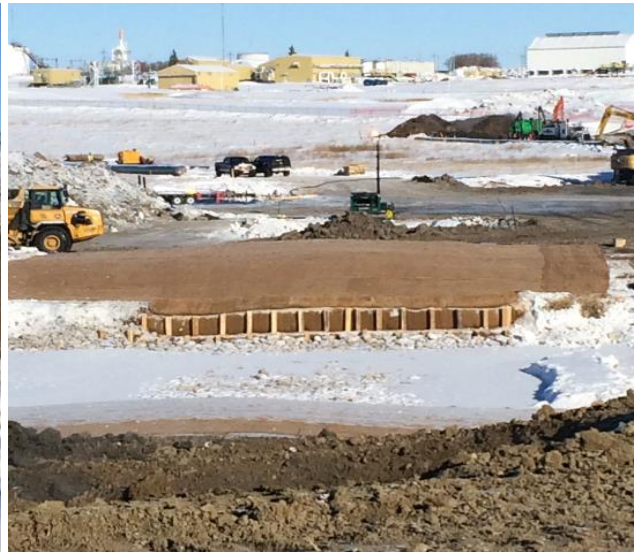
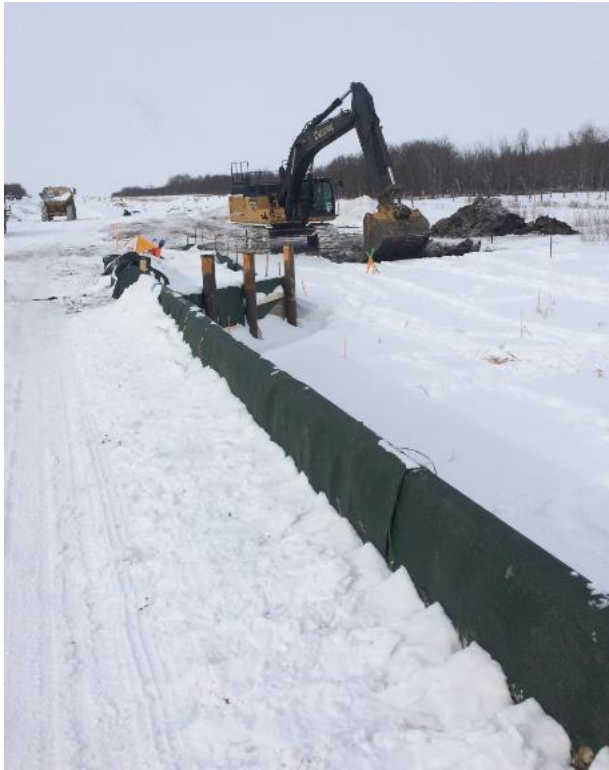
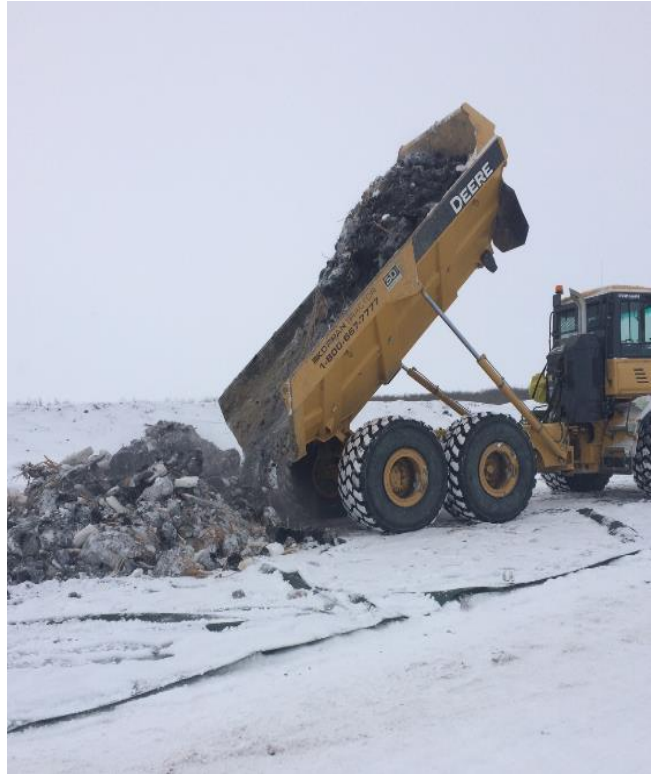
Stony Creek SK WC 89 Excavating ditch line, placing WC material on geo & sand shading pipe.

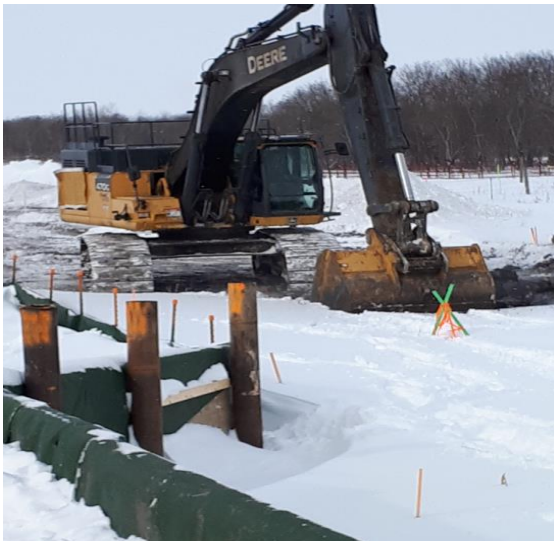
787 + 700 Track hoe stripping wetland SK – 944

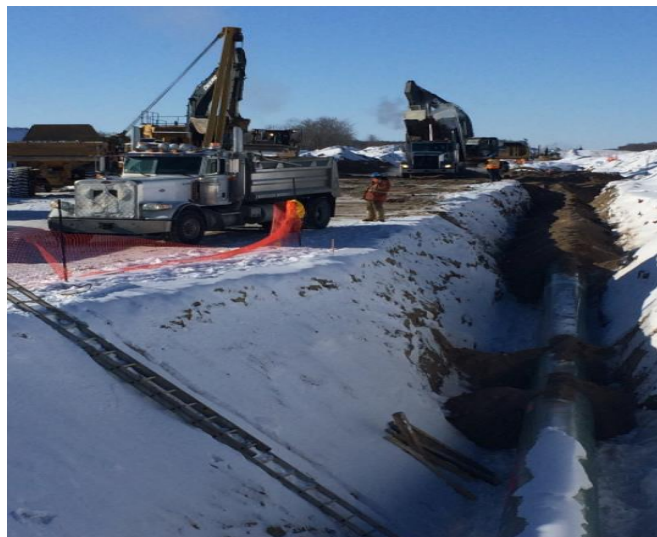
787 +500 Track hoe to digging at Stony Creek
