SGS MUSCOWPETUNG

ABORIGINAL CONSTRUCTION MONITORING

WEEKLY REPORT

SPREAD 6

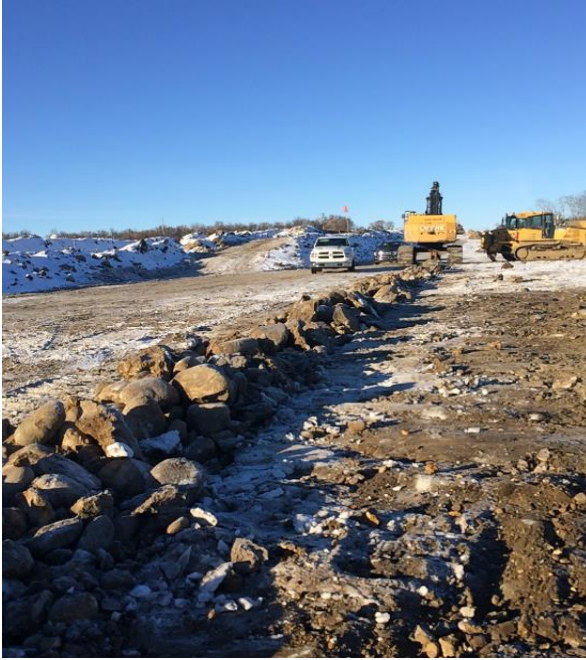
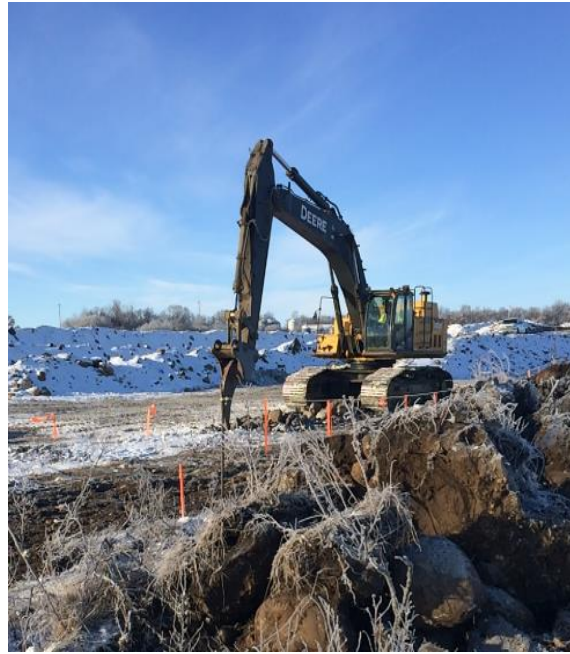
805 + 500 Ripping ditch line

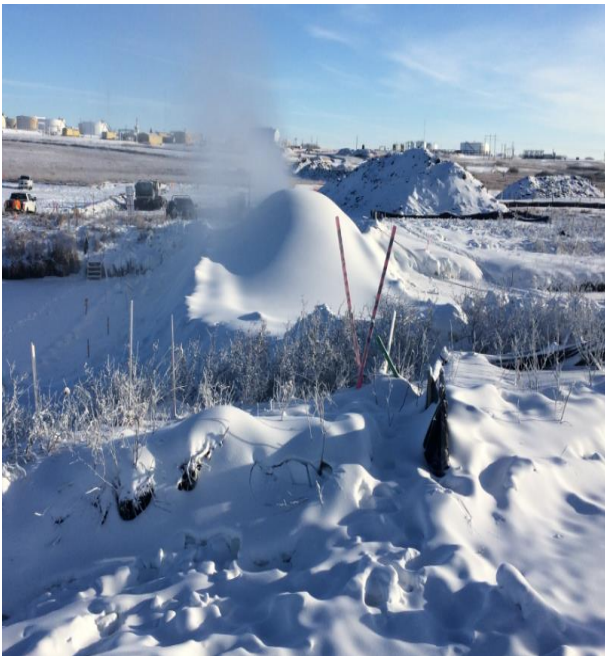
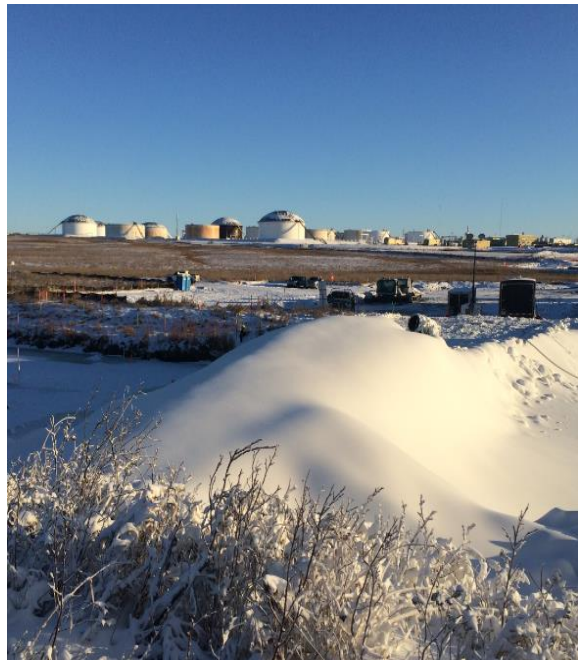
Making snow for ice bridge across Pipestone Creek MB 1010

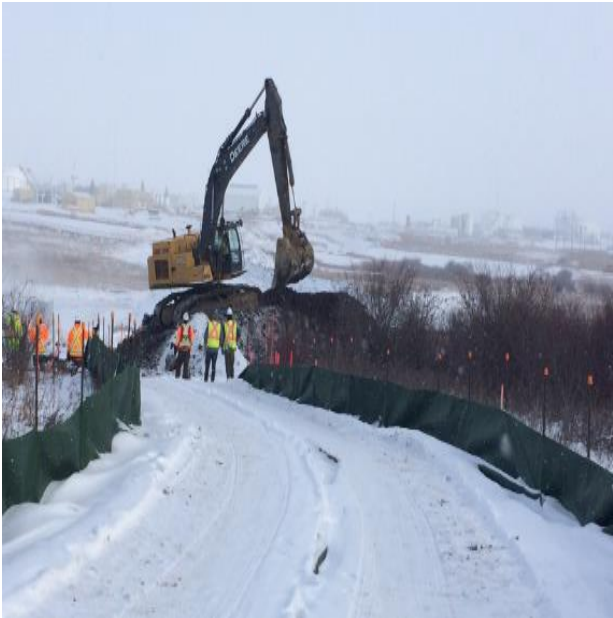
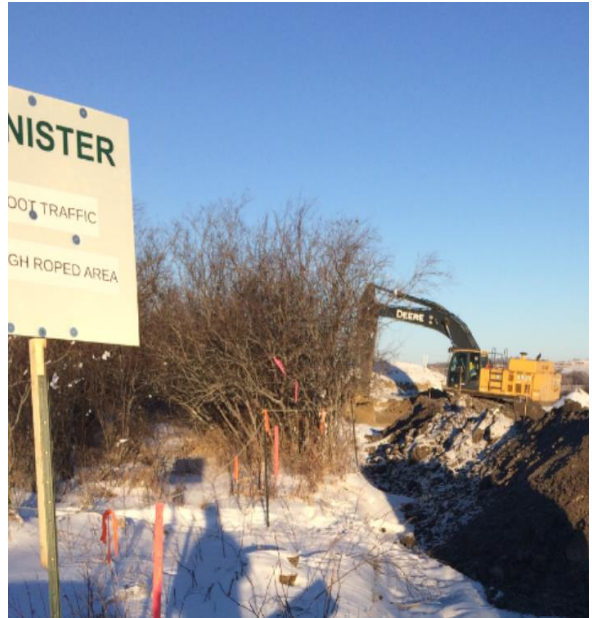
805 + 567 re locating soil piles (Archaeologists & ICM on site) & note: foot traffic sign at area of interest

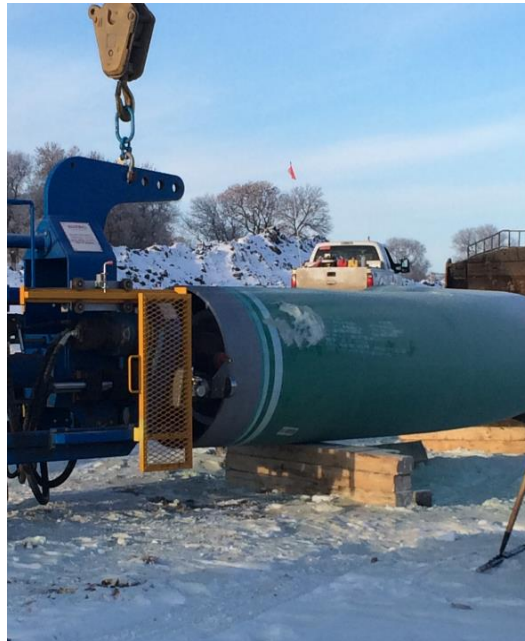
Counter bore on pipe 805 + 400

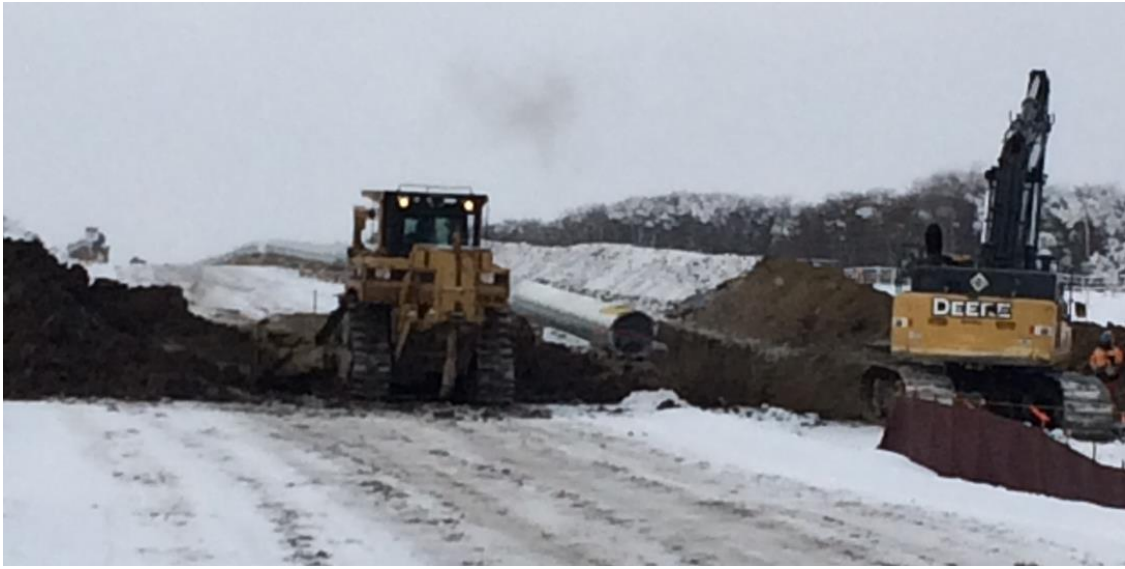
741 + 779 SF Excavating ditch

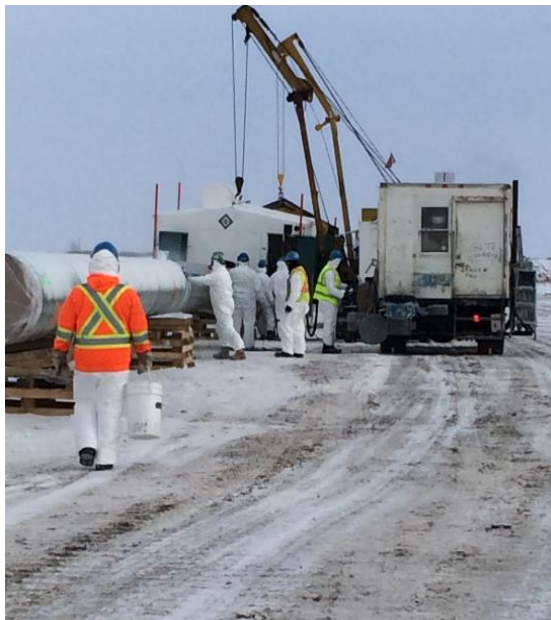
Pipe coding 756 + 081

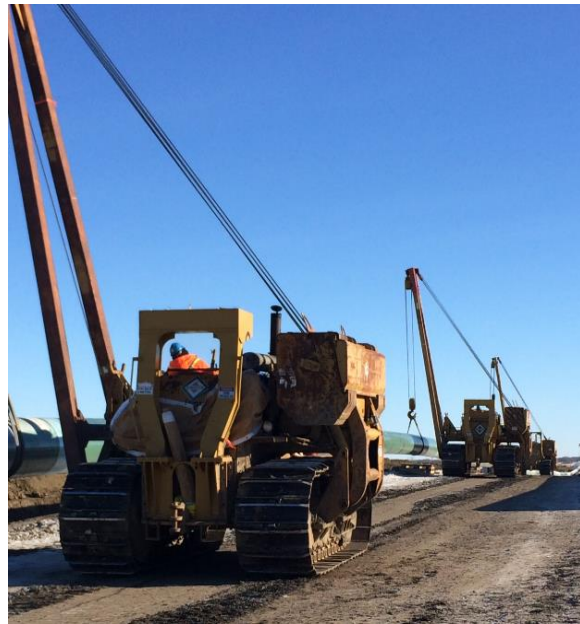
Side booms holding product pipe 746 + 071

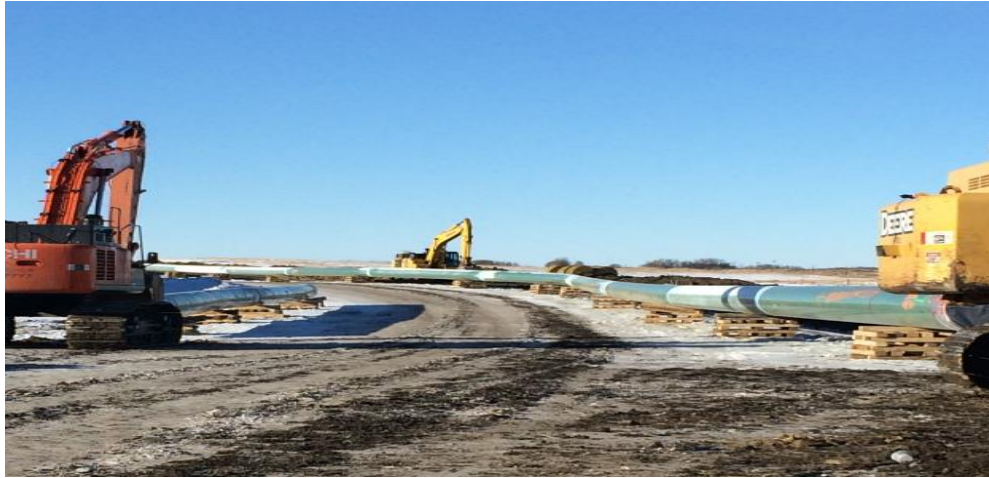
Product pipe ready for tie ins

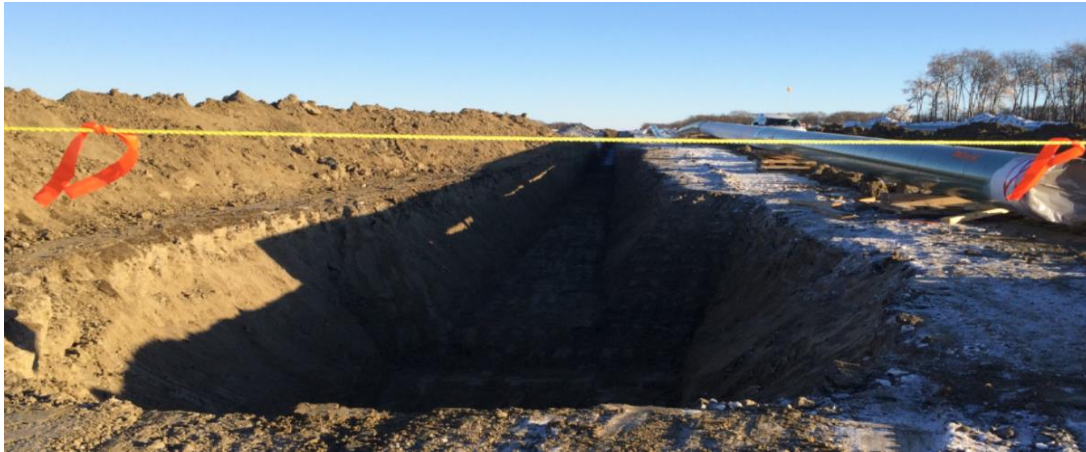
Little Pipestone Creek ditching completed 751 + 400
