SGS MUSCOWPETUNG

ABORIGINAL CONSTRUCTION MONITORING

WEEKLY REPORT

JANUARY 14TH TO JANUARY 20TH, 2019

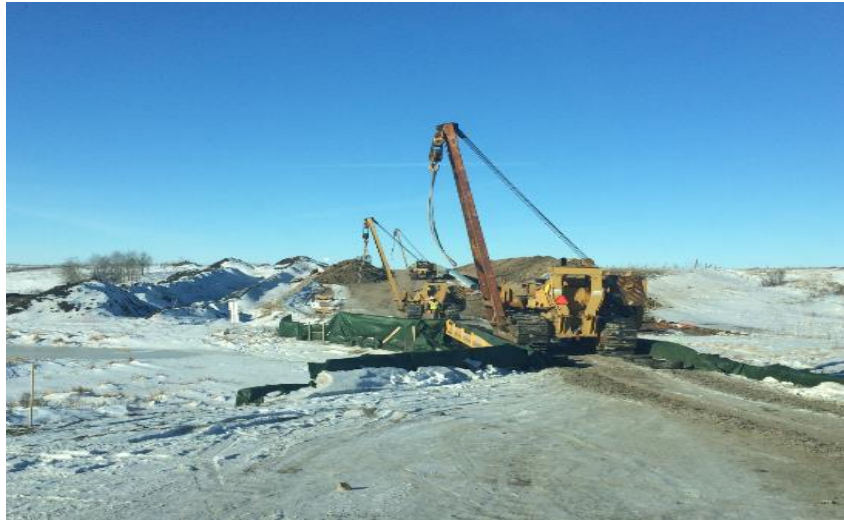
Side booms crossing Bridge at SK WC 87 Little Pipestone Creek

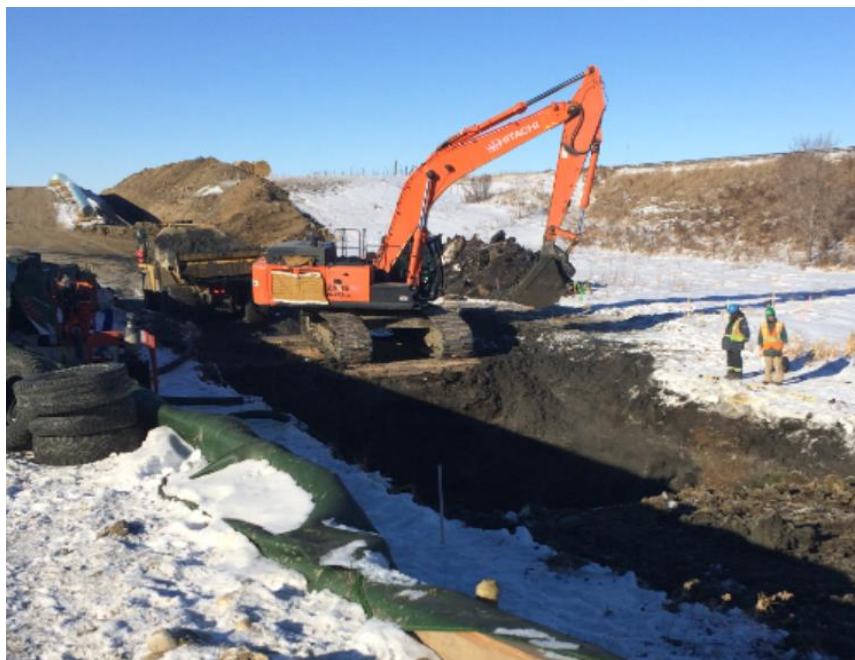
Excavating ditch line at Little Pipestone Creek SK WC 87

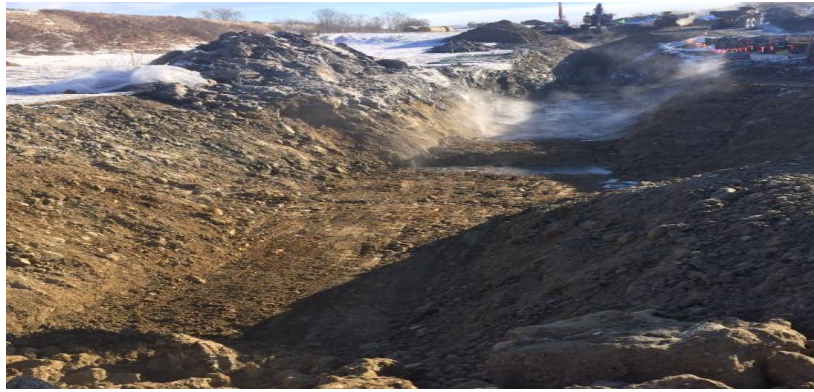
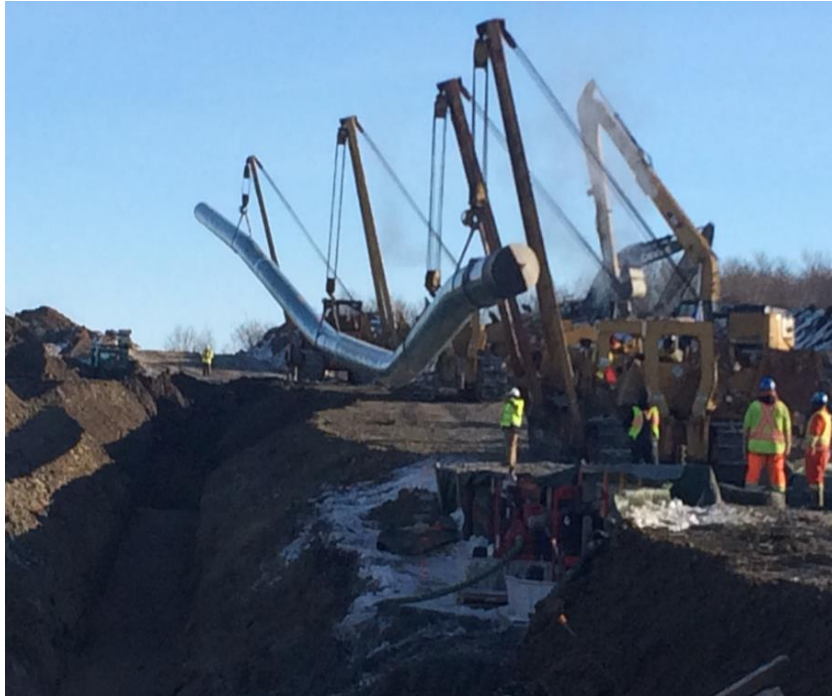
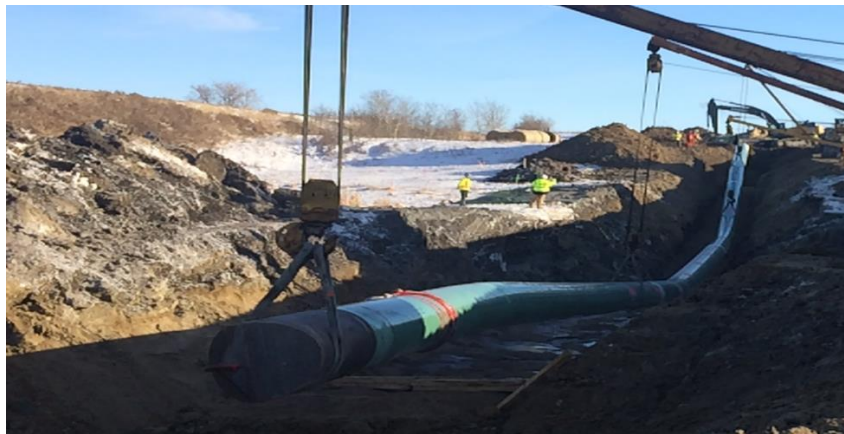
Lowering Pipe through excavated ditch at the Little Pipestone Creek

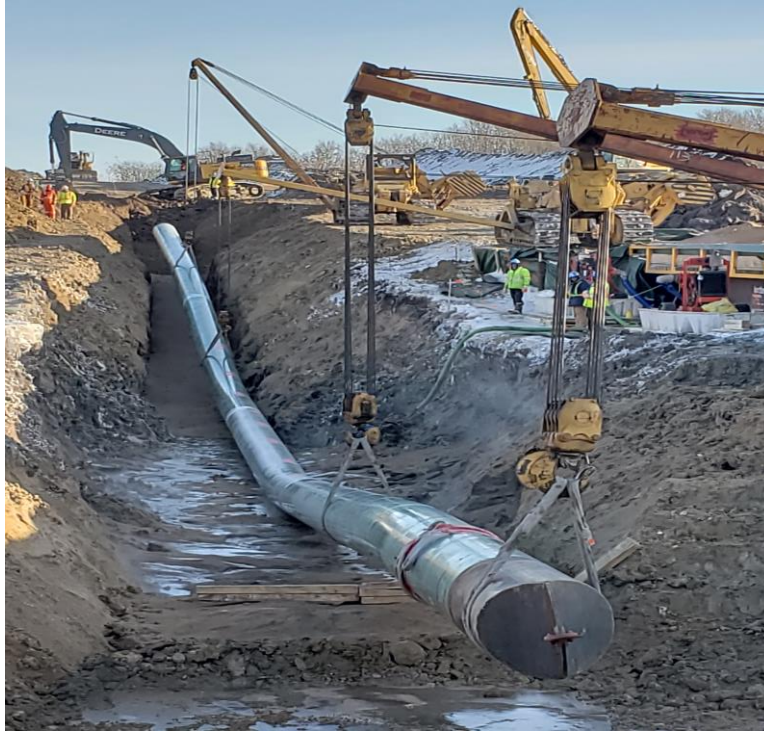
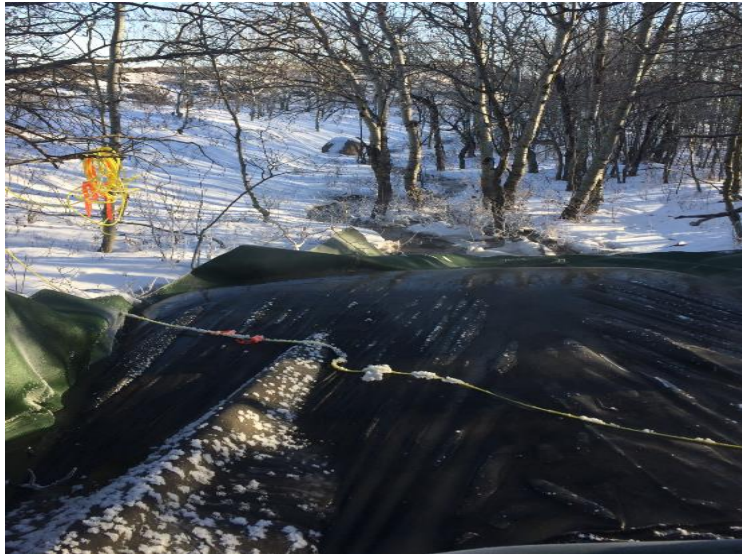
Geo teck and silk cloth placed for ground water pumped

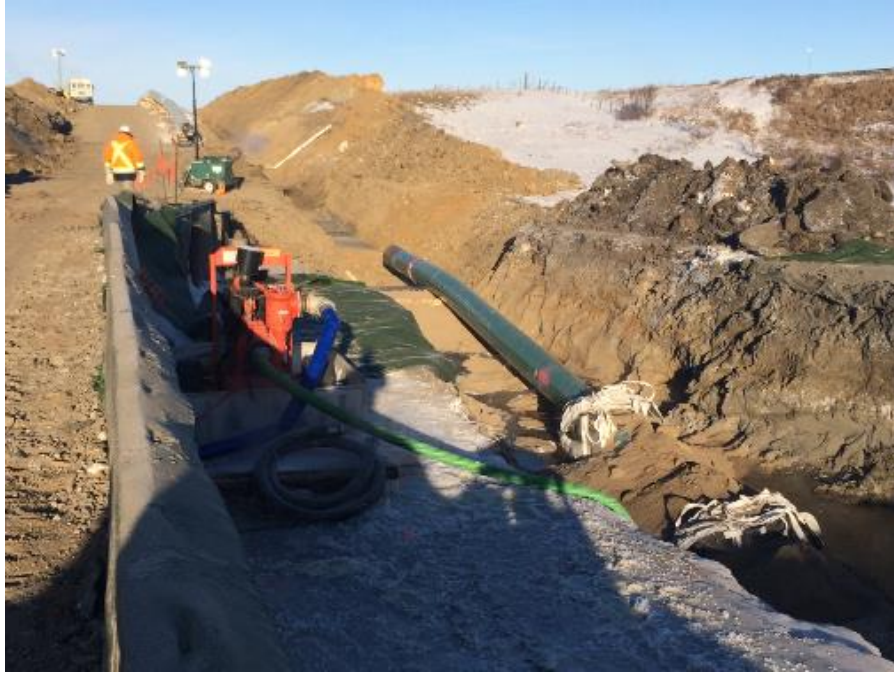
Bag weight and sand placed over product pipe

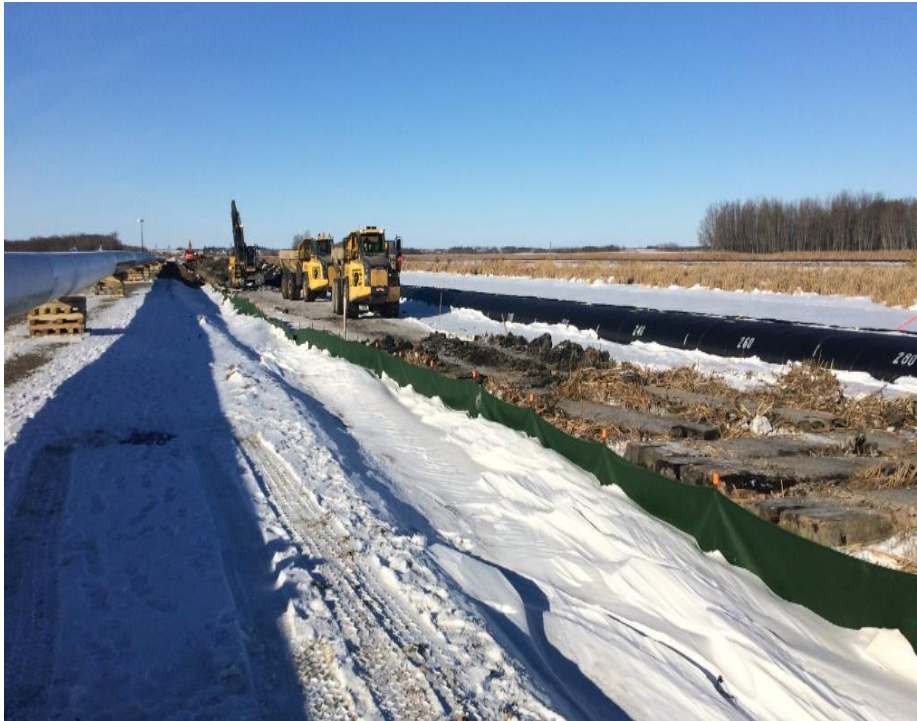
753 + 300 Excavating wetland ditch at SK 876 Class IV

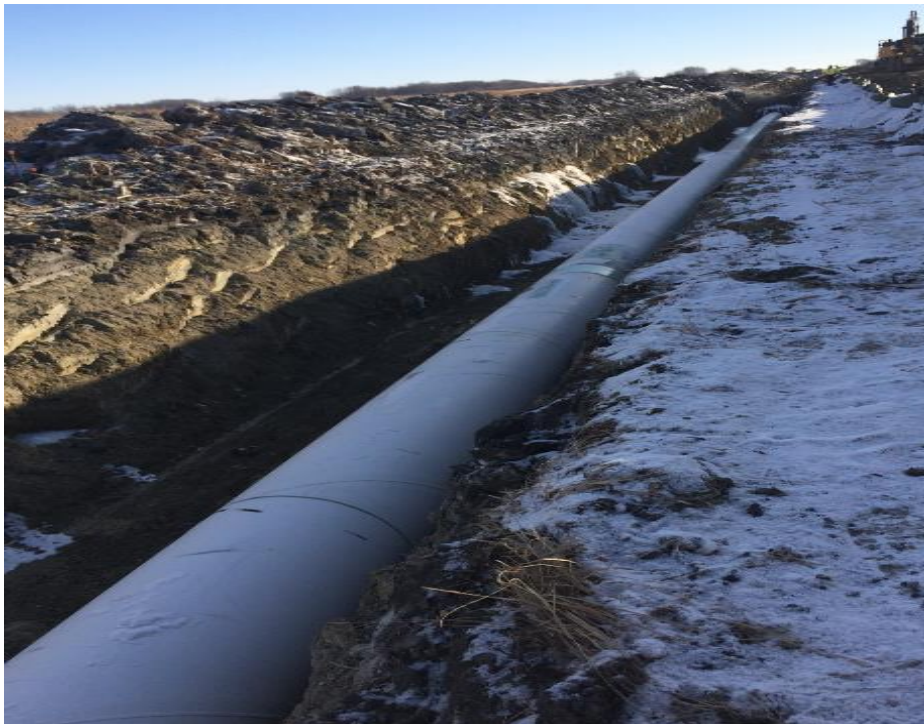
Pipe lowered into excavated ditch SK 876 Class IV

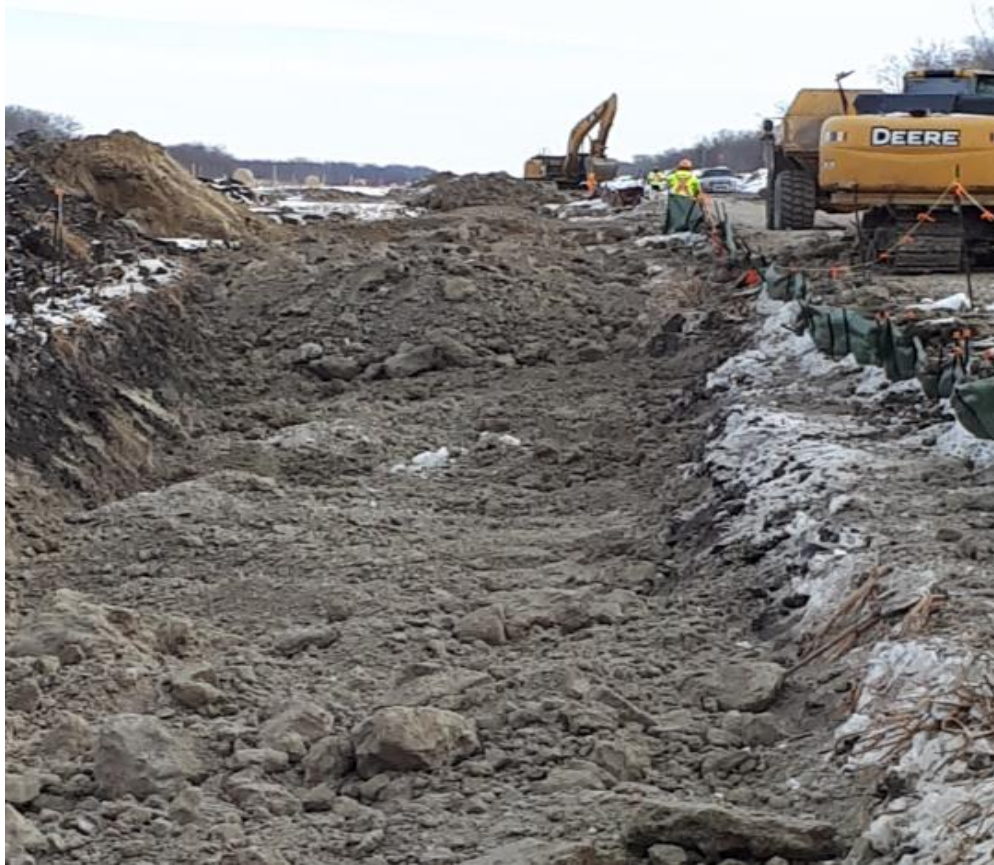
Backfilling Ditch SK 876 Class IV

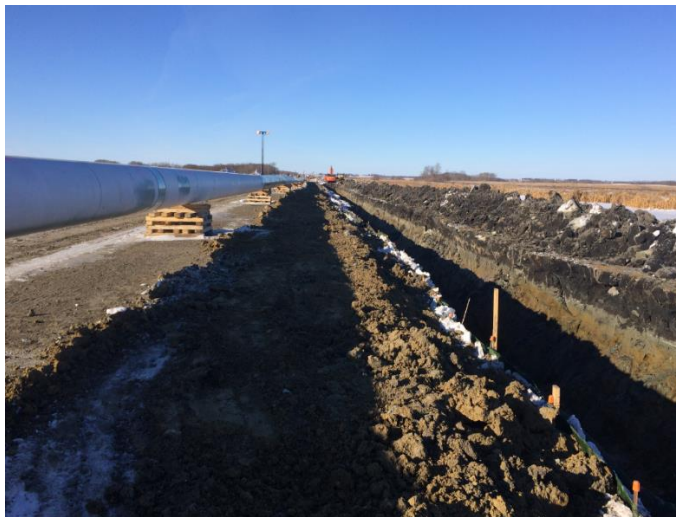
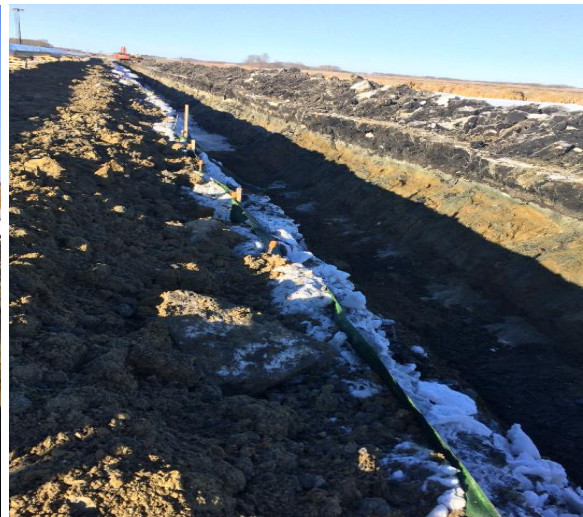
805 + 150 Ditch excavated West side of the Pipestone Creek

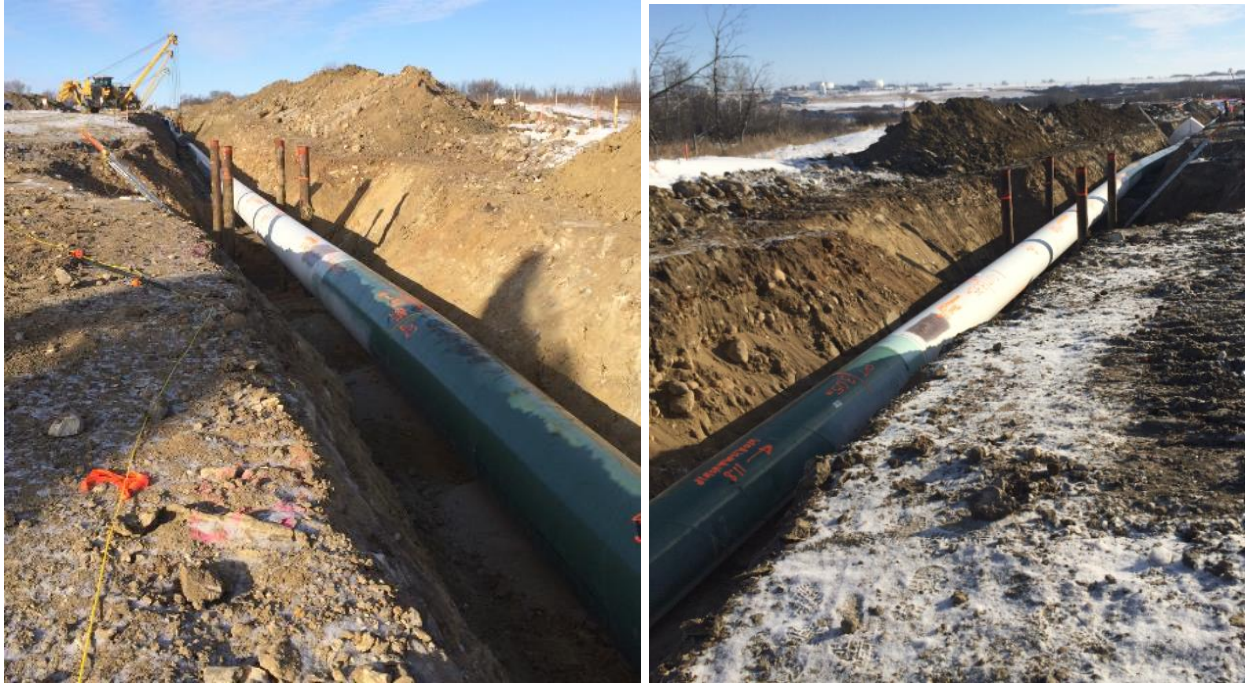
805 + 150 Sand bedding placed in ditch bottom & pipe lowered in

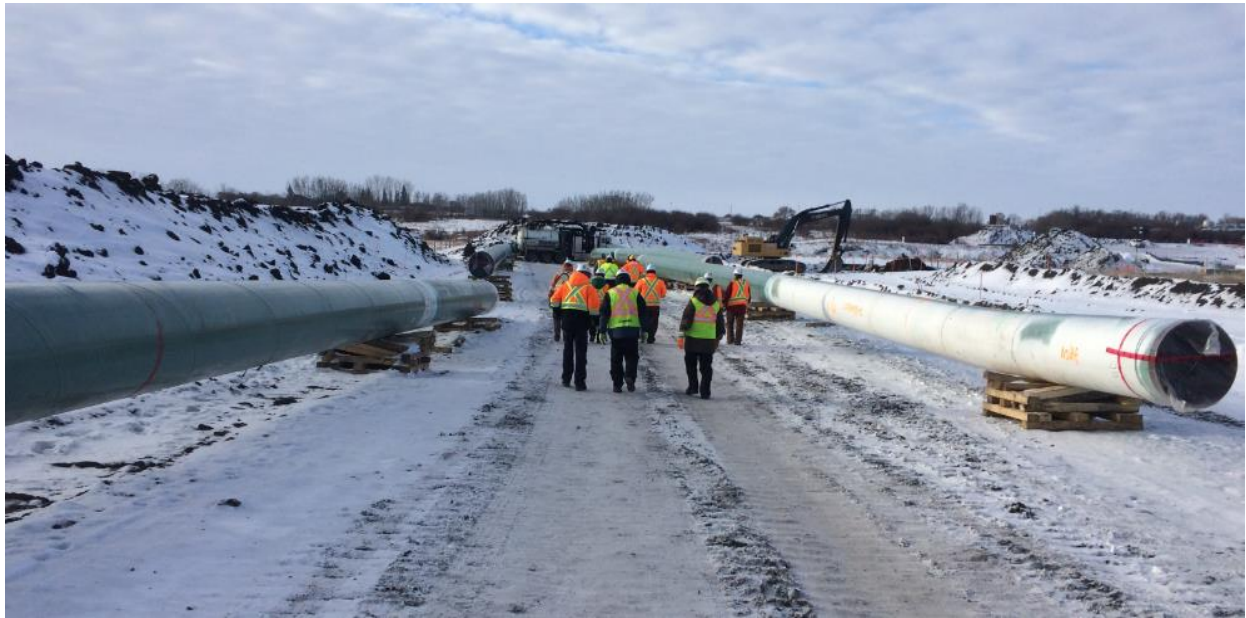
Site tour of East side of the Pipestone Creek Archaeologists and ICM's

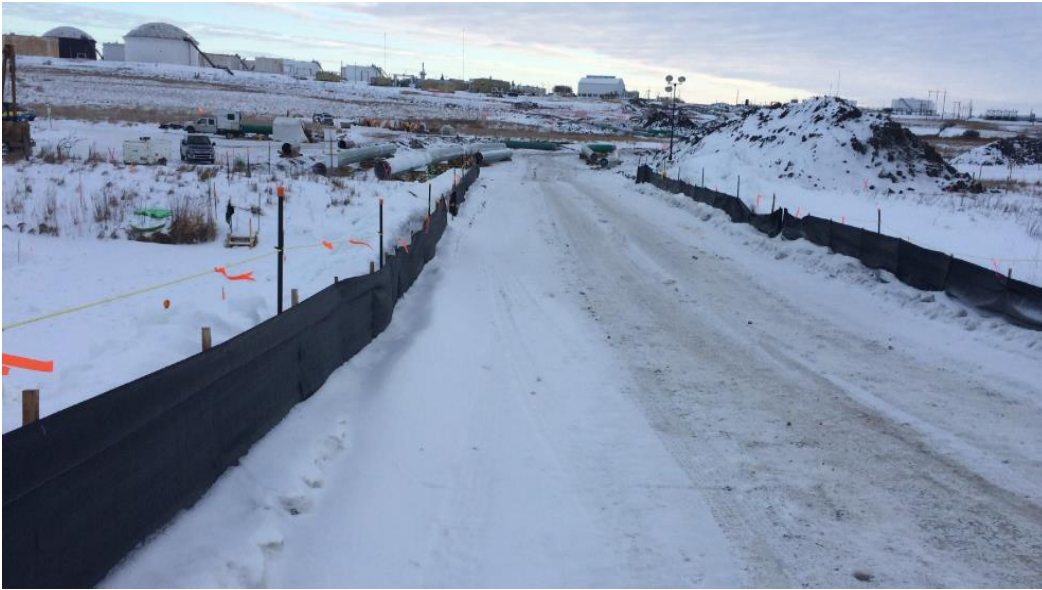
Ice bridge across the Pipestone Creek

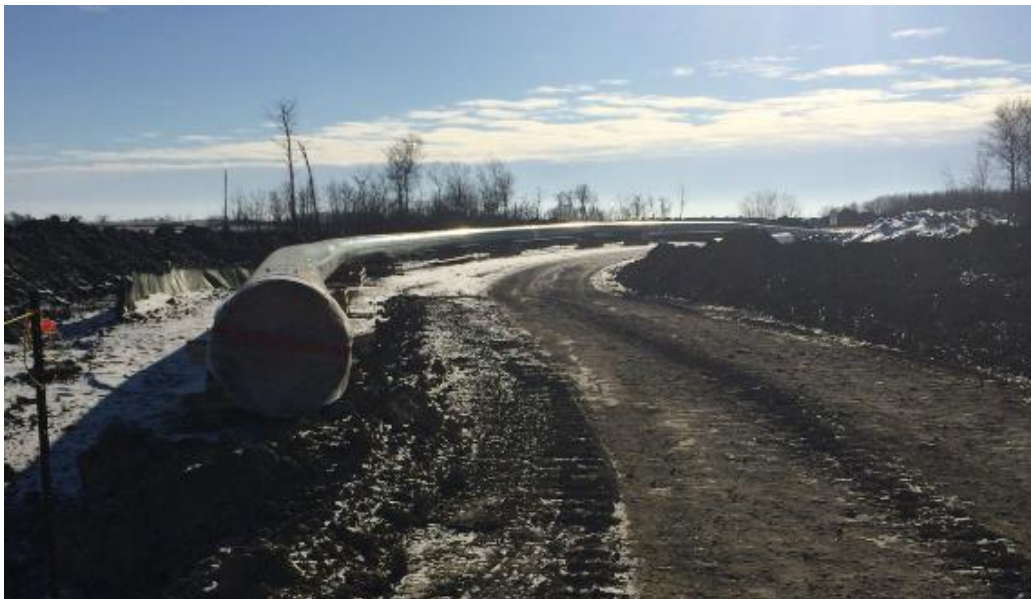
Excavated ditch through MB 1027 – 802 + 500 - pipe prepped for lowering in
