**SGS MUSCOWPETUNG**  
**ABORIGINAL CONSTRUCTION MONITORING**  
**WEEKLY REPORT**  
**SPREAD 6**  
**JANUARY 21<sup>ST</sup> TO JANUARY 27<sup>TH</sup>, 2019**

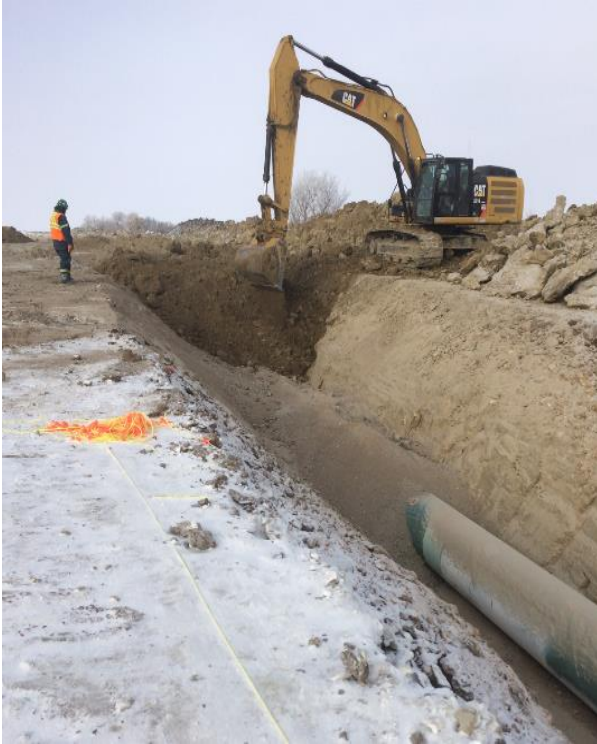
804 + 600 sand shading pipe

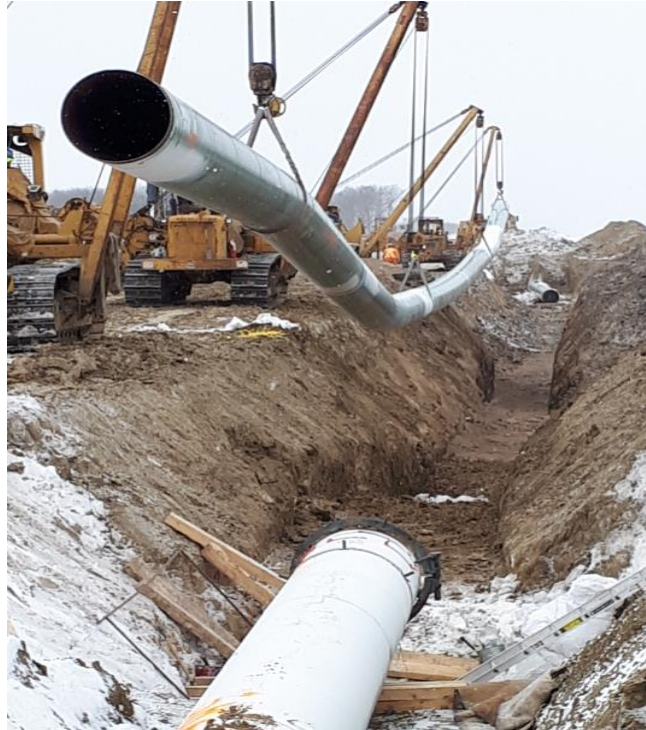
755 + 100 Lowering pipe

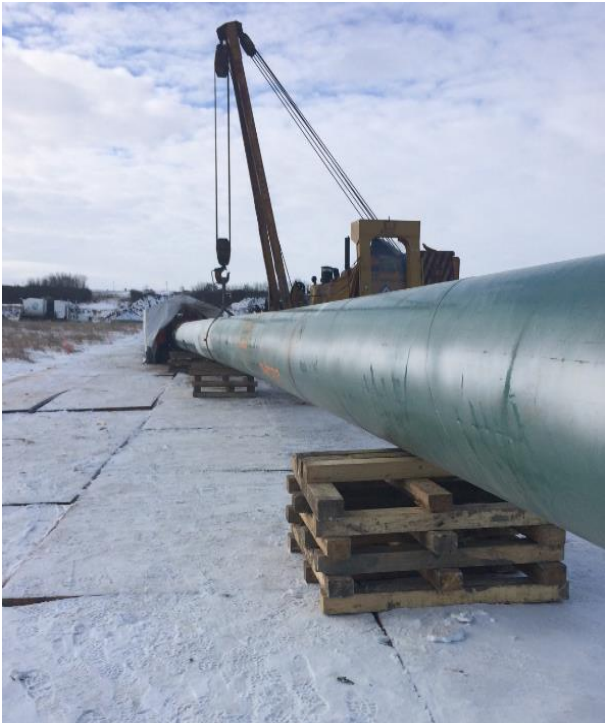
806 + 200 welding onto section

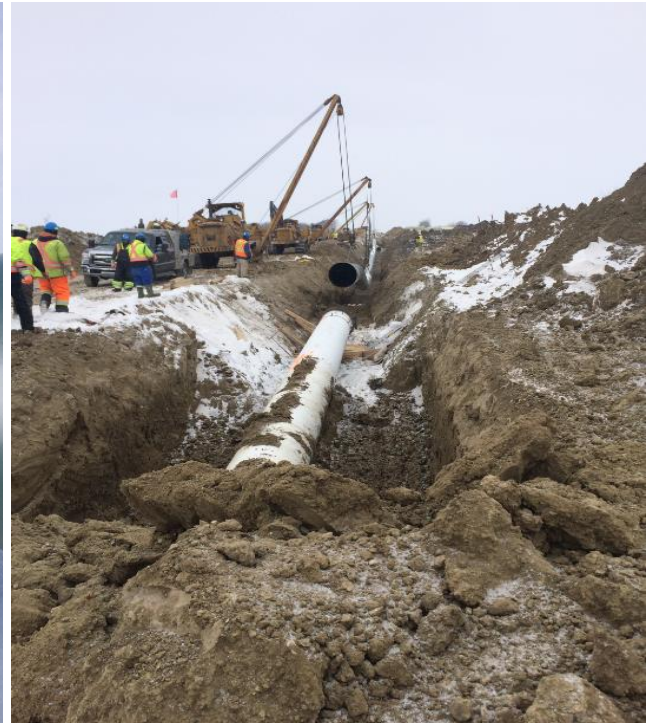
755 + 100 lowering in pipe for tie in

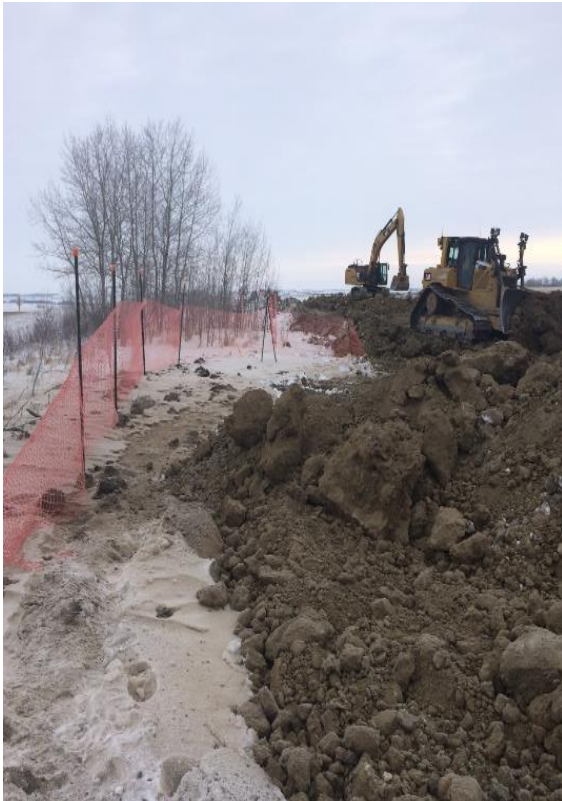
802 + 500 backfilling ditch.

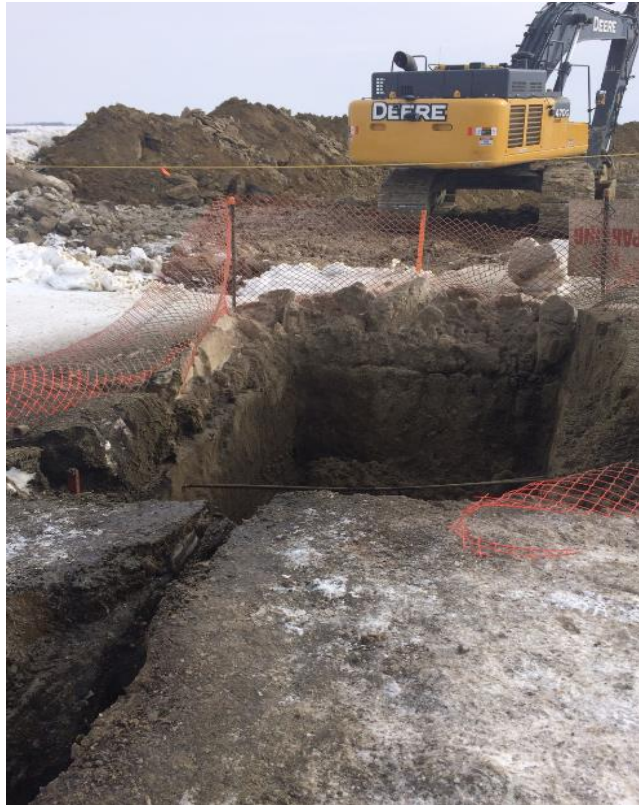
798 + 950 daylighted cable

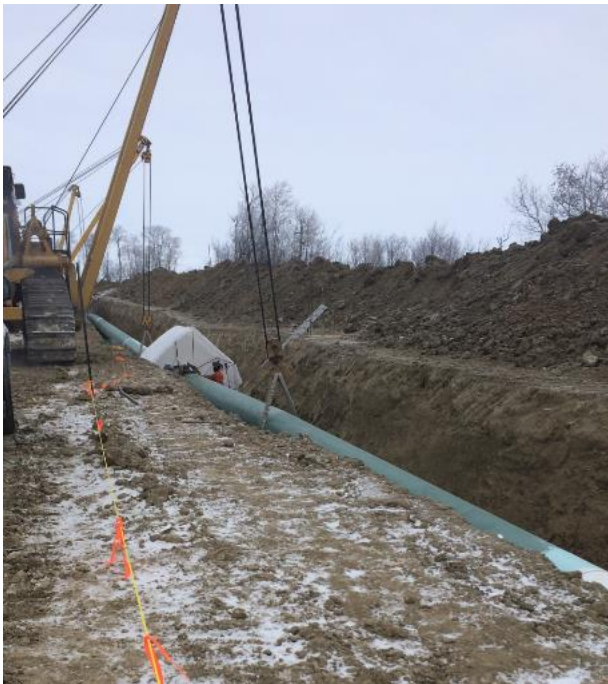
802 + 300 Welders completing tie in on pipe

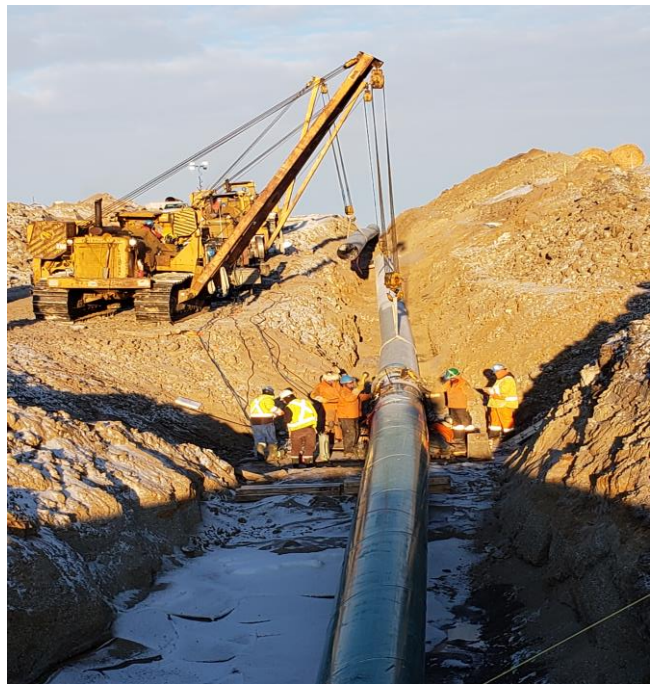
751+400 Crew doing a tie in.

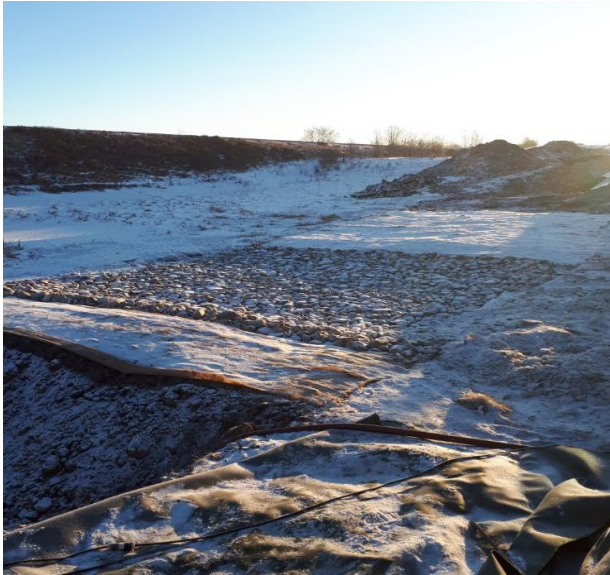
Little Pipestone restoration

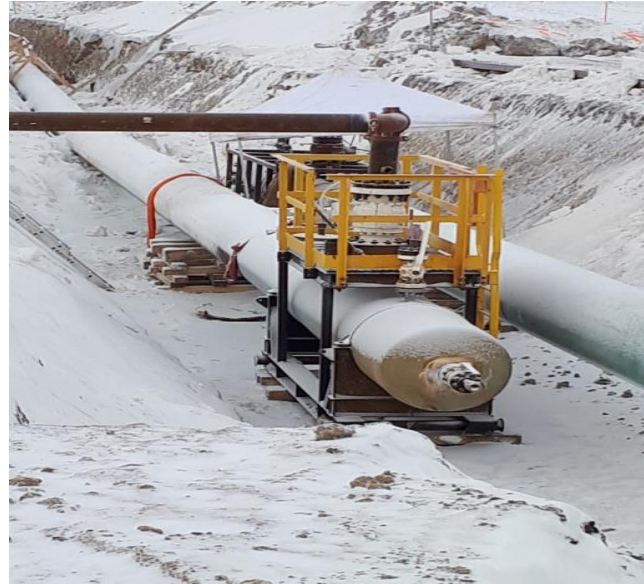
Our team observed crew prepping for the pressure test at 735 + 560 A ramp and water hose was installed across field to water source (Charles Lake) The discharge location was set up. Over two hundred straw bails were placed at the dewatering area and a berm was installed at the dewatering area. Utility crew set up hoarding around the pumps and equipment. Test trailers were on site with instrumentation. At 706 + 950 (Test Point) Spoil pile was moved for extra work space, additional ditching was completed. Boiler was set up at water source., the water must be heated to 50°C.Crew started filling the sections to conduct the test.

735 + 600 Hydrostatic testing head installed for testing

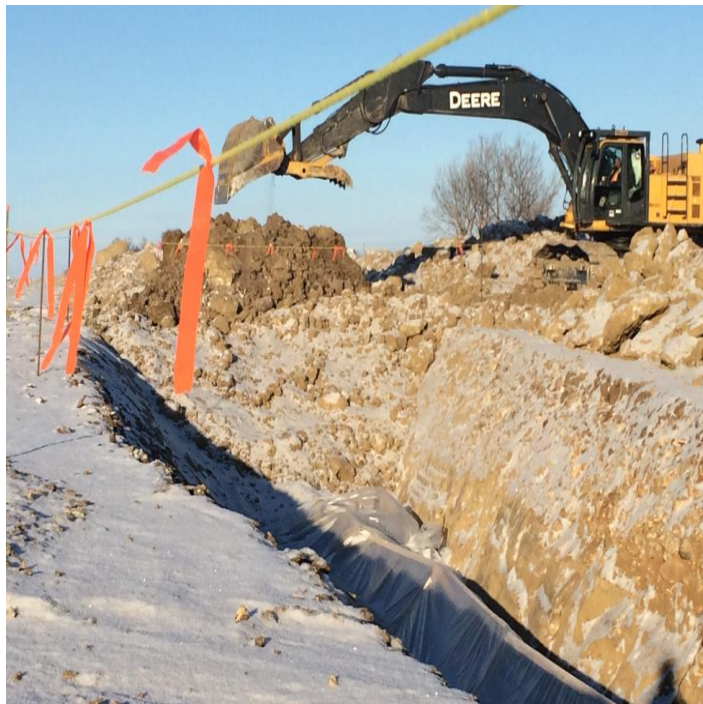
8055 + 100 backfilling ditch & pipe hoarded in

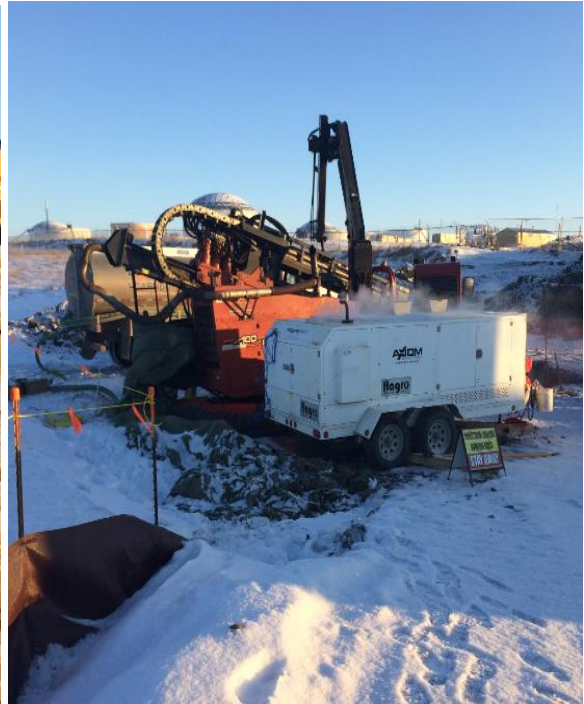
806 + 253 HD Bore
