SGS MUSCOWPETUNG

ABORIGINAL CONSTRUCTION MONITORING

WEEKLY REPORT

SPREAD 6

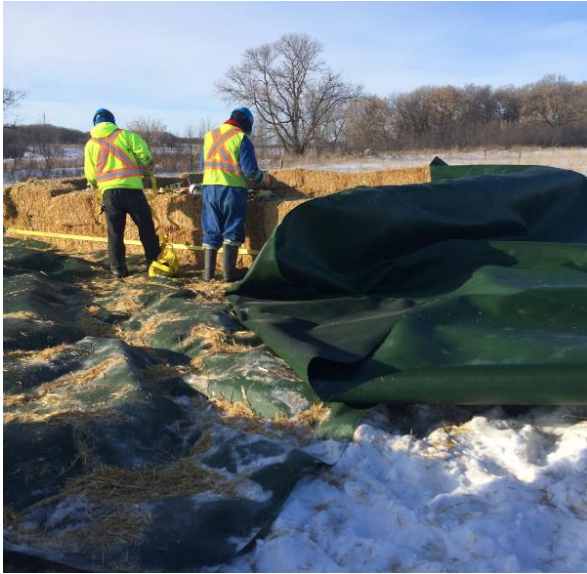
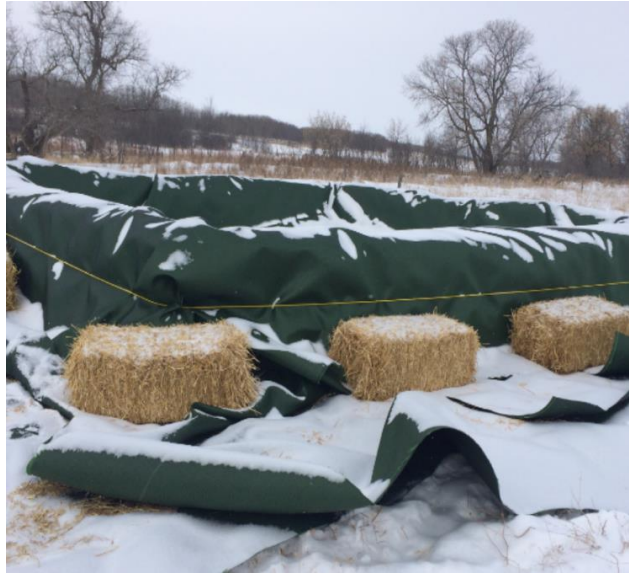
Crews completed the construction for the water pump out containment. Geotechnical membrane (Geotech) was placed on the ground, straw bales were hauled in and placed on Geotech. Additional Geotech was placed over the bails to complete the containment for water discharge (pig pen.). Excavator continued clearing out both east and west banks of the creek. The spoil pile from the pit excavated was relocated to the south side of the right of way. The clay excavated on the west bank was loaded onto rock trucks and hauled to the east side across the tracks. Archaeologist ICM's and ACM's – walked the excavated areas and located more bison bones. Two parallel lines were cut into the creek the crew worked with two ice saws to complete the cuts for the isolation. The sand bags were hauled closer to the creeks edge and placed for instalment. Track hoes continued with excavating the ice out of the creek.

Crew setting up the straw bails and Geotextical membrane for the ditch water containment

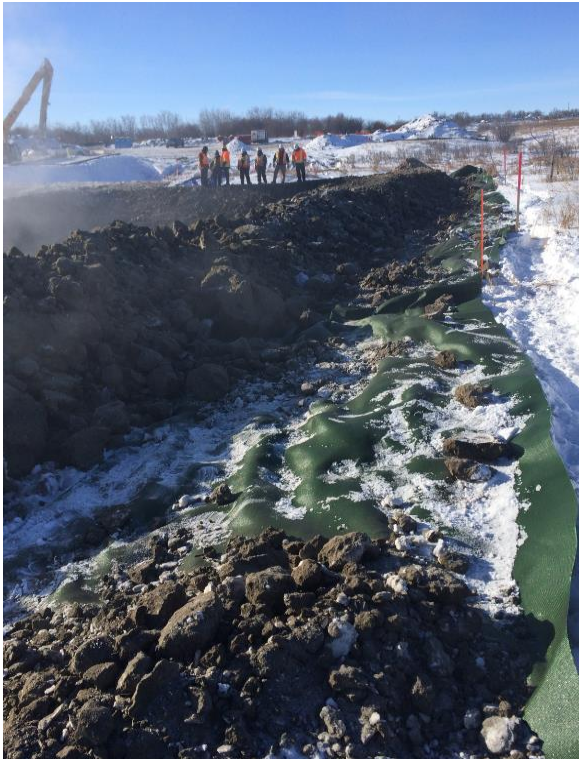
Pit constructed for Creek excavated material

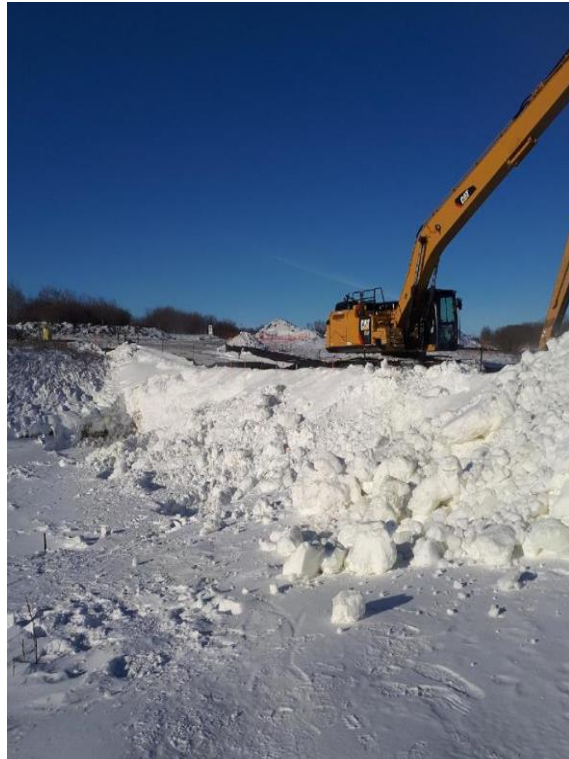
Cutting back the ice bridge to boundary on south side

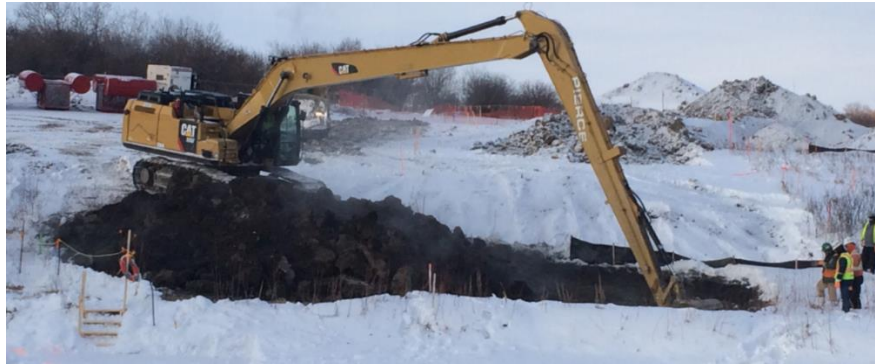
Pipe Stone Creek excavating west side

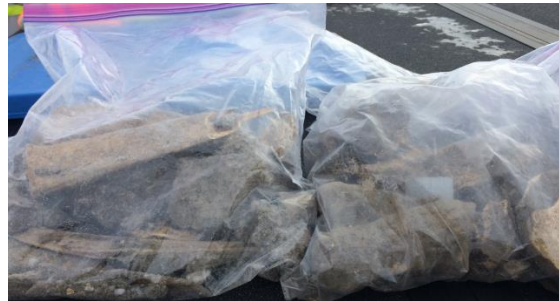
Dozer cleared the ditch line path on the east side of the Creek. Track hoe excavated an area on the west side of the creek bank. Excavation of the pit for the wet ditch material was completed. Archaeologist ICM's and ACM's were all on site – walked the excavated areas and located more bison bones and a bison skull. The skull was first noticed by an equipment operator, who stopped and motioned that he had uncovered something. The operator dug up the skull at approximately 2.1m depth below frost line in coarse sandy material. A prayer was said by one of the ICM elders. The skull was wrapped in a blanket and placed in a rubber tote with the sand material placed on the bottom and on top of the skull to preserve the item. The Manitoba Heritage board was contacted, and the Canadian Conservative Institute will give the Archaeologist further direction.

Bones and Bison skull located during excavation at the Pipestone Creek

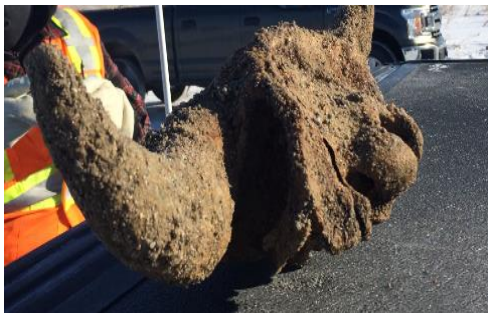
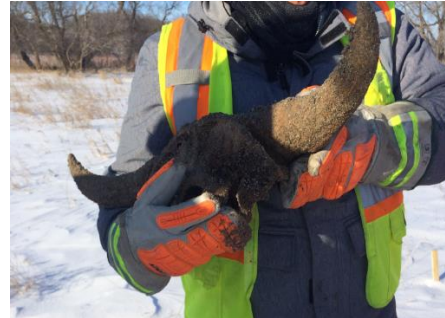
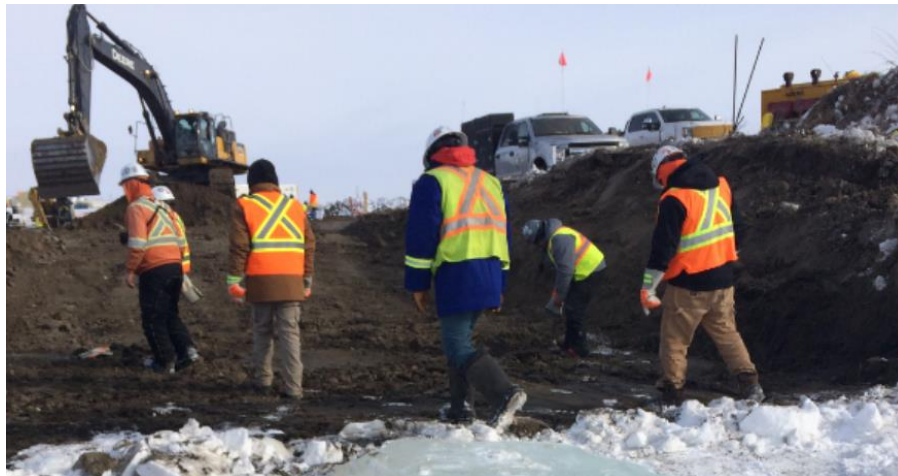
Archaeologist's ICN's and ACM's walking the area looking for artefacts

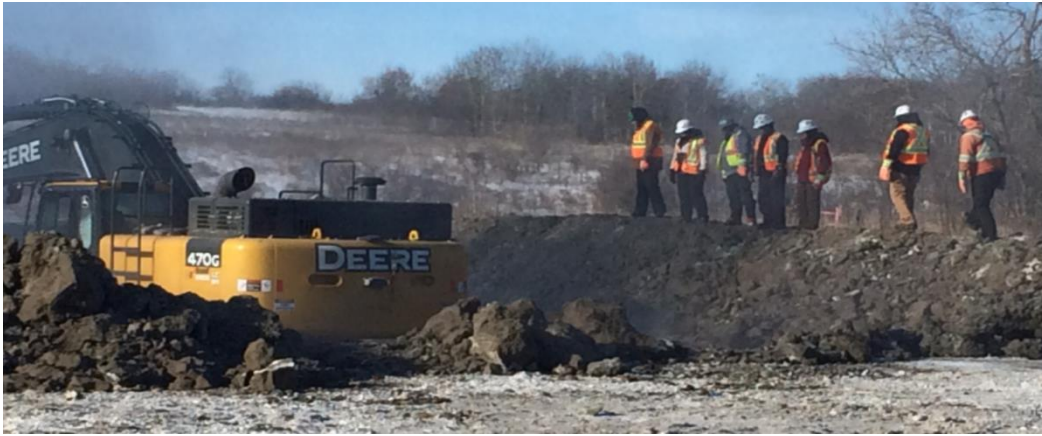
Excavating pit for Creek ditch material at the Pipestone Creek Archaeologist observing for items of interest in the soil

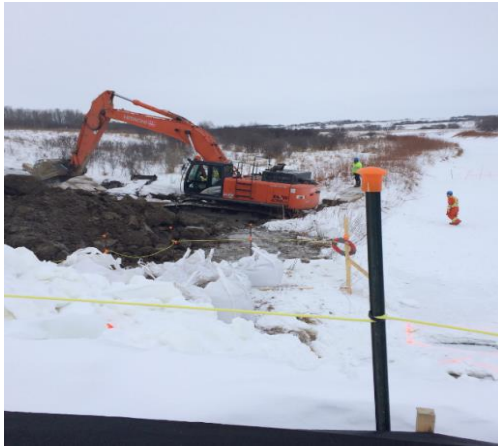
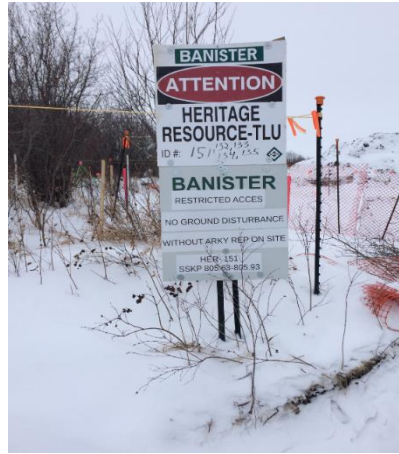
Excavating ditch line through the Pipestone Creek

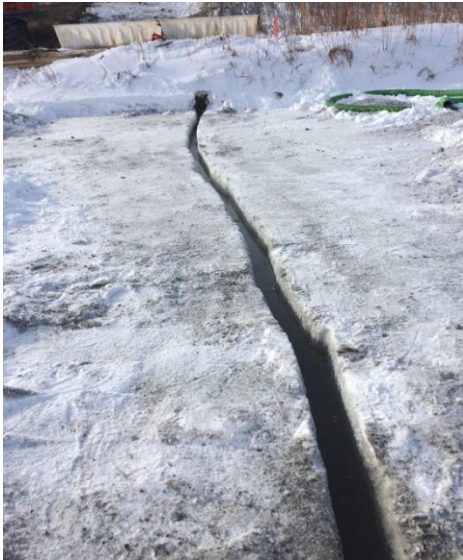
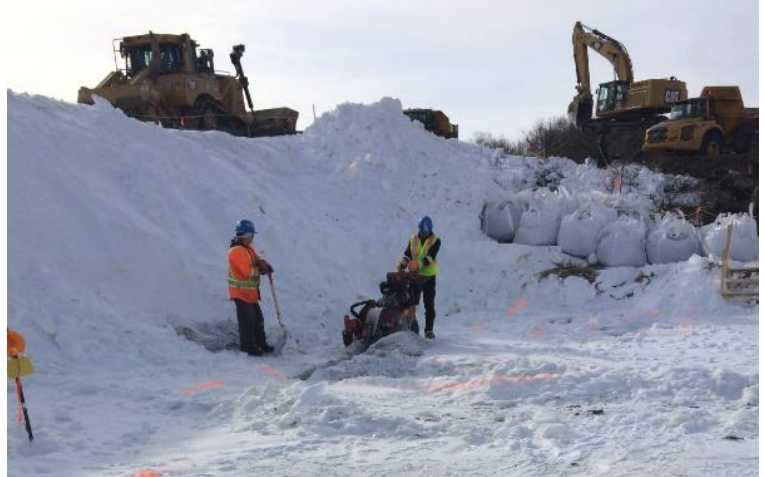
Pipestone Creek - Crew cutting line into the ice for the isolation

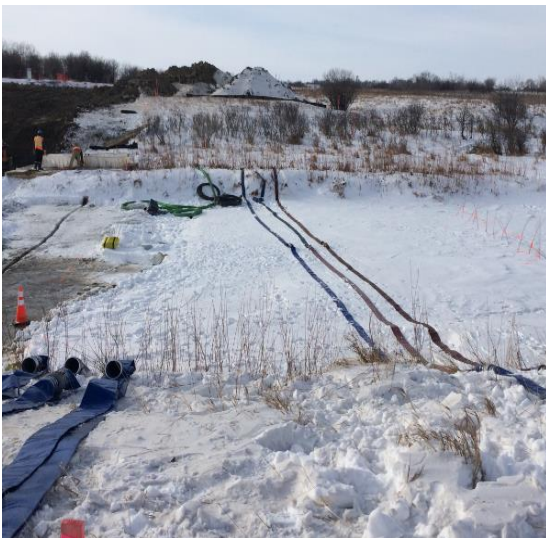
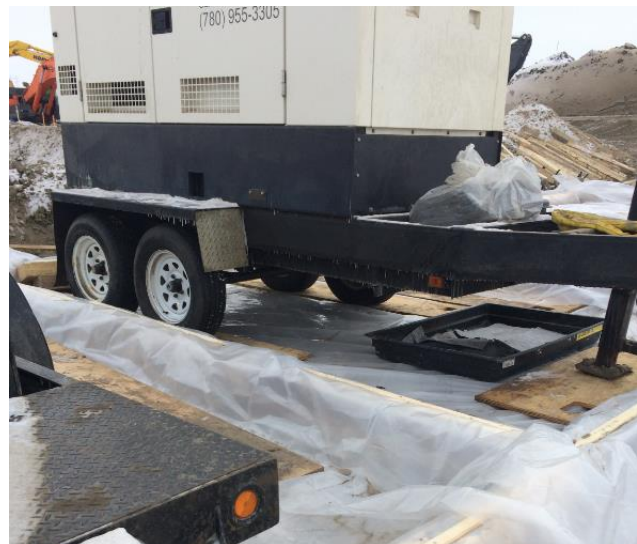
Hoses set across the Pipestone creek & Containment for the generators

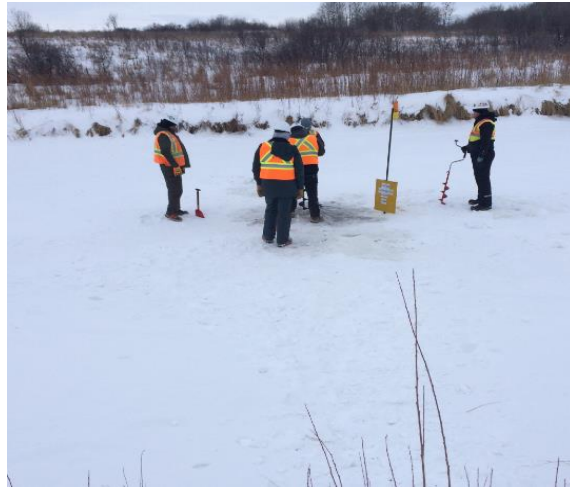
Biologist and their team were on site conducting turbidity test on the creek. Twelve holes in total two upstream and five sets downstream. For testing - holes are re-opened with an auger, the holes are left to set for a while and tests runs are completed 3 times per day. Wood framed boxes with poly plastic were constructed for containment of the pumps and generators. Filter baskets were installed at the creek, biologist conducted testing for aquatic life in the creek.

Biologist conducting tests on the Pipestone Creek water

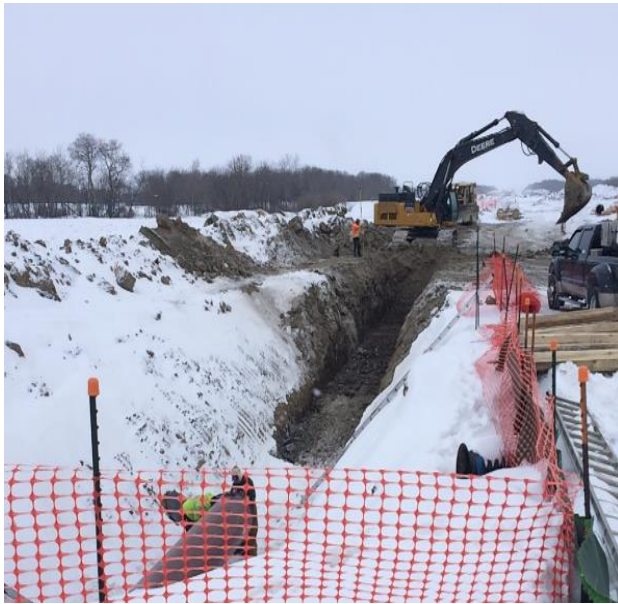
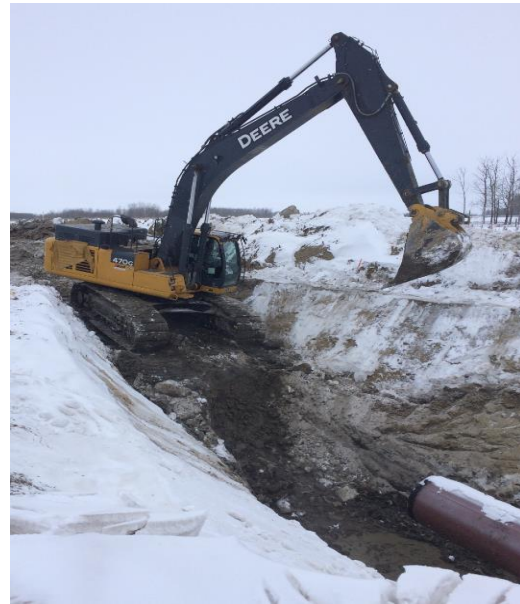
788 + 460 & 796 + 200 Excavating ditch for tie ins.
