**SGS MUSCOWPETUNG**

**ABORIGINAL CONSTRUCTION MONITORING**

**WEEKLY REPORT**

**SPREAD 6**

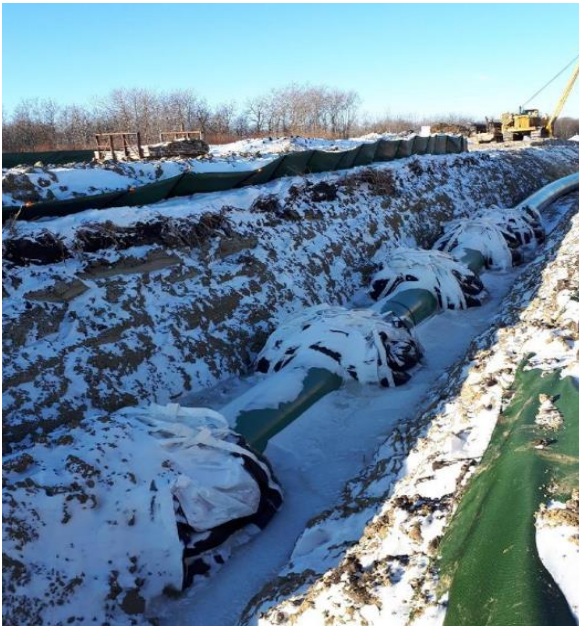
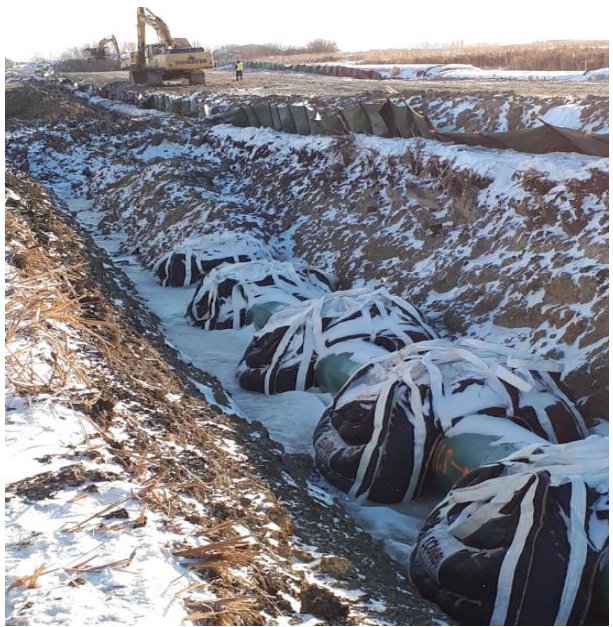
Eco bag weights placed on pipe in wetlands and coconut matting placed on top for wetland restoration

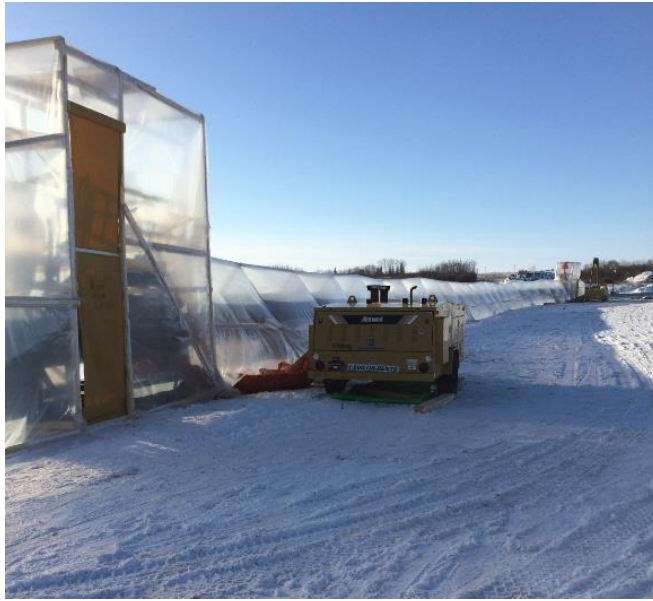
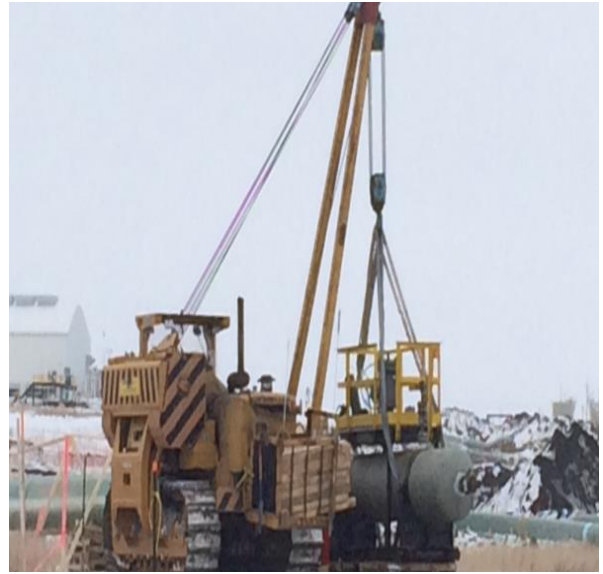
East side of the Pipestone Creek – Hoarding for test pipe string & removing test head.

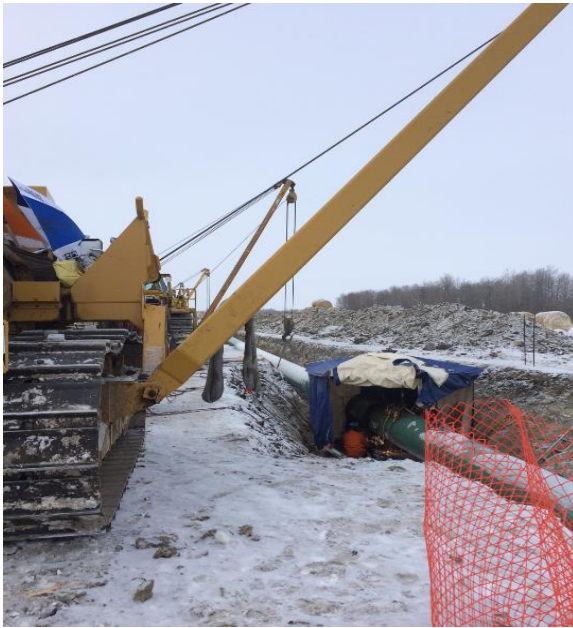
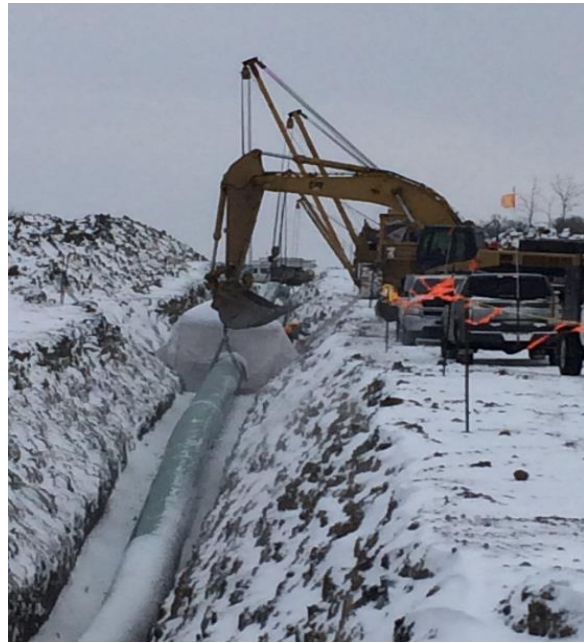
742 + 101 welder tying in pipe & 741 + 779 coating pipe

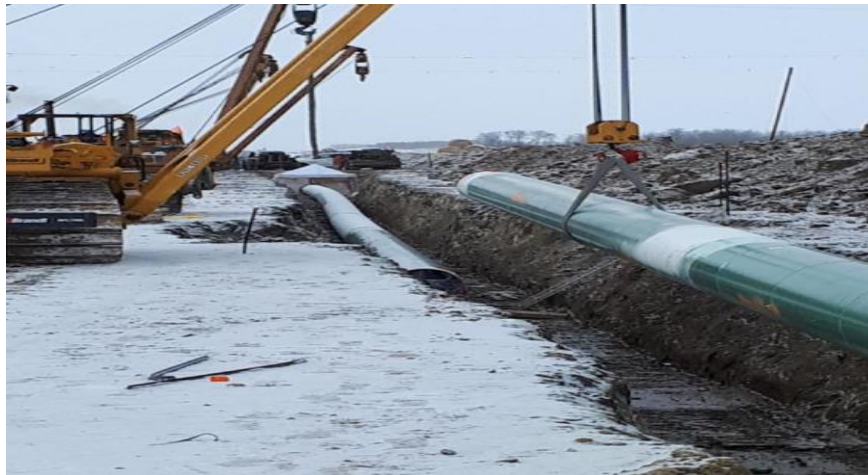
721 + 632 lowering pipe

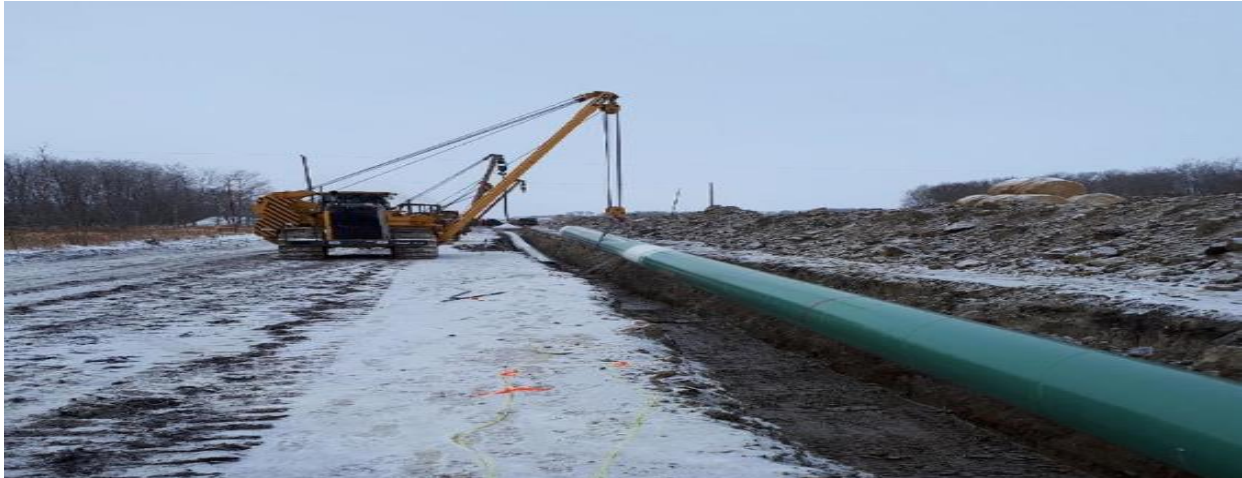
735 + 081 Lowering pipe into ditch

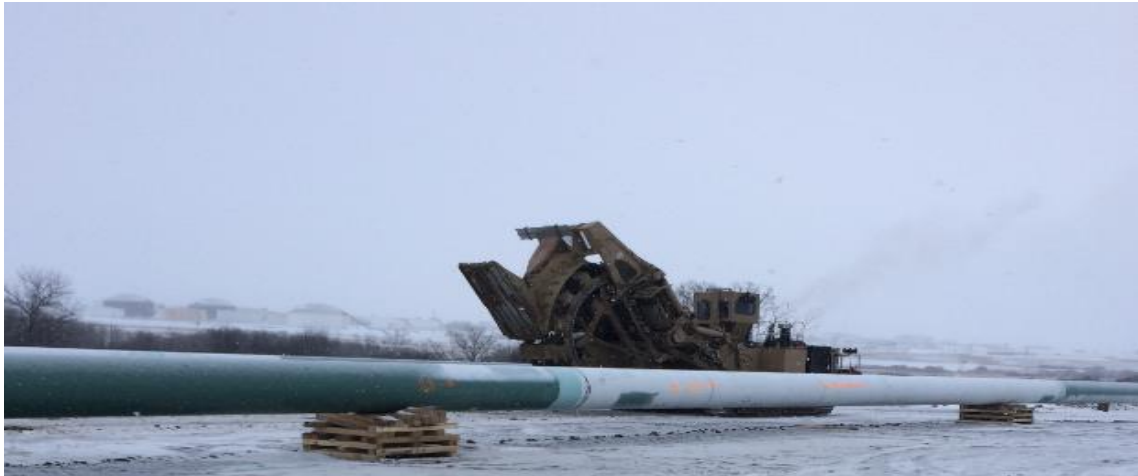
802 + 562 ditch wheel

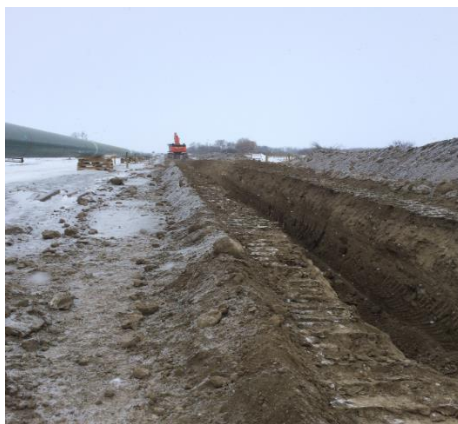
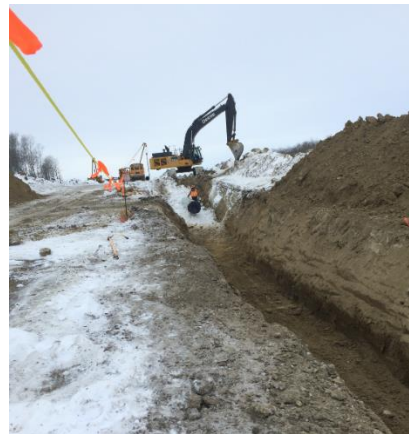
784 + 842 Excavating ditch lines

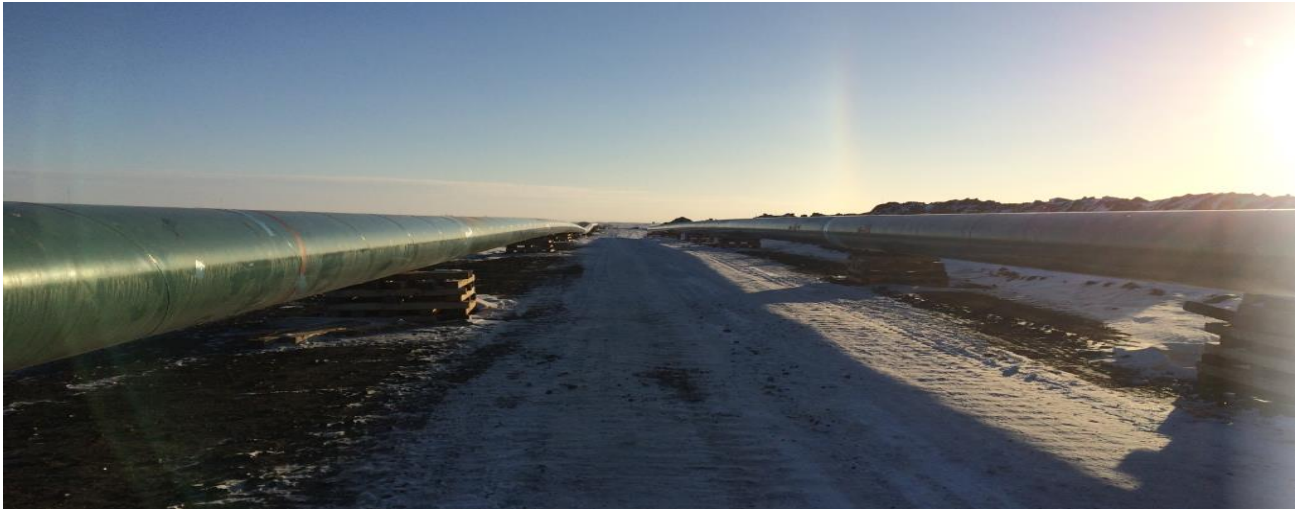
755 + 066 Pipe strung and prepped for lowering in

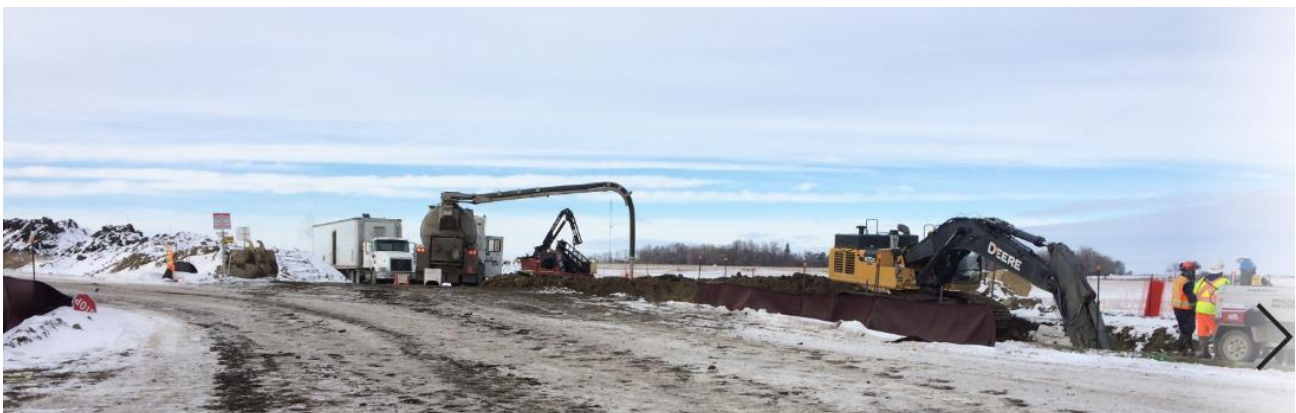
Stoney Creek HD Bore at access road

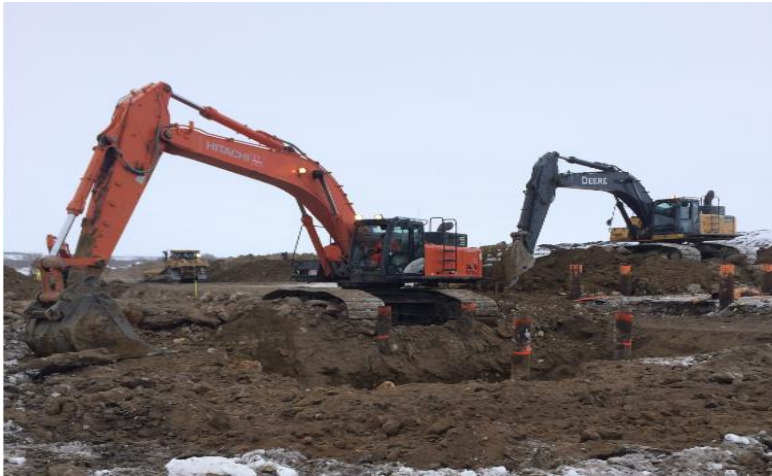
**West Pipestone Creek Excavating ditch**

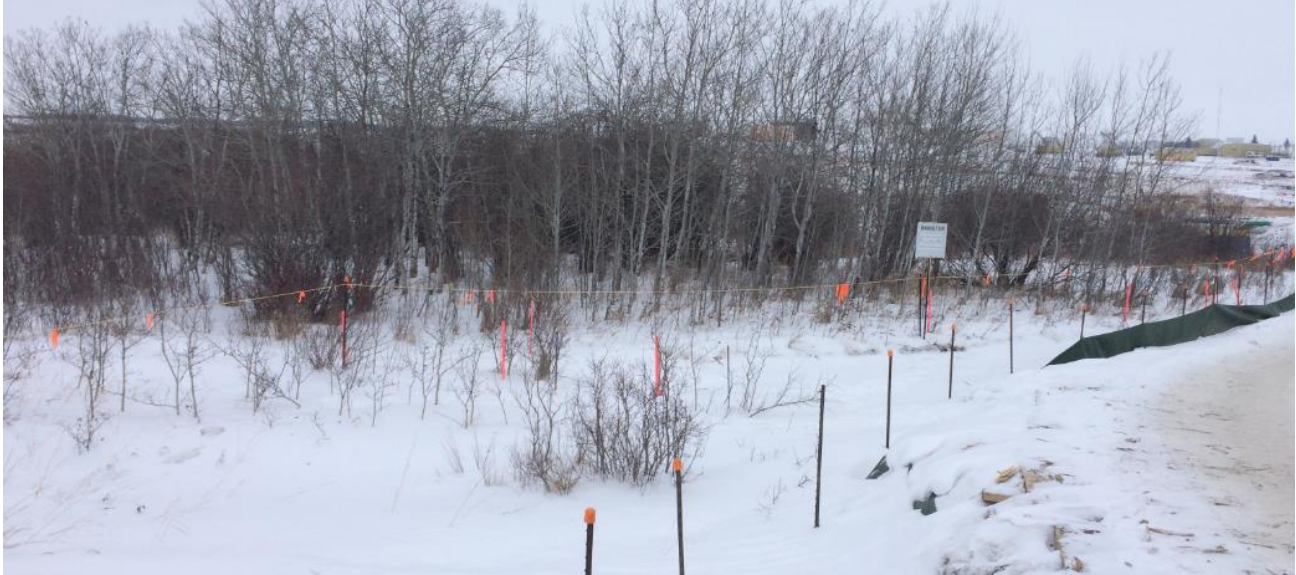
**East side of the Pipestone Creek area of interest roped off**

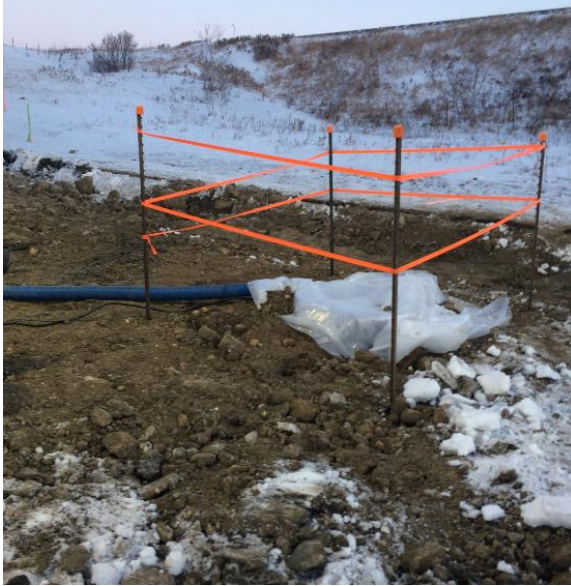
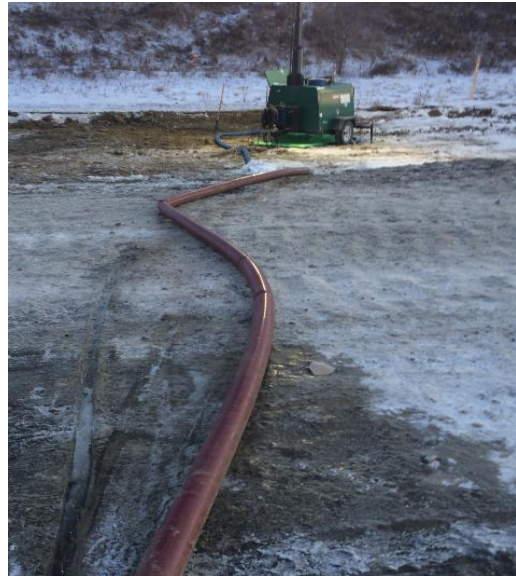
The Little Pipestone Creek Excavating ditch, Pumping water and sand pipe installation
