**SGS MUSCOWPETUNG**  
**ABORIGINAL CONSTRUCTION MONITORING**  
**WEEKLY REPORT**

**SPREAD 6**

**NOVEMBER 12<sup>TH</sup> TO NOVEMBER 18<sup>TH</sup>, 2018**

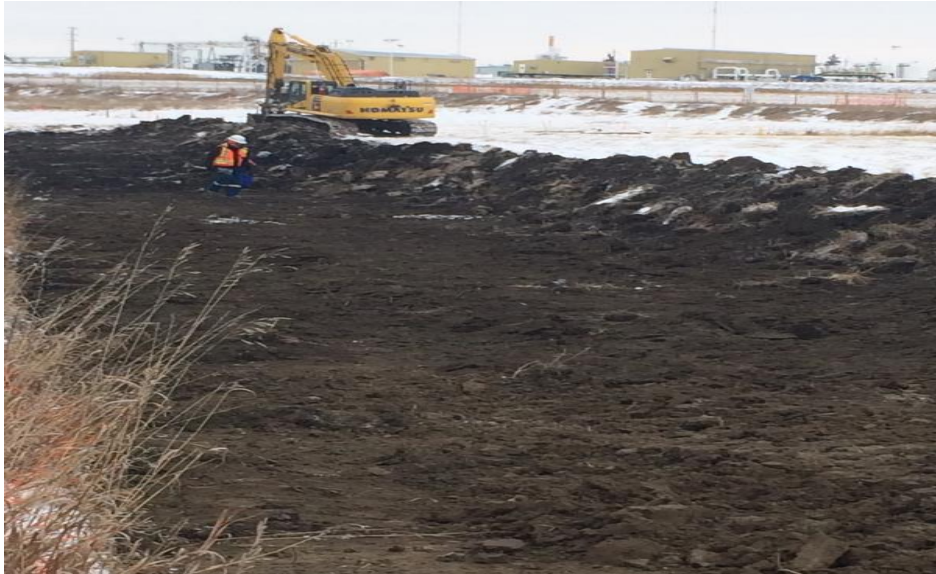
806 + 400 East side of the Pipestone Creek Archaeologist looking through soil piles

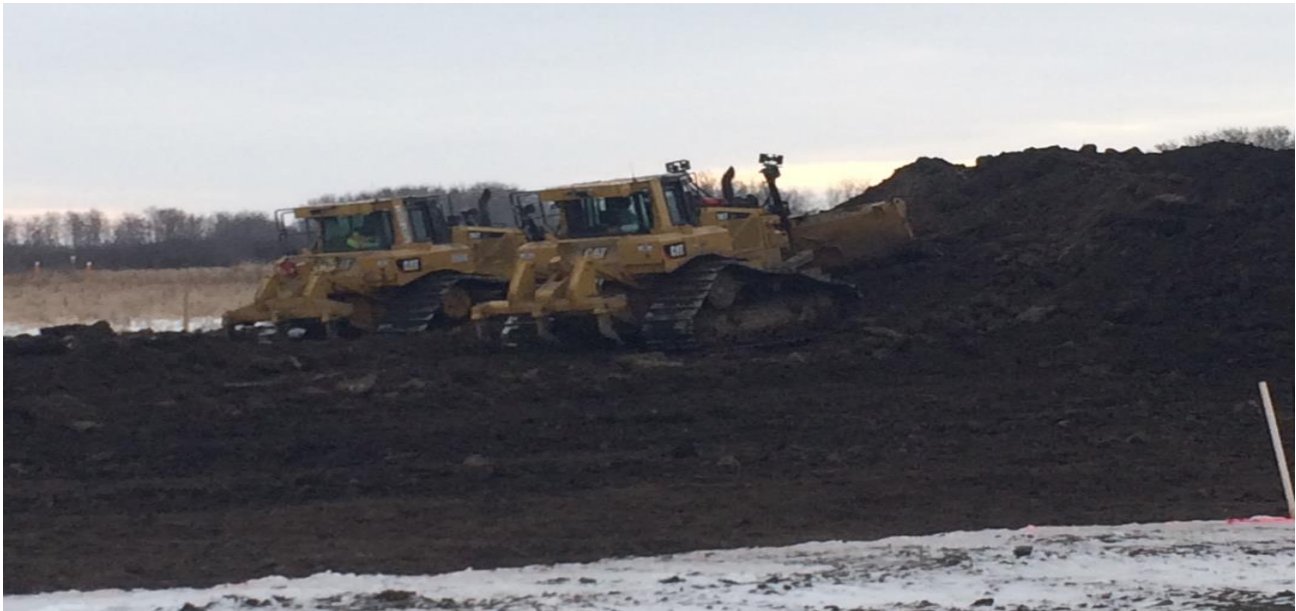
806 + 140 East side of the Pipestone Creek Dozers tandem pushing topsoil

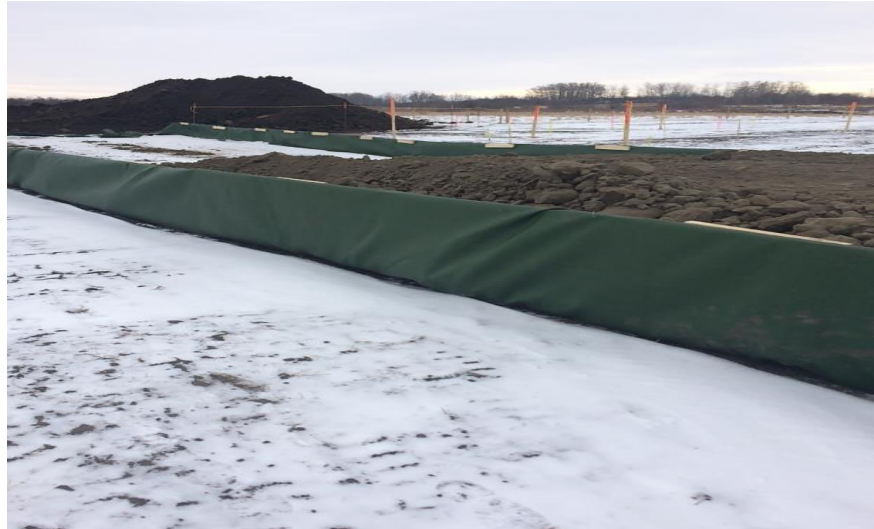
806 + 128 Ramp completed east side of the Pipestone Creek

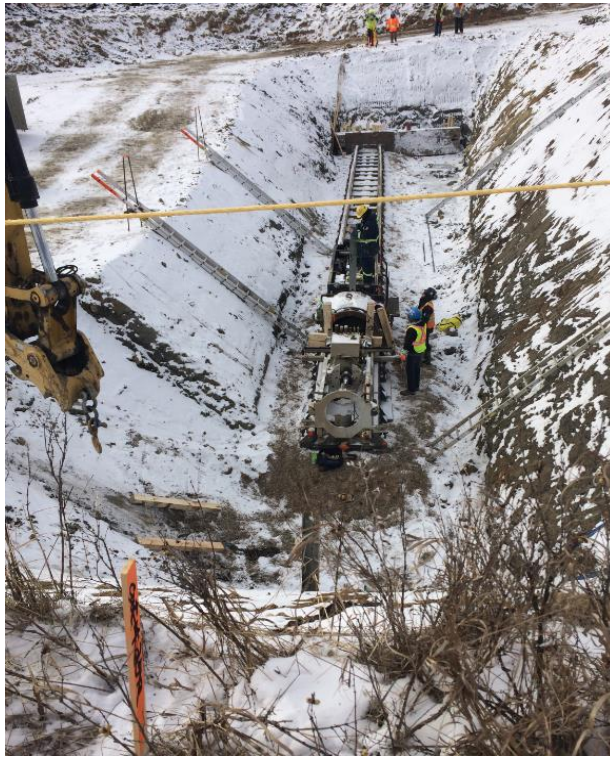
805 + 420 Track bore East side of the Pipestone Creek
