SGS MUSCOWPETUNG

ABORIGINAL CONSTRUCTION MONITORING

WEEKLY REPORT

NOVEMBER 26TH TO DECEMBER 2ND, 2018

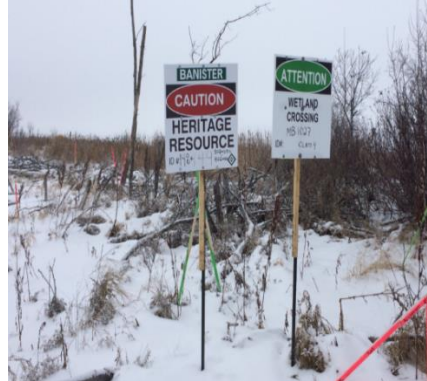
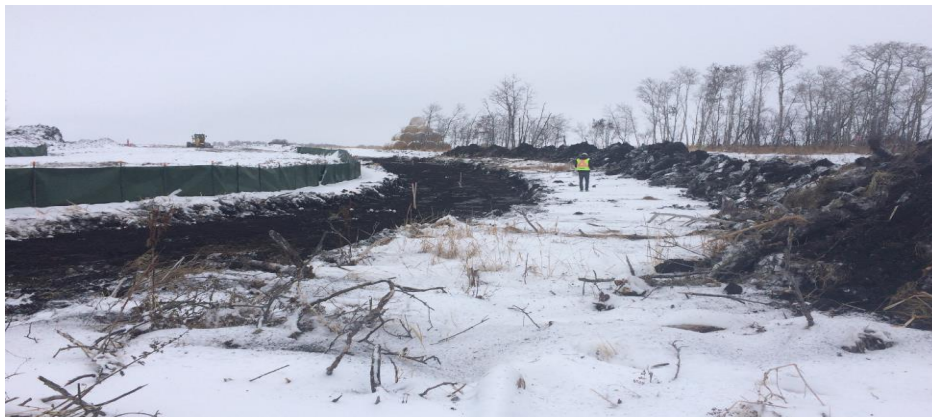
Our team monitored at 801 + 500 MB 1027 wetland being stripped adjacent to HER Resource148 and 149 sites. A clay bridge was built over part of the wetland, and to the northwest an area along the work side was stripped 20feet wide. Crew laid Geo cloth on edge of stripped wetland over topsoil, to separate the soils when ditch is excavated. At Heritage resource HER 140 Stoney Creek 786 + 600 A section of the roped area was down. Our team put the t post and rope back up. additional monitoring of the cradle bore under the CN tracks at 794 +301adjacent to Her Resource 143 DkMi-9 Casing was prepped by the welders and set in the ditch with side booms. The casing bored through the 45m and product pipe was welded attached to the casing and pulled through.

801 + 500 MB 1027 wetland stripped adjacent to HER Resource 148 and 149

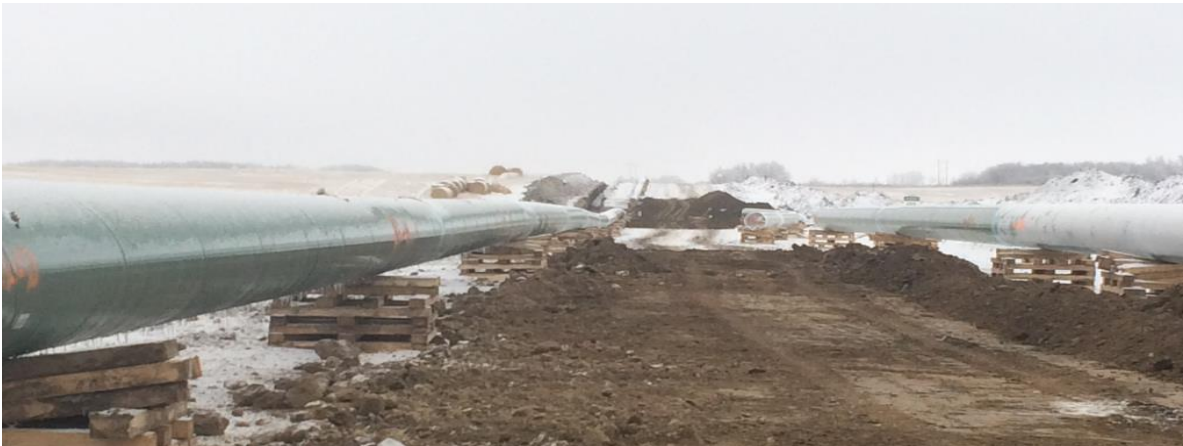
Monitored Montgomery Creek 714 + 600 – 717 + 200 two ditch wheels excavated ditch/trench and worked east through 716 + 700. The excavators followed through and completed excavating the ditch. Piping was strung on skids along the right of way welded and prepped for lowering in the ditch. By the end of the week sections pf product pipe were set in the ditch and excavators backfilled the ditches.

Montgomery Creek 714 + 600 – product Pipe strung along right of way

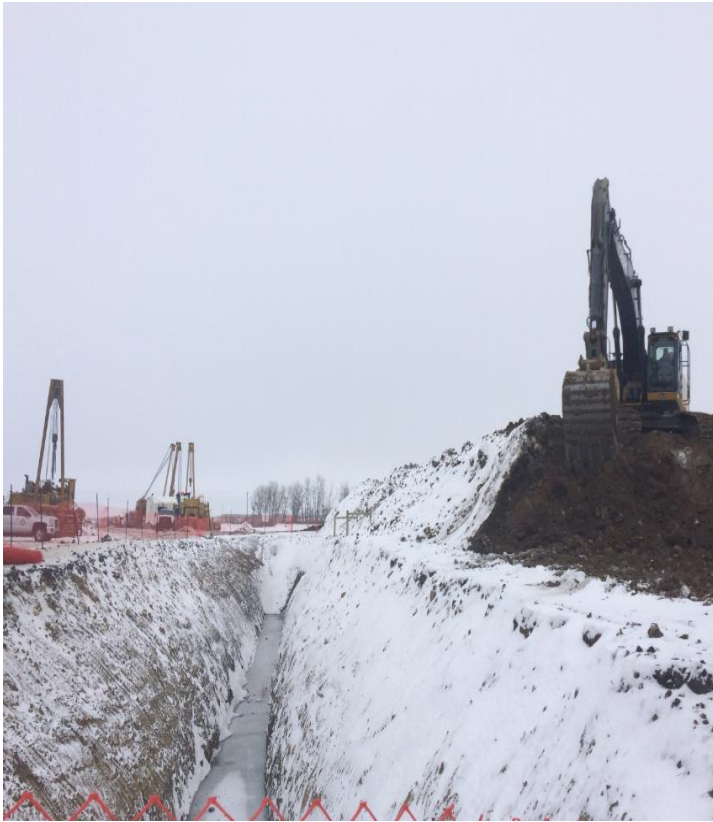
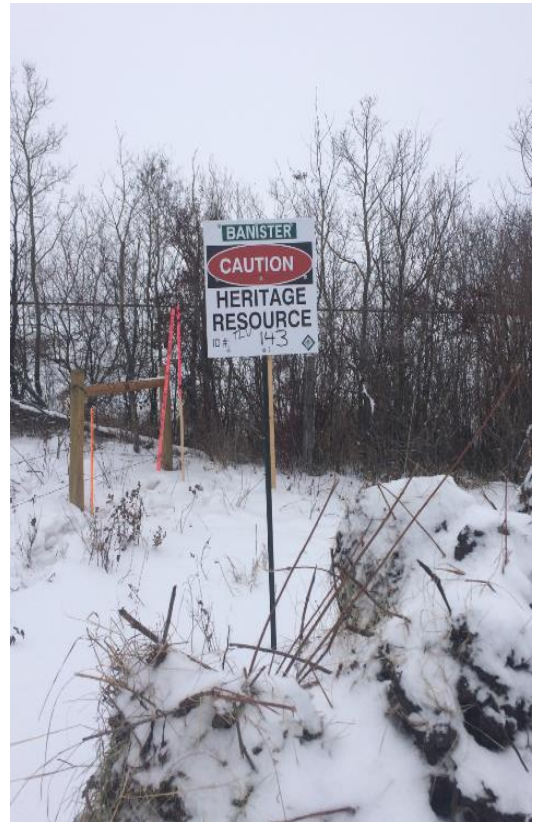
795 + 877 Cradle bore under the tracks

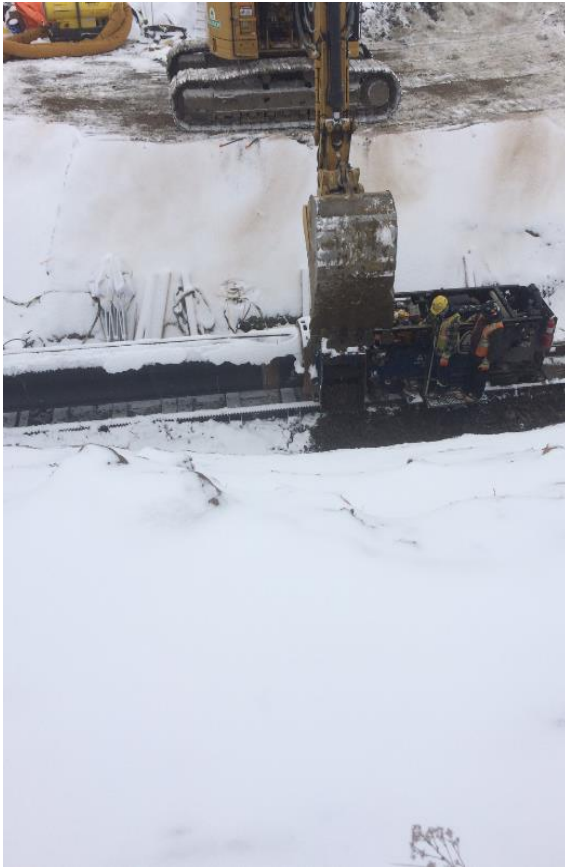
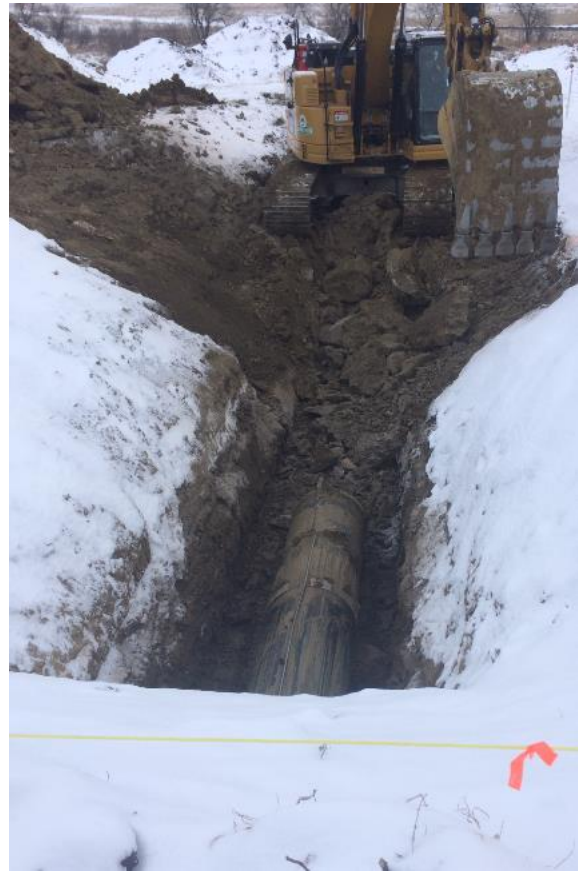
Our team continued monitoring 803 + 494 – Heritage resource TLU area 805.43- 805.93 West side of Pipestone Creek – Welders welded Casing and augers to bore spider. The tail ditch was completed and later in the week the bell hole was excavated to make it wider, the additional clay was piled to the east. Boring the casing continued and the crew set in and welded another section of casing with augers and continued to push the bore under the tracks and area of interest. The augers had to be pulled out of the casing and cutting head on the bore machine had to be changed. the tailings were moved with the excavator along the ditch. The product pipe was prepped in the laydown area, one joint at a time was walked with three spotters and tag lines to be set in bore ditch. Crew set in and welded the final section of casing and augers Boring continued with casing through to tail ditch, the spider was cut off. Augers were removed, and product pipe was welded to the casing, sections of the casing were bevelled (cut off) as the product pipe was pushed through. Crew continued to build the ice bridge across MB1010 Pipestone Creek. Again, the weather warmed up and the ice bridge is still in the process. On the East side of the creek the area was graded, the archaeologist walked the area and found additional bison bones. Throughout the week The Archaeologist ICM's and ACM's have been on site monitoring the area. Observations and sightings of Deer elk and Moose have been spotted close to our work area. There are footprints and paths made by the deer through the area of interest.

803 + 494 Pipestone Creek track bore under the Tracks and area of interest
