SGS MUSCOWPETUNG

ABORIGINAL CONSTRUCTION MONITORING

WEEKLY REPORT

SPREAD 6

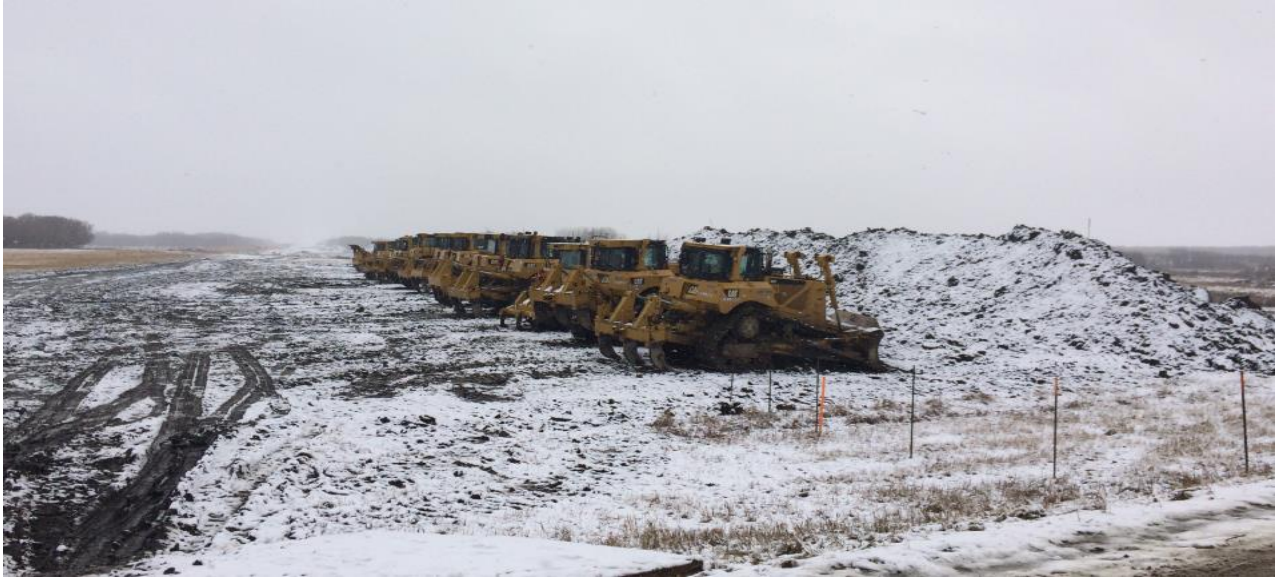
Dozers at 787 + 500 Stony Creek – Heritage sign at area of interest and right of way stripped.

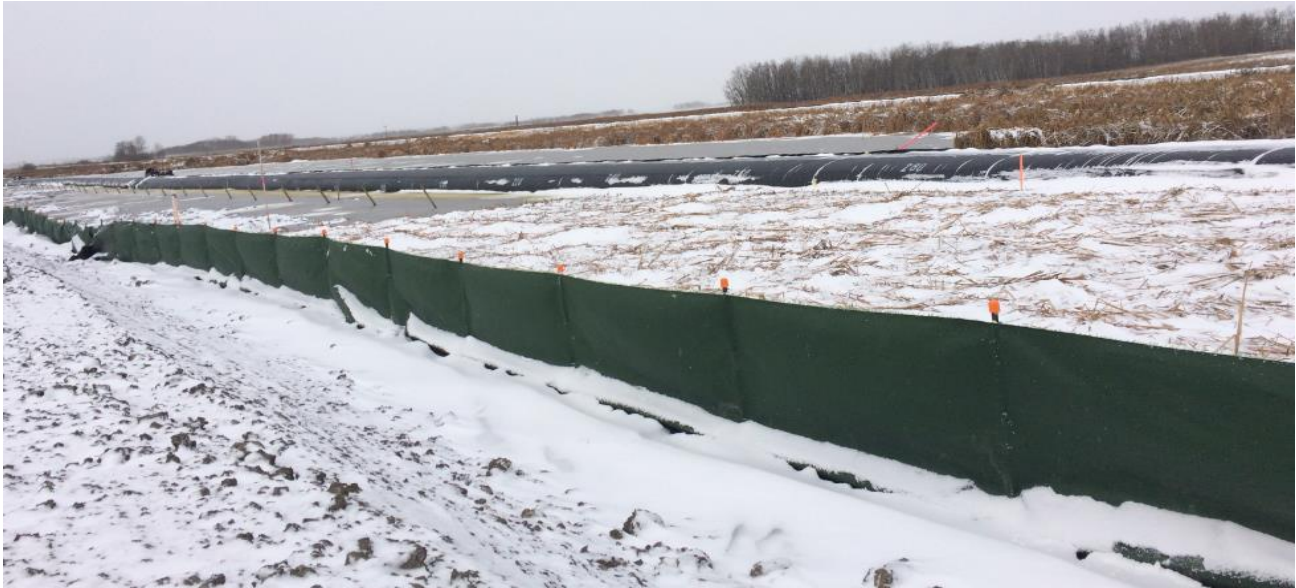
767 + 953 Aqua dam SK 902-2 Class V

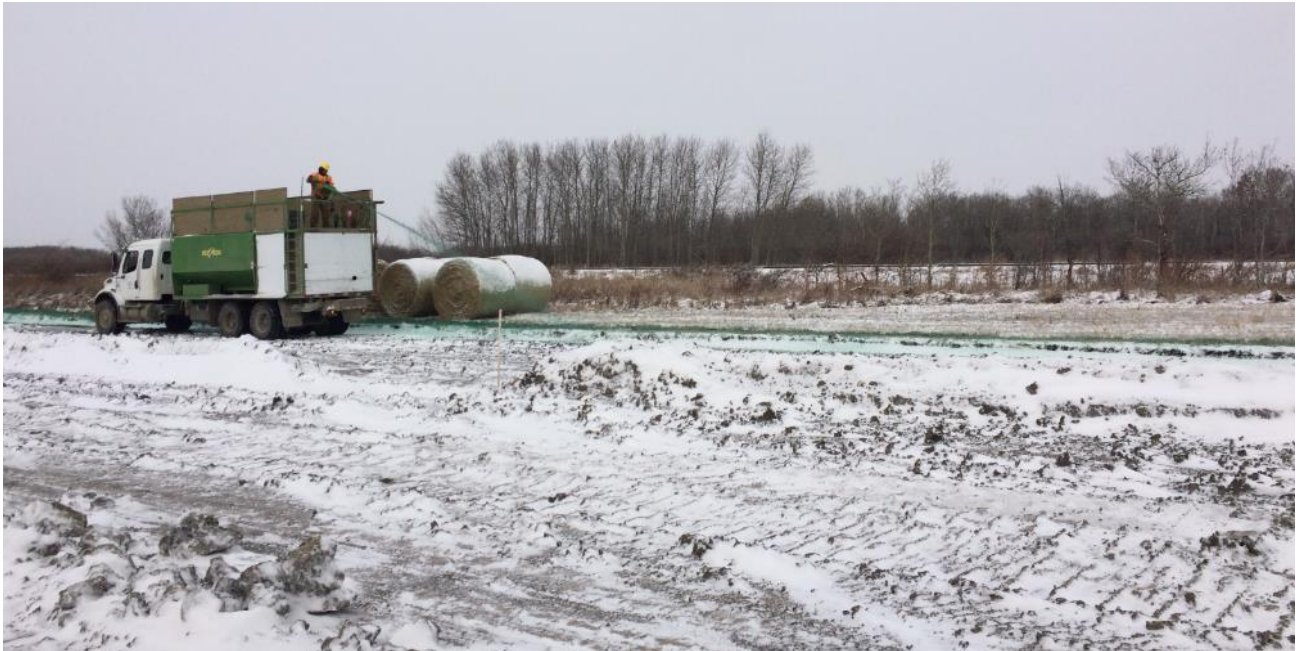
Tackifying (Soil Stabilization)

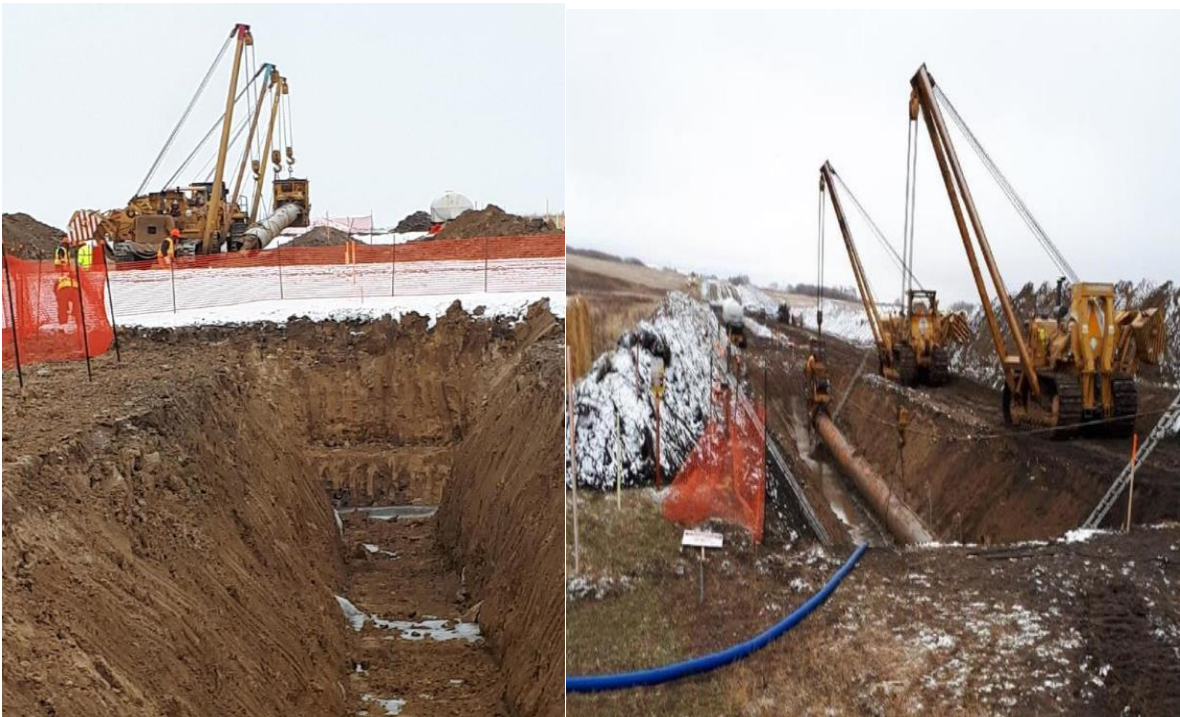
Picture left Tail ditch – Picture right bore hole entry (Side Booms)

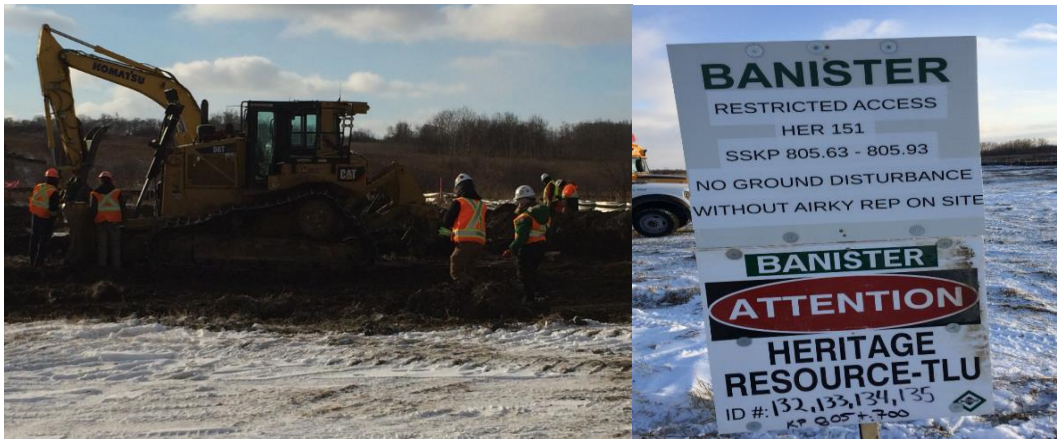
Pipestone Creek East side track hoe stripping topsoil – Archeologists and teams walking the area.

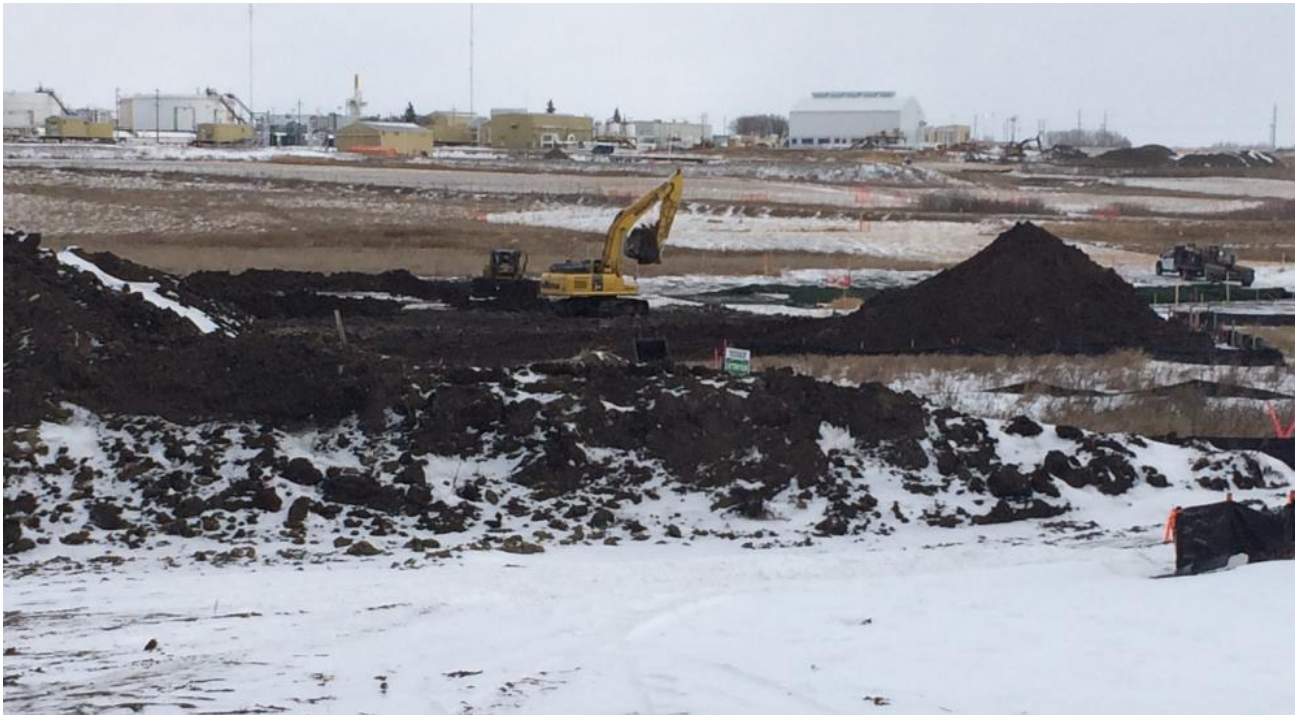
East side Pipestone Creek stripping topsoil

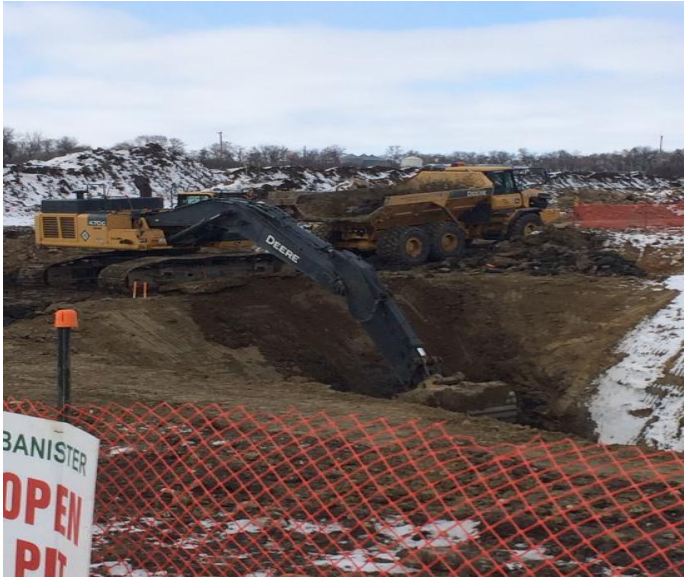
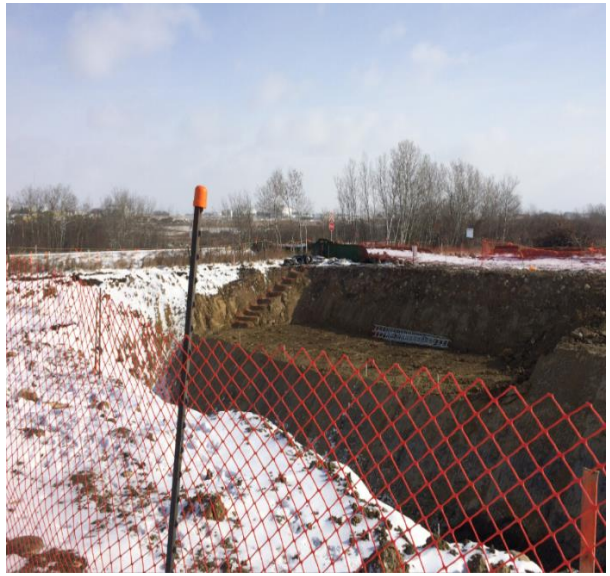
During the week our team monitored 803 + 494 Her 151 SSKP 805.63 – 805.93 West side of Pipestone Creek. Bore pit excavation and preparation for the bore under the tracks continued this week, Archaeologist was on site all week to monitor the excavation. Soil pile was relocated from the extra work space to the North side of the right of way. Additional drill string and equipment were brought in for assembly of the bore track. Fencing was put up around the open pit excavation with signage. Proper access egress with steps and ladders were installed. The track was assembled at the bottom of the pit. A pump is in place to pump out any water from the snow melting or water from the bottom. The Northern leopard frog 400 m buffers are still up on both sides of the creek. The rare plants VG 77 VG78 VG79 are roped off and have proper signage, Small areas the soil was removed containing seeds were relocated to a separate designated pile and are roped off and marked. On the North side of the tracks additional space that was required within the area of interest was agreed upon. And the area of interest was re surveyed. The exit bore pit was excavated with the track hoe, adjacent to the area of interest the track hoe keyed the edged with a spotter, snow fence and signage was put up with caution open pit signage.

Pipestone Creek West side 805 + 700 – Track bore excavation
