SGS MUSCOWPETUNG

ABORIGINAL CONSTRUCTION MONITORING

WEEKLY REPORT

FEBRUARY 11TH TO FEBRUARY 17TH, 2019

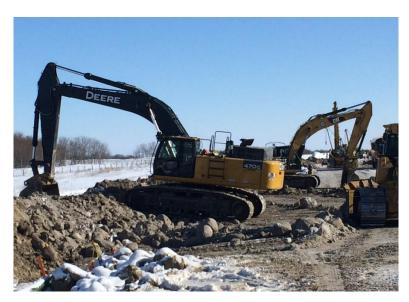
805 + 600 cut out and tie in of pipe

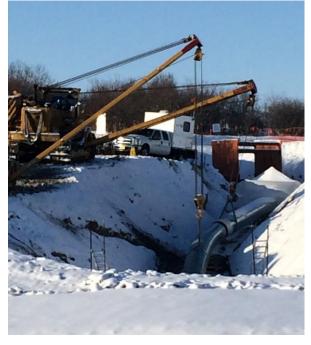
788 + 400 Backfillling ditch and placing roach back on ditch line

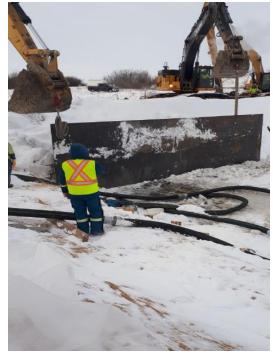
805 + 600 Tie in of pipe west side of the Pipestone Creek

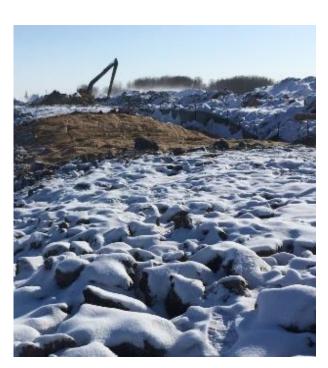
788 + 300 Stony Creek SK WC 89 Backfilling and restoration

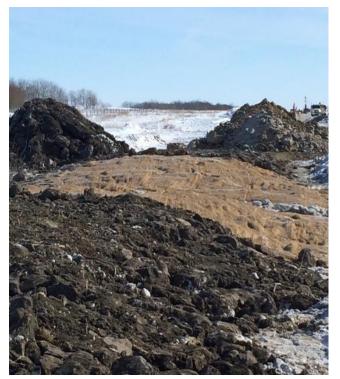
SK WC 89 & SK WC 90 Restoration
