**SGS MUSCOWPETUNG**

**ABORIGINAL CONSTRUCTION MONITORING**

**WEEKLY REPORT**

**FEBRUARY 18<sup>TH</sup> TO FEBRUARY 24<sup>TH</sup>, 2019**

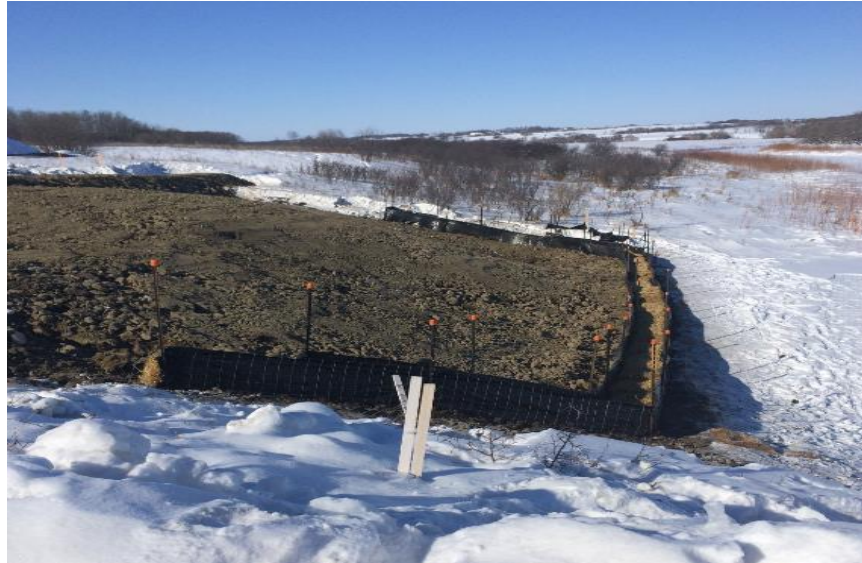
805 + 700 West bank of the Pipestone Creek erosion control.

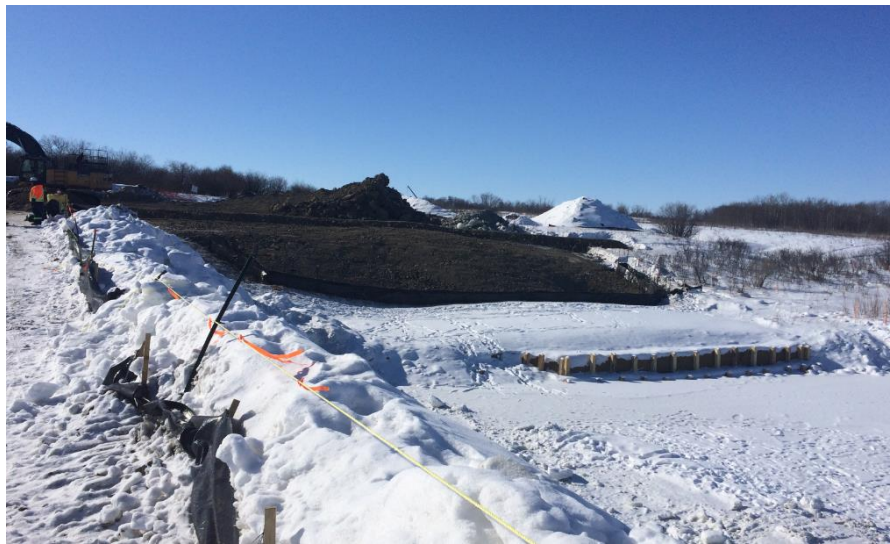
West bank at the Pipestone Creek MB 1010

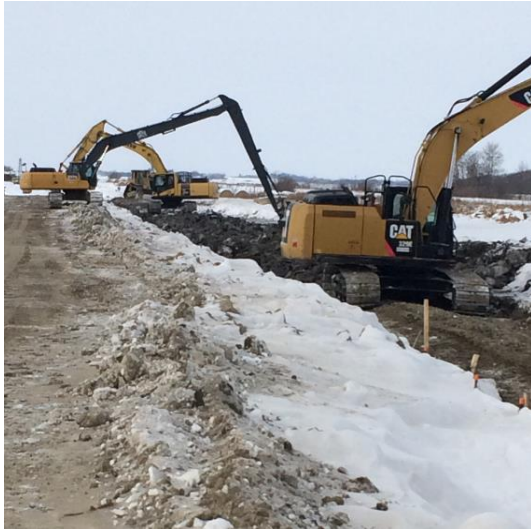
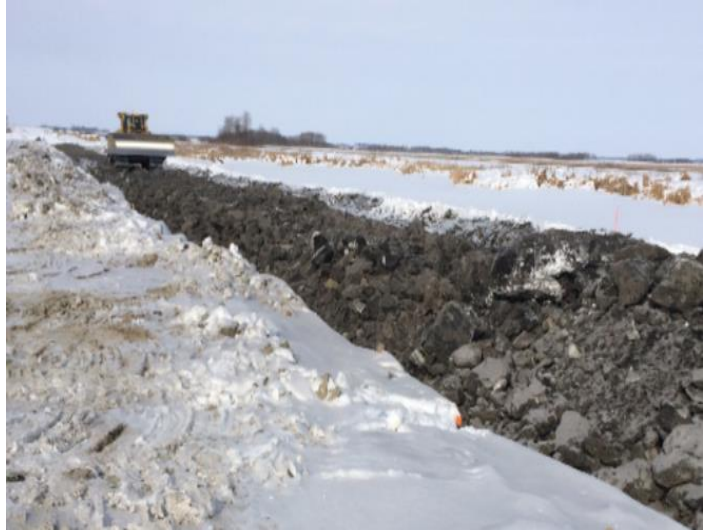
Wetland SK 799 restoration in process

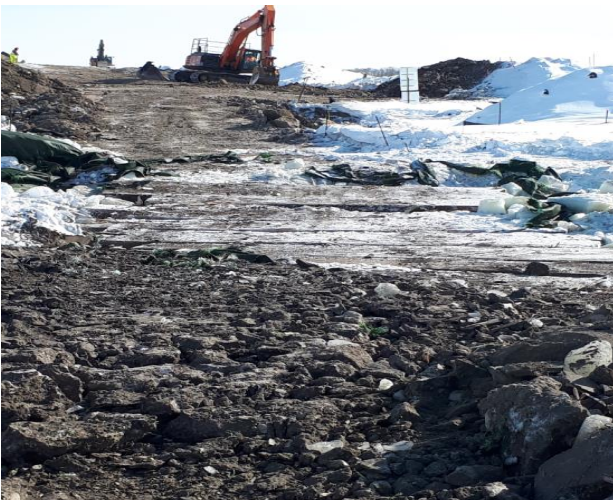
716 + 700 Removing ramp at Montgomery Creek SK WC 79.

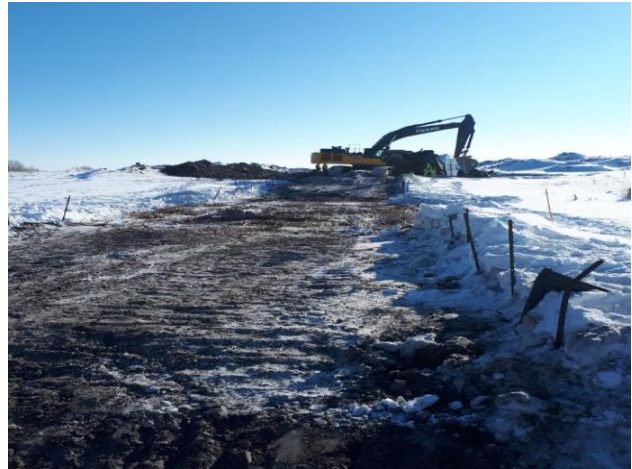
715 + 100 Track hoe stripping wetland SK 752 - WC 78.

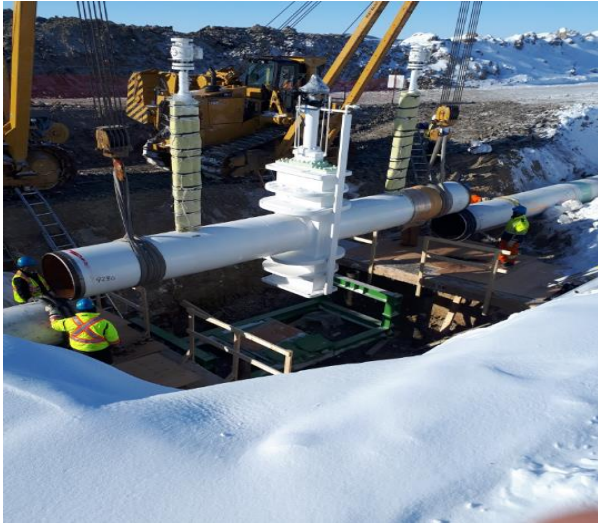
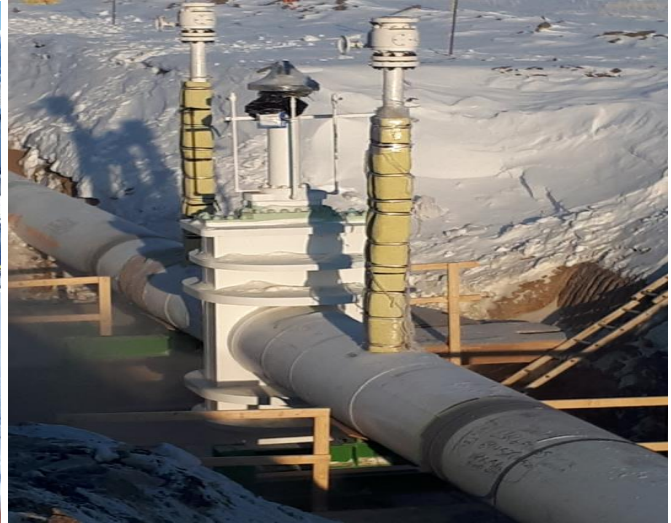
691 + 535 Installing MLBV # 18

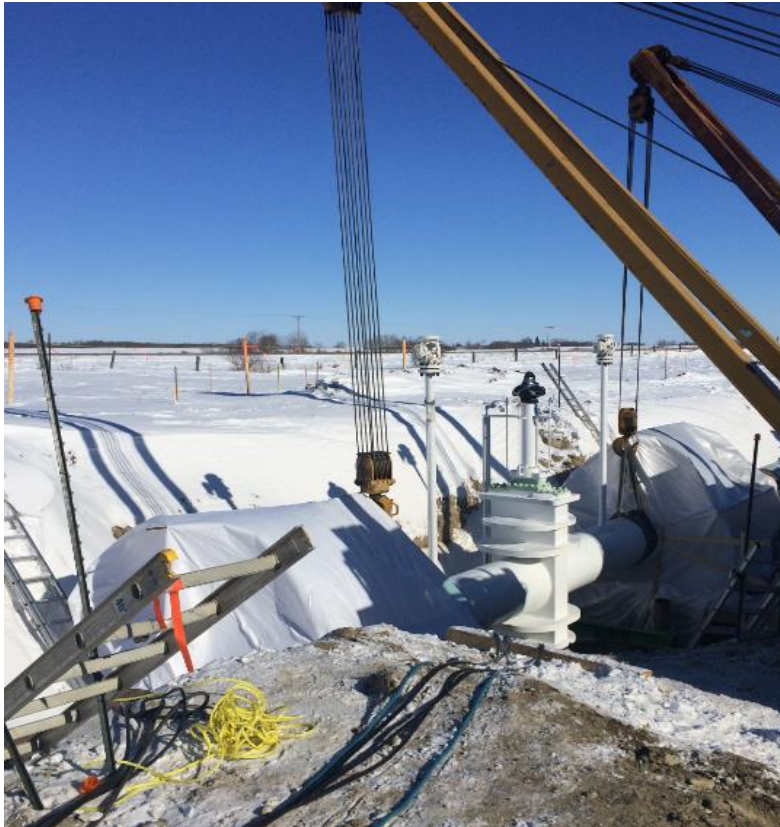
774 + 232 Installing MLBV # 21
