SGS MUSCOWPETUNG

ABORIGINAL CONSTRUCTION MONITORING

WEEKLY REPORT

SPREAD 6

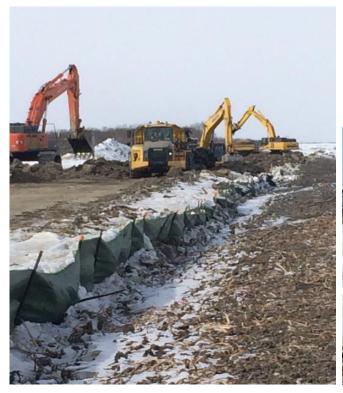
753 + 200 Stripping ramp through SK 876

705 + 200 Stripping ramp through SK 727 + 2

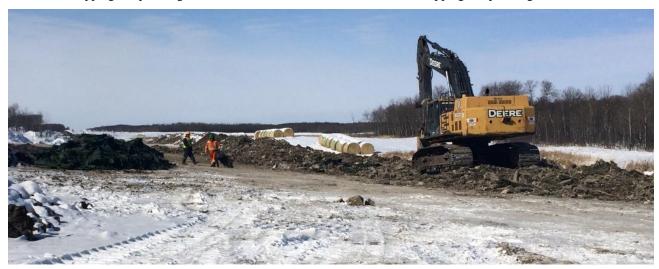
730 + 100 Ramp removal – removing geo teck SK 799

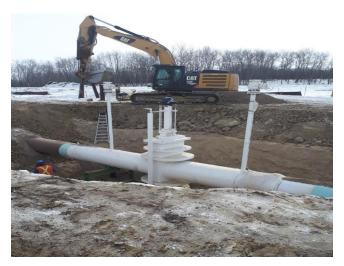
744 + 650 Crew sand shading block valve MLBV #19

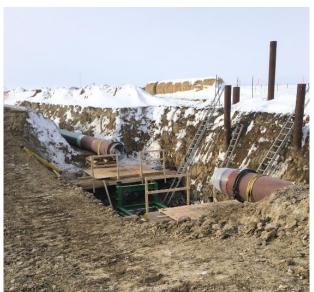
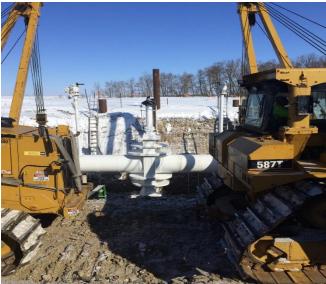
785 + 233 MLBV #22 site prepped for installation and sidebooms cradling valve at install
