**SGS MUSCOWPETUNG**

**ABORIGINAL CONSTRUCTION MONITORING**

**WEEKLY REPORT**

**MAR 11<sup>th</sup> TO MARCH 17<sup>th</sup>, 2019**

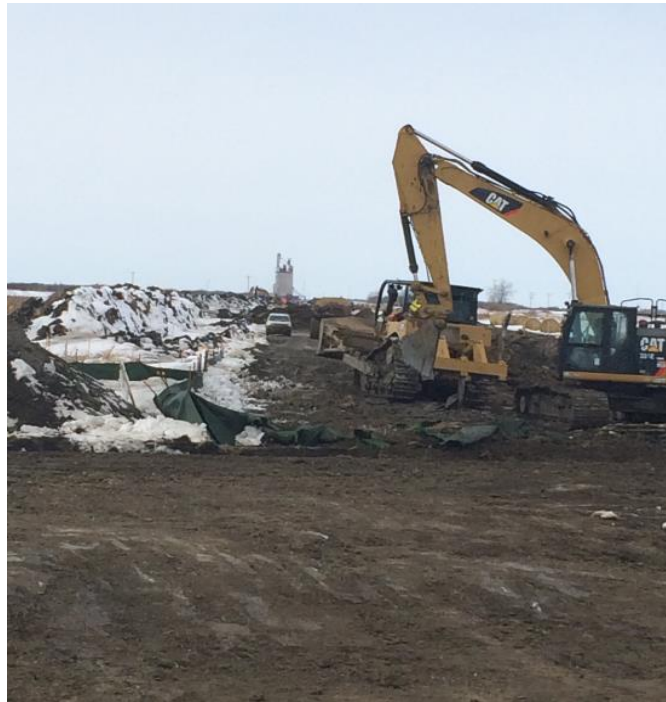
772 + 700 SK 908 Class IV Ramp removed

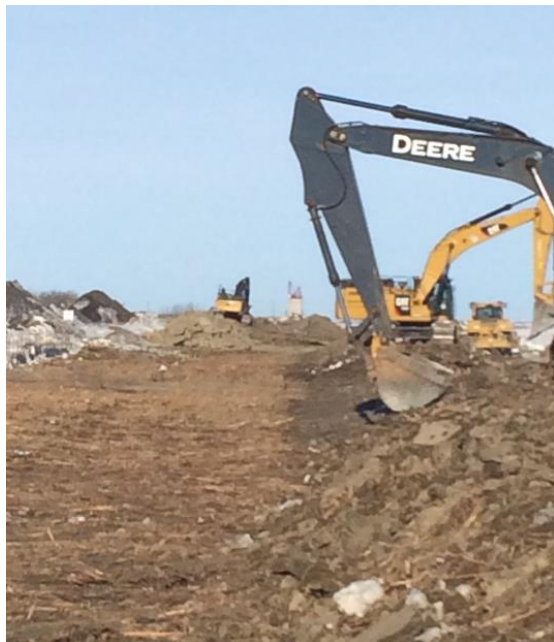
775 + 150 SK 911 Class IV Ramp removed

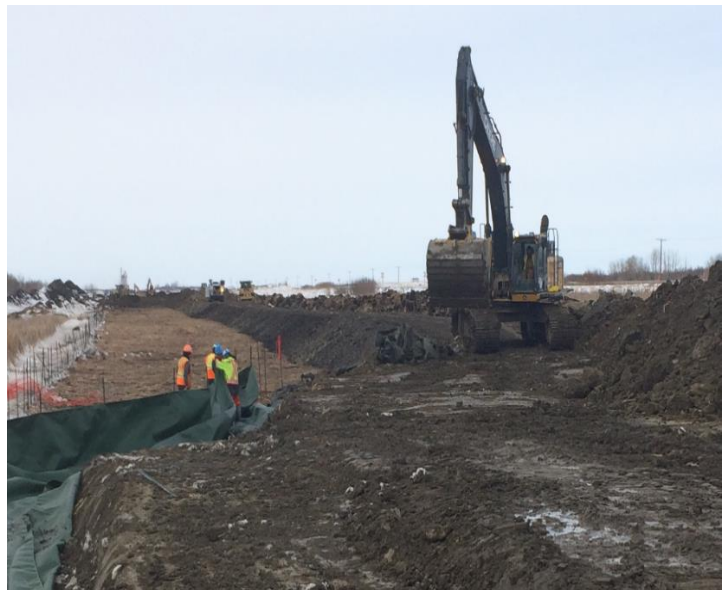
772 +200 SK 909 Class V Ramp removed

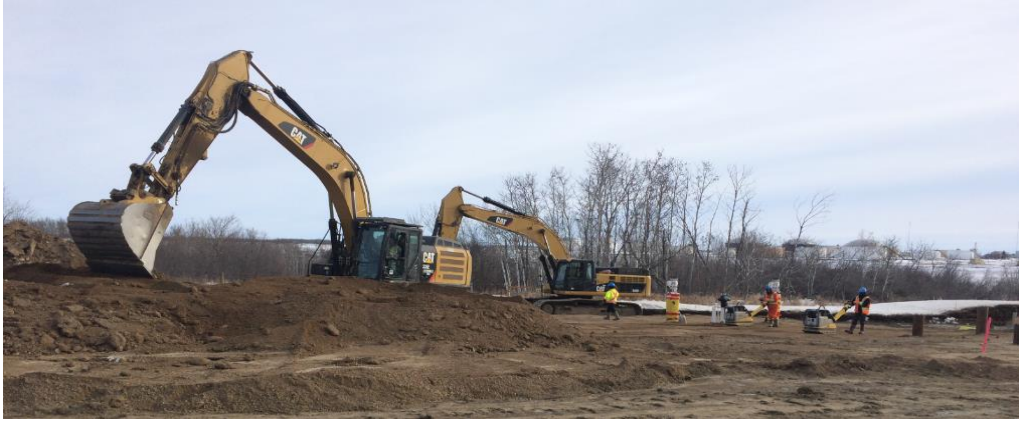
Additional observations included 805 + 300 - MLBV#23A Backfilling was completed this week, sub base was hauled in and packed at valve location. Once backfilling was completed a fence was installed around the valve site. Access ramps were removed at various locations. Heavy equipment and the test heads were loaded and moved off site. Machine clean-up was completed through Spread six (6).

805 + 300 MLBV #23A Backfilled and packing.

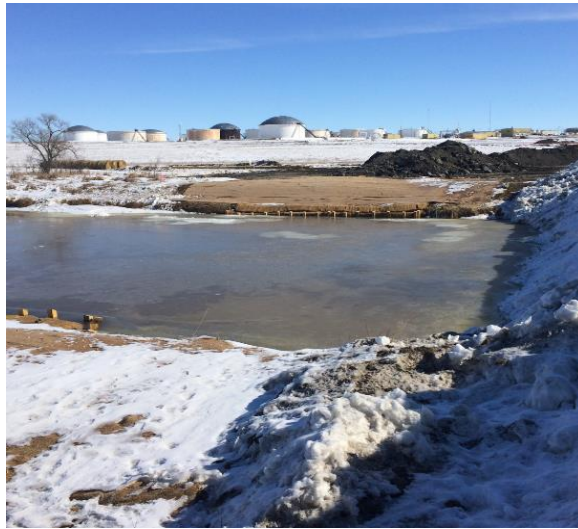
805 + 600 The Pipestone Creek MB 1010

805 + 200 – 806 + 200 HER 147, 148,149,150,151,152, Wing walls were down due to deer crossing over the matted area protecting the rocks of interest. The area of interest with the no foot traffic signage was still in place. MB 1010 The Pipestone Creek – Silt fencing across the bridge is partly taken down. On the Creek observed the amber light with signage and willows sticks with ribbon attached and one pylon. Our team followed up the following day and the items on the creek were removed. Further observed the ice bridge cut for water flow through and an additional berm built on south side. Observed Heritage Resource 189 at 802 + 500 & Heritage Resource 147, 148 and 149 at 801 + 500 - 802 + 500 (no concerns) 787 + 500 SK WC 89 Observed the crew cleaning up the area on west side of the creek. 786 + 500 Heritage Resource 140 right of way clean up completed. Observed 788 + 700 Heritage Resource area of interest roped off with the nine Heritage markers. (no concerns). 776 + 900 – 779 + 500 Jackson Creek – observed the area (no concerns) – 778 + 900 labour monitoring the brush pile burning. 746 + 950 Observed the area for any debris left behind. Little pieces of geotextile and piles of brush were cleaned up the next day Heritage # 46 TLU area no further concerns. 747 + 920 Observed and assessed the area (no concern's) Heritage # 137 TLU SK WC 86.
