SGS MUSCOWPETUNG

ABORIGINAL CONSTRUCTION MONITORING

WEEKLY REPORT

MARCH 4th TO MARCH 10th, 2019

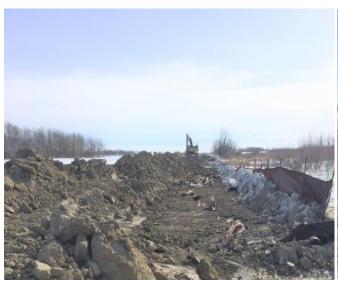
738 + 300 removing ramp at SK 834 Class III

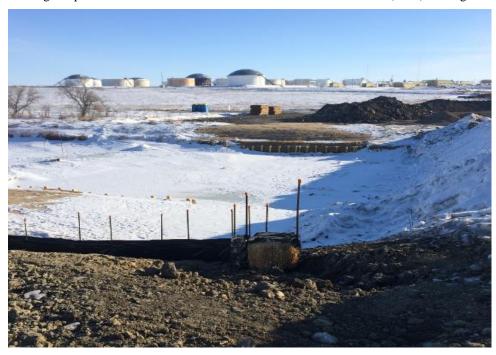
805 + 700 Looking East at The Pipestone Creek

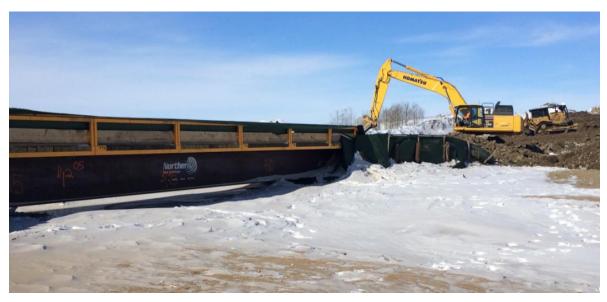
751 + 750 SK WC 87 (NFB) The Little Pipestone removal of the bridge & restoration

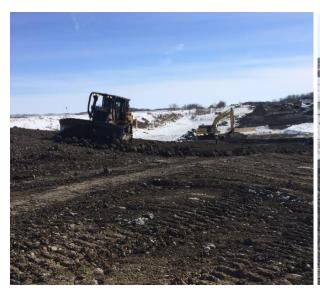
805 + 304 MLBV # 23A Tie in

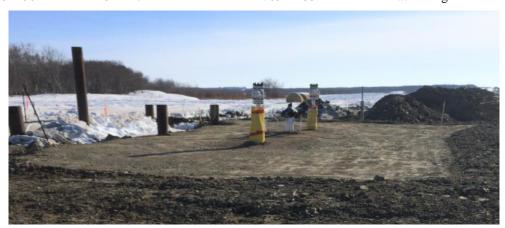
774 + 230 MLBV # 21 Backfill completed

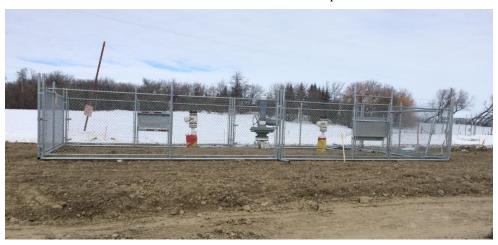
744 +666 MLBV # 20 Fencing installed
