SGS MUSCOWPETUNG

ABORIGINAL CONSTRUCTION MONITORING

WEEKLY REPORT

OCTOBER 22ND TO OCTOBER 28TH, 2018

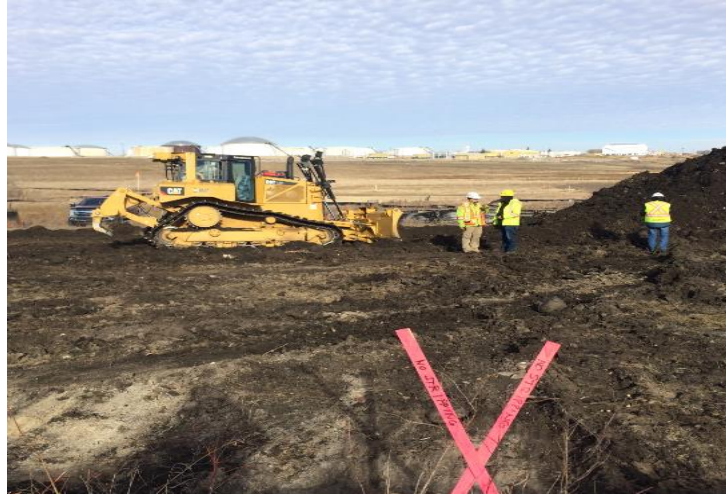
Pipestone Creek ICM's and Archaeologist walk the area excavated

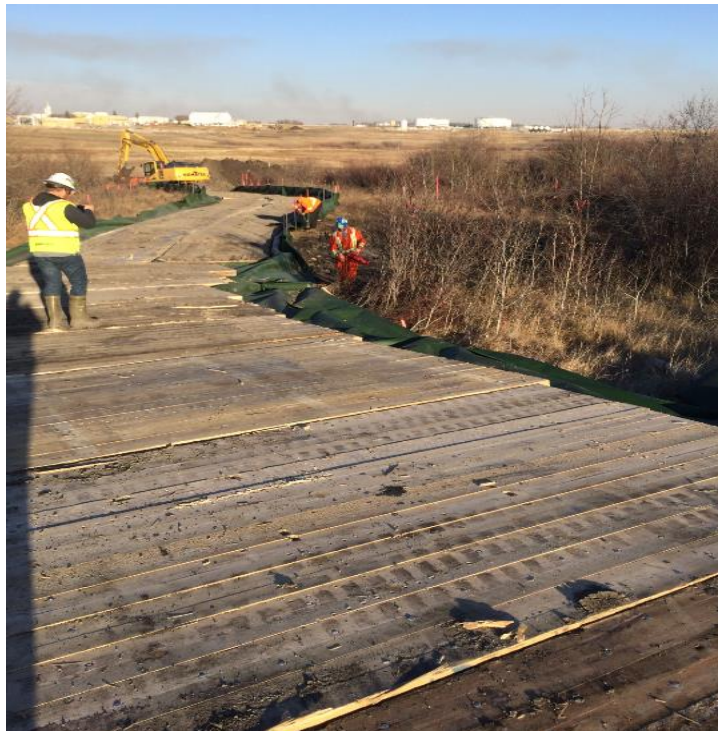
Bridge constructed over the rocks of interest at the Pipestone Creek

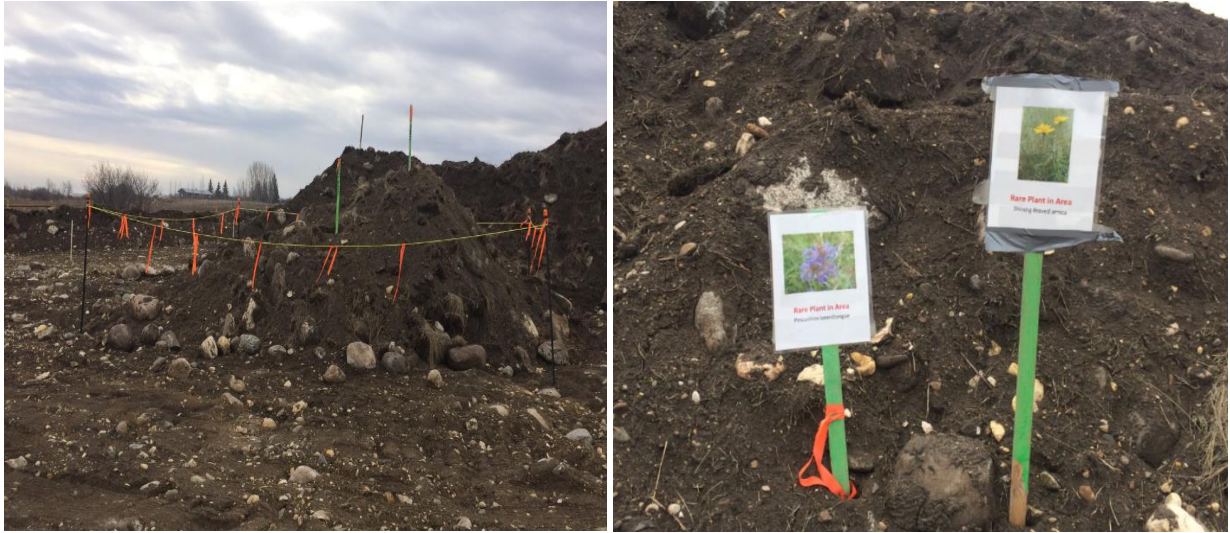
Soil piled with rare plant seeds Pipestone Creek West side

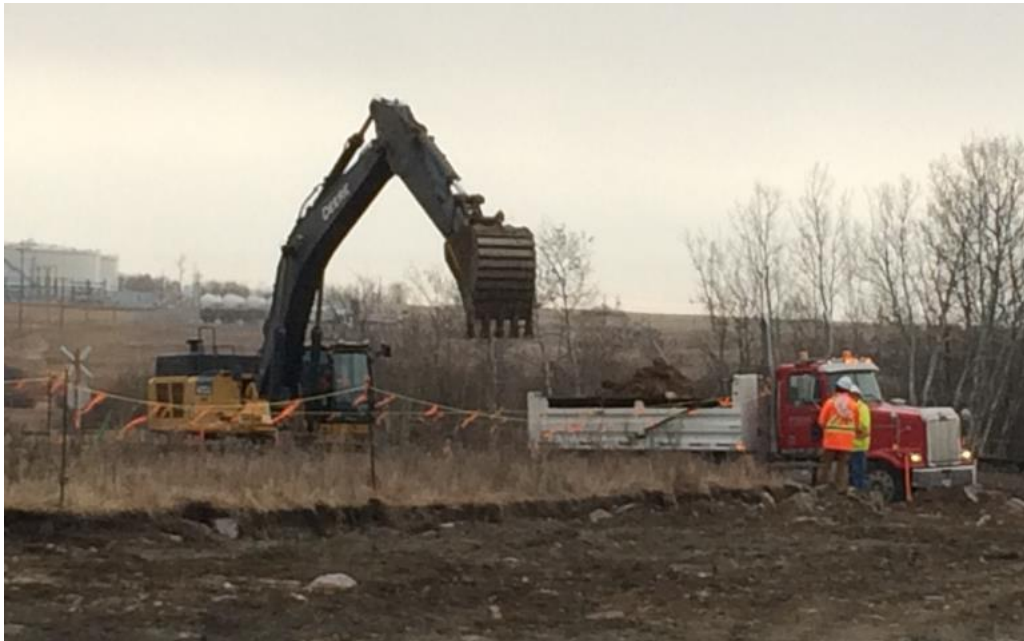
Track hoe digging bore pit west side of Pipestone creek

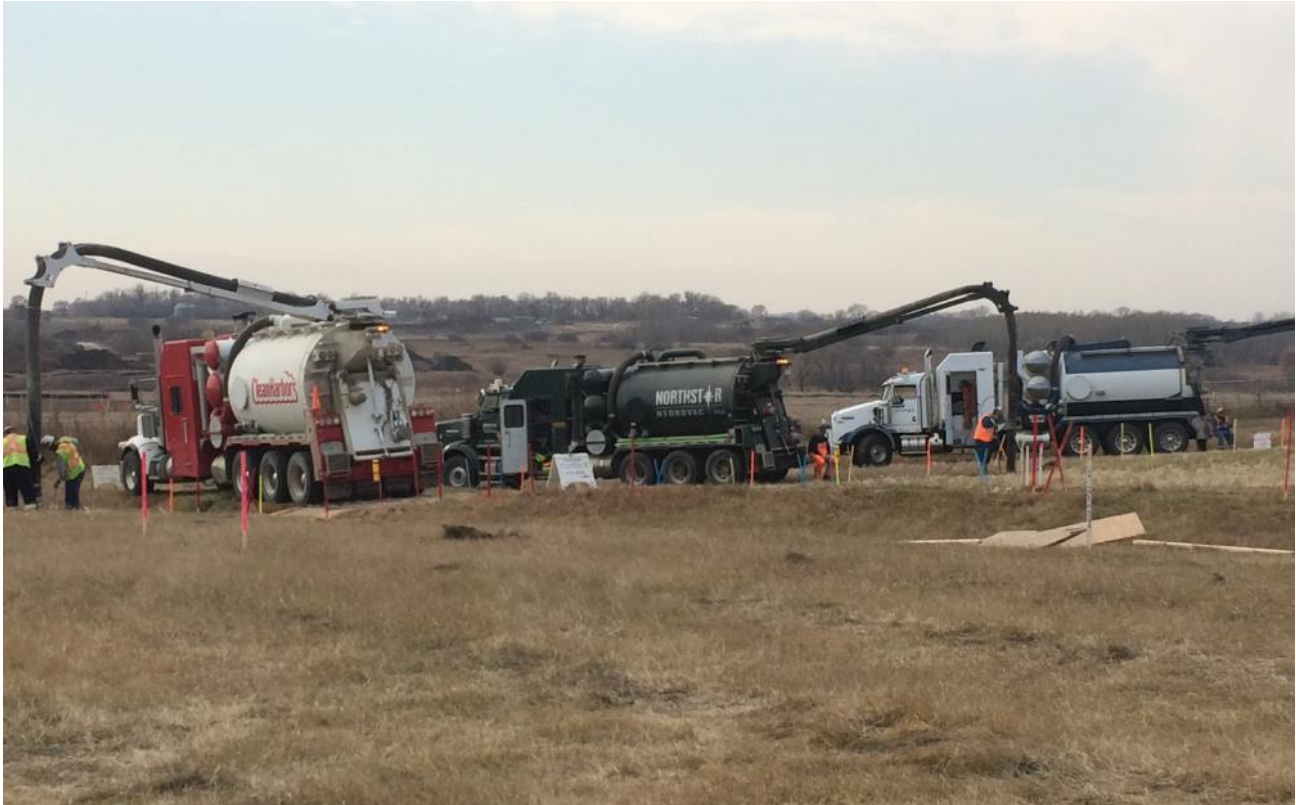
Hydro vacs exposing lines at the Pipestone Creek East side within the Cromer Station

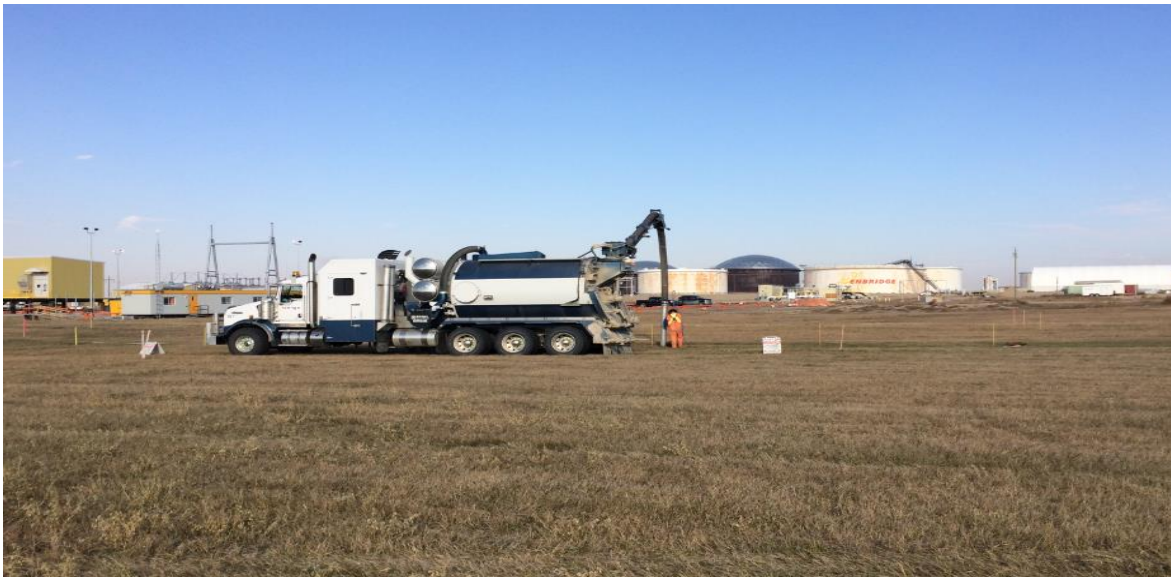
Hydrovac at Outside of Cromer station exposing lines.

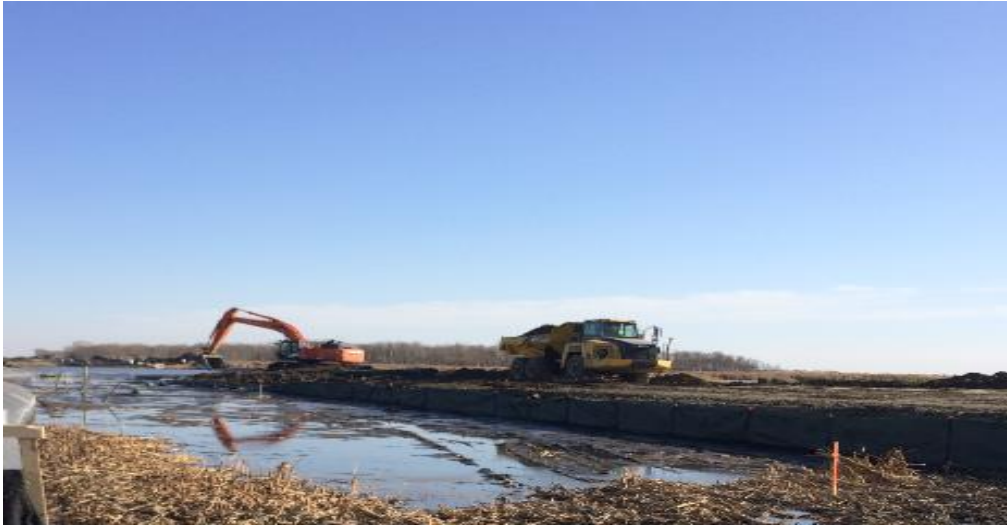
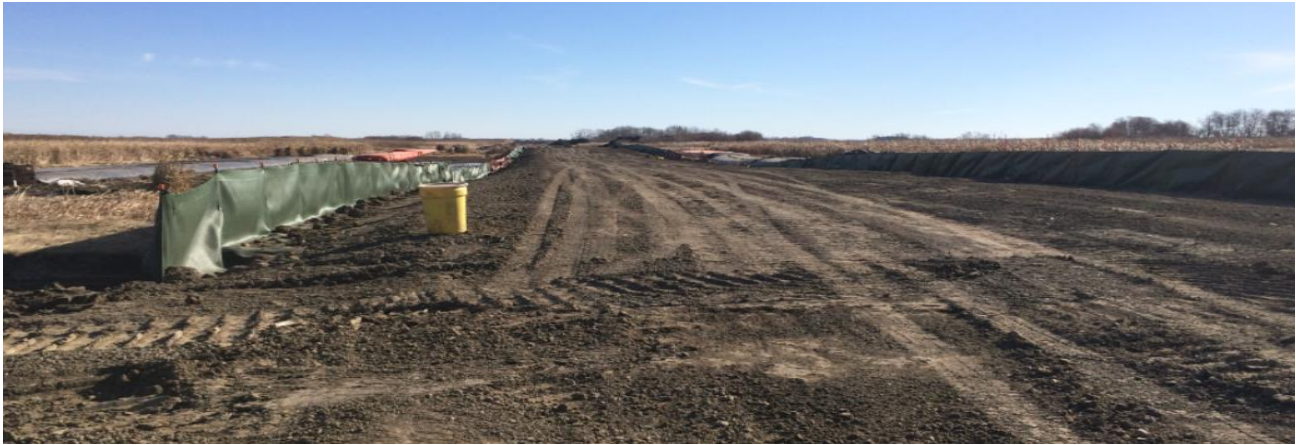
729 + 467 Ramp built across Wetland SK 799

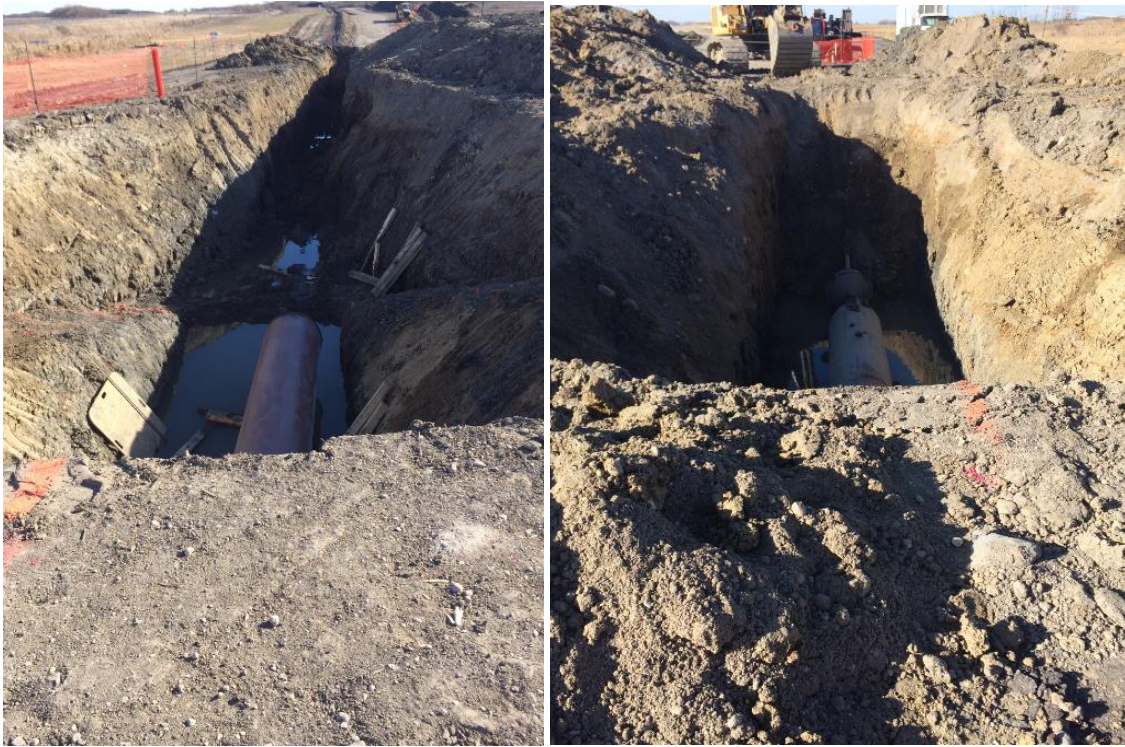
749 + 602 Bore pit excavation

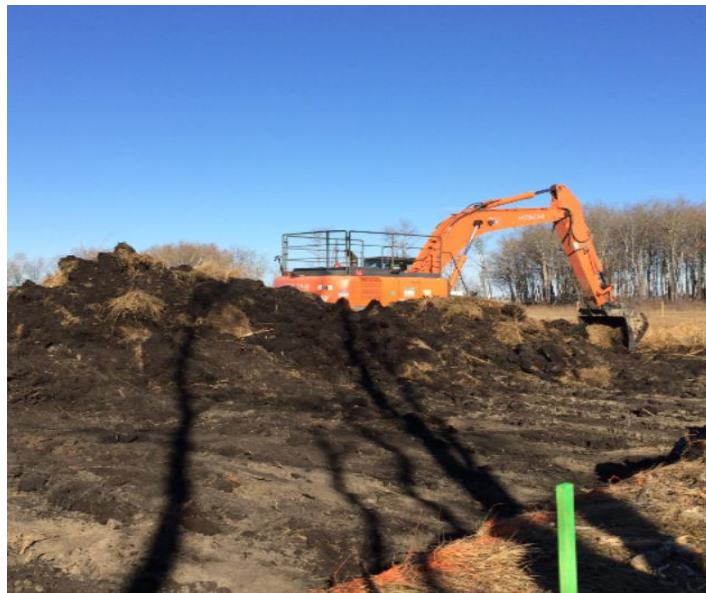
740 + 150 Track hoe pilin clay for ramp across wetland SK 847

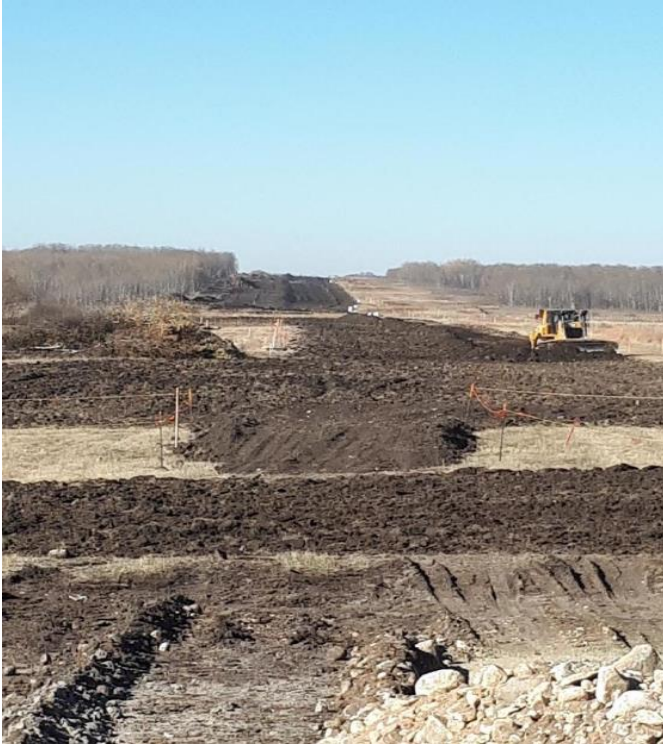
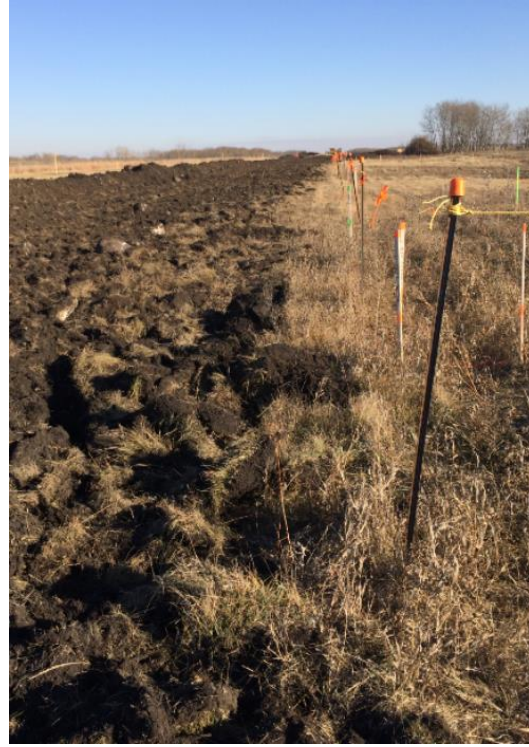
Stony Creek area disced around the rocks of interest buffer

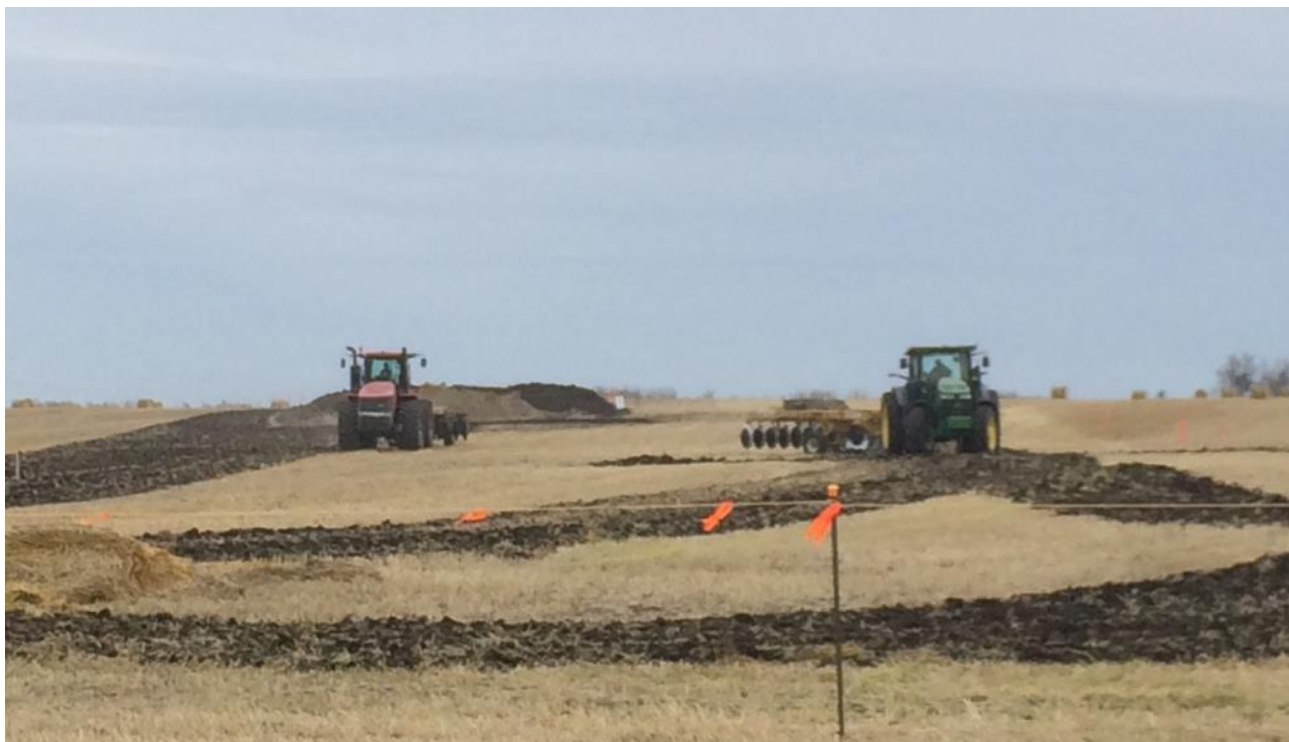
Discing 800 + 902
