**SGS MUSCOWPETUNG**

**ABORIGINAL CONSTRUCTION MONITORING**

**WEEKLY REPORT**

**OCTOBER 8<sup>TH</sup> TO OCTOBER 14<sup>TH</sup>, 2018**

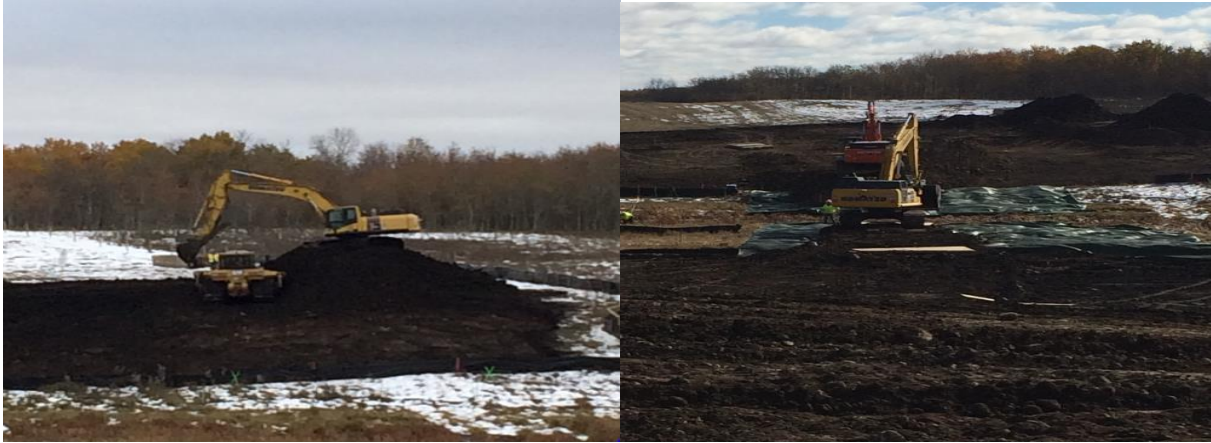
The Little Pipestone Creek SK WC 87 - 751 + 781 (FB) Crews prepped for the bridge installation, Geo textile was placed on both the East and West sides of the creek, skids and matting were put in place and geo teck was put on top of the matting. Select clay from the excavated area was placed on top. The seventy-foot engineered bridge was installed at the end of the week and crews finished with geo textile wingwalls and access ramps on both sides were completed. Within this area the right of way is completely stripped and graded with soils separated in piles along the south side (topsoil seconds and clay are clearly identified). The DIMI-3 Bison Rubbing Rock (HER-139) and DIMI-4 Broken rock fragments are located on either side of the creek. The DIMI - 3 is located to the South of the bridge. A fence was put up around and along the right of way and a marker identifying the Rock. the fences for the leopard frogs are still in place. A fine wash station was set up at the access road west side. Throughout the week this wash station was busy cleaning heavy equipment compliance with the bio security system.

Little Pipestone Creek Prepping for the Bridge Installation

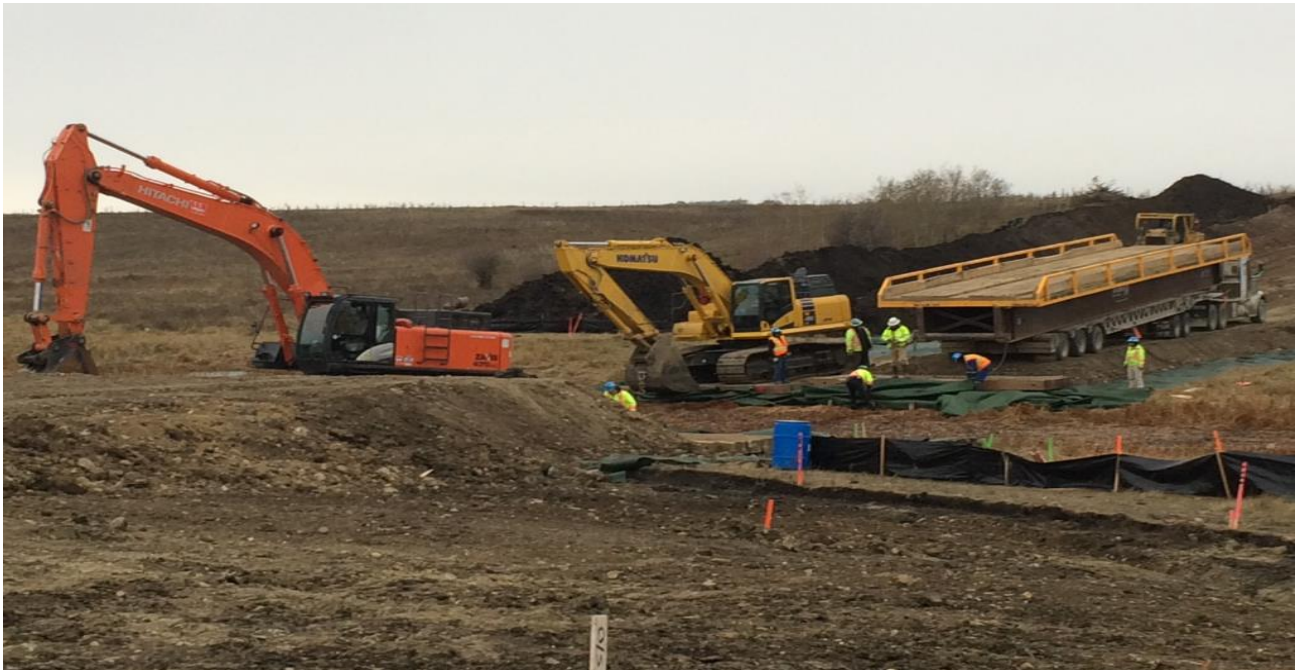
Little Pipestone Creek setting Bridge in place

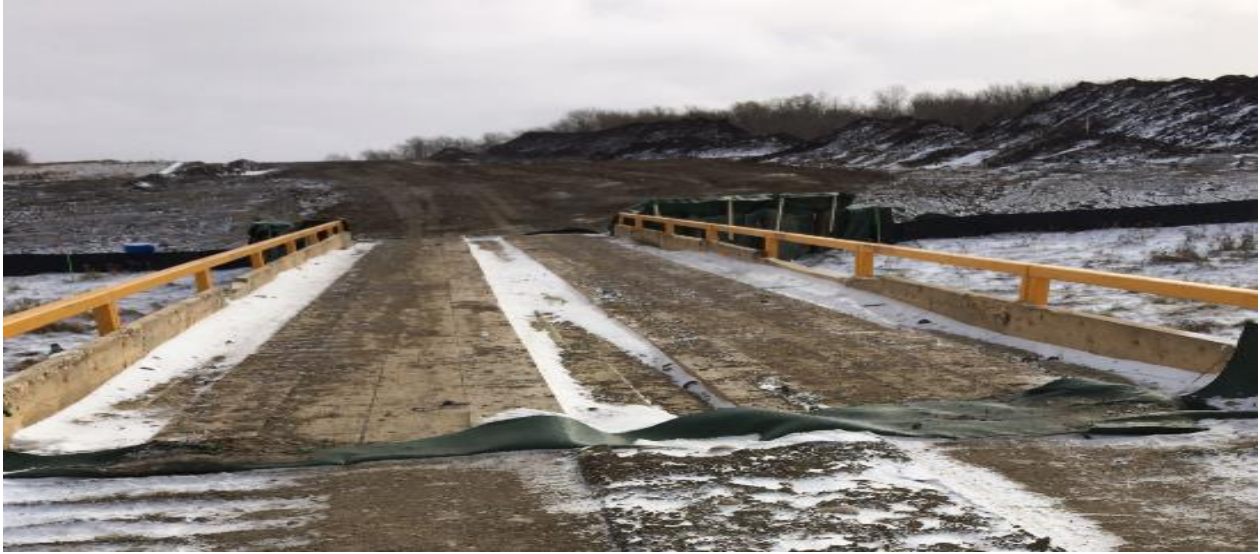
Little Pipestone Creek Bridge Installed

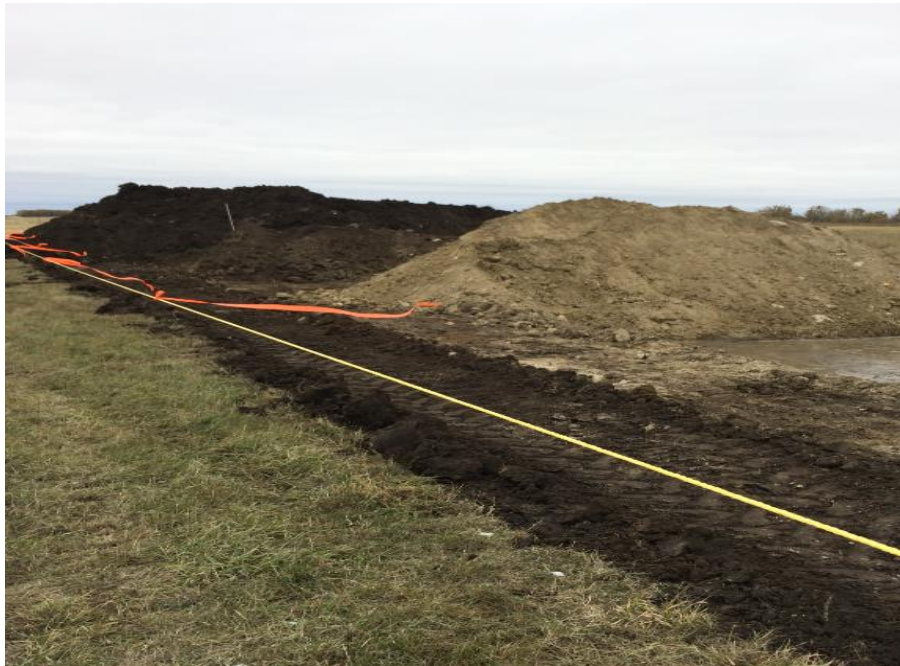
pits were excavated ahead of the hydro vacs, the slurry pits were excavated separating the soils properly, roped off and signage was installed at each location.

Stony Creek one of three slurry pits excavated

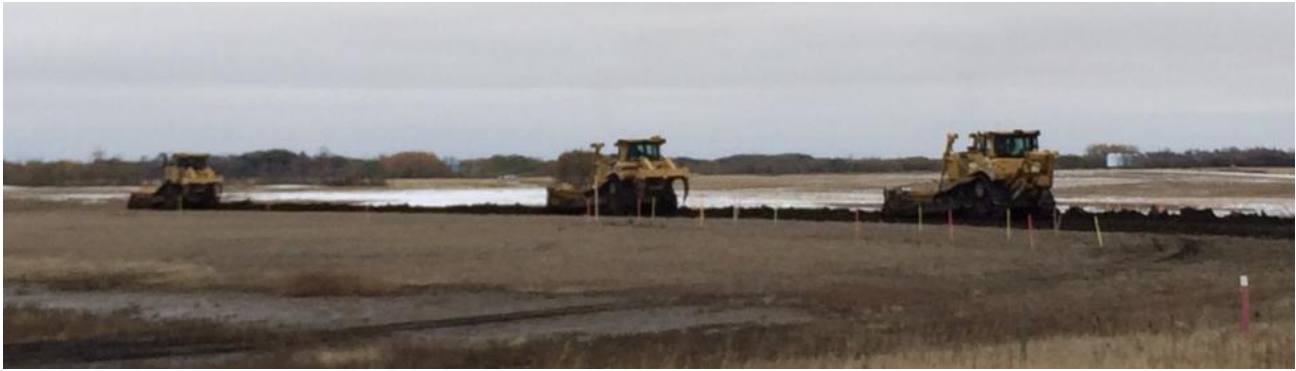
Dozers stripping topsoil

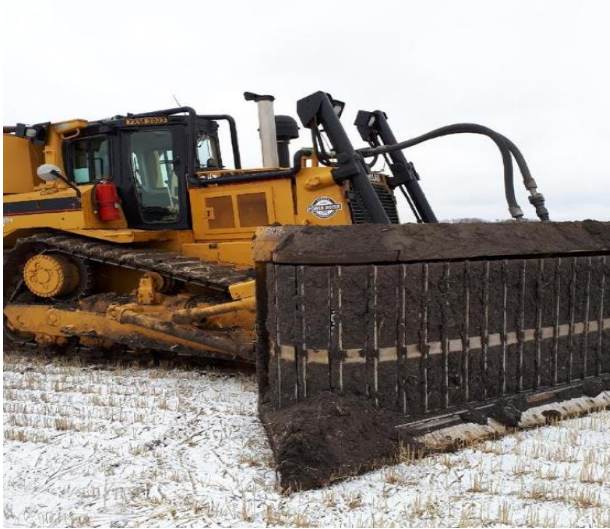
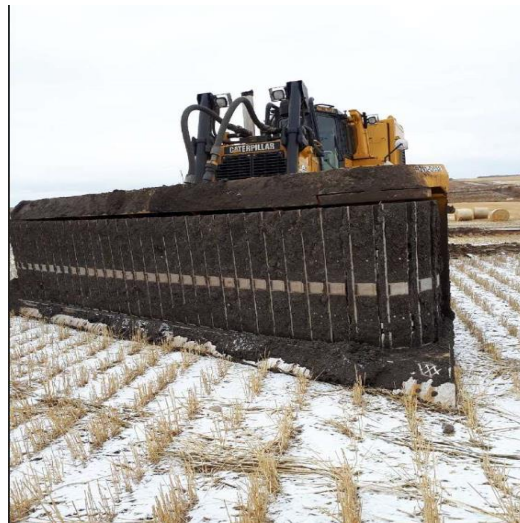
Super Dozer

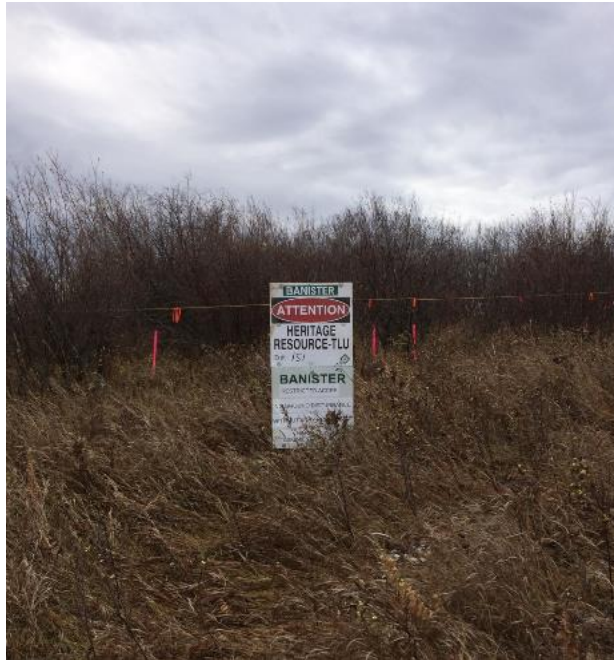
During the week our team travelled to the Pipestone creek 805 + 300 the area was re surveyed and staked to give our team proper alignment for roping of the area of interest. Our team also attended a ceremony. The rare plants are still properly roped off and the frog fences are still in place. Restricted access signs were installed (Heritage Resource Site).

Heritage Resource sign at the Pipestone Creek

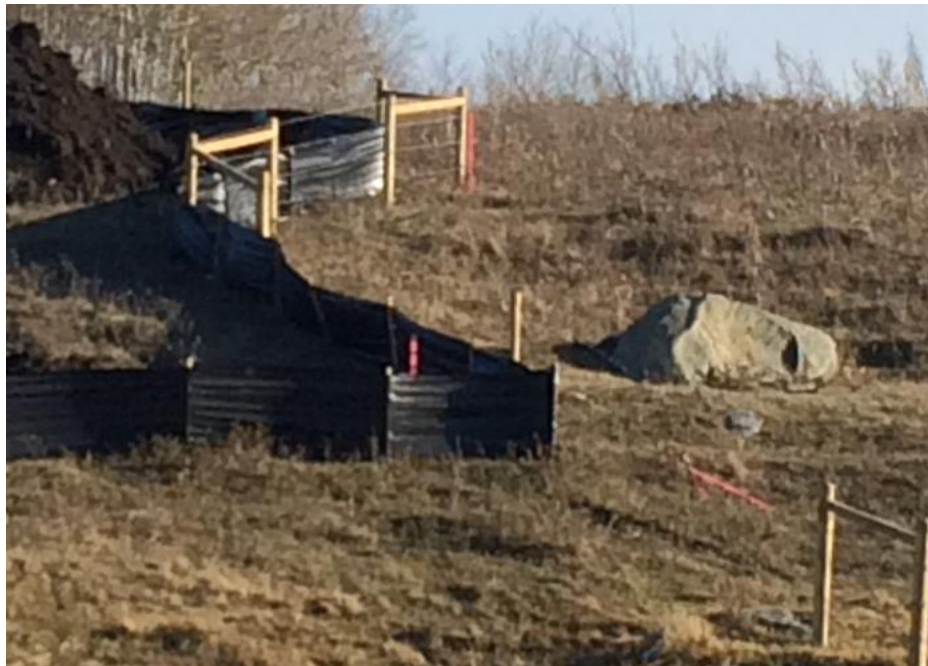
LITTLE PIPESTONE CREEK DIMI-3 BISON RUBBING ROCK (HER-139)

Field Observation	# of occurrences	Description and Mitigation Measures	Mitigation Status	Further Action Required (Yes/No)
Traditional Use Area (hunting, fishing, gathering, trapping)	0			
Rock Formations (rocks of significance, tipi rings, etc.)	1	DIMI-3 Bison Rubbing Rock (HER-139)	Fenced off and marked	No
Artifacts	0			
Bones	0			
Potential Gravesites	0
