SGS MUSCOWPETUNG

ABORIGINAL CONSTRUCTION MONITORING

WEEKLY REPORT

DECEMBER 10TH TO DECEMBER 16TH, 2018

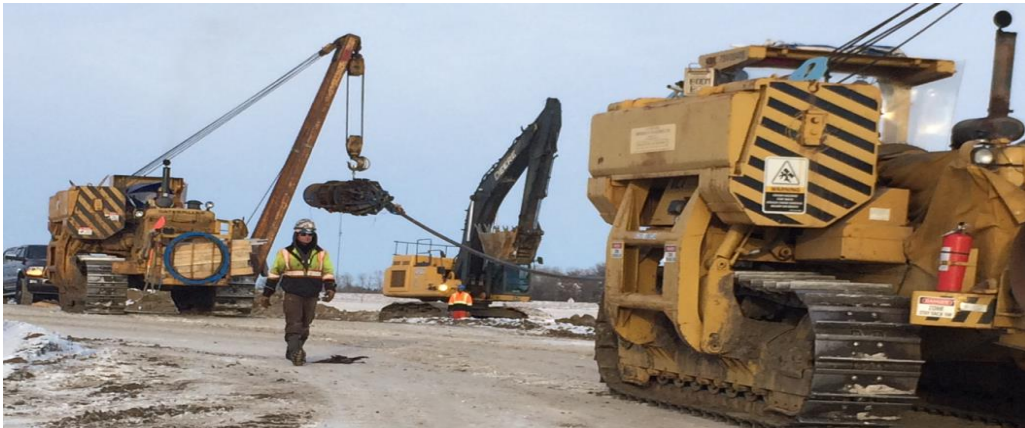
785 + 051 welding crew crossing access

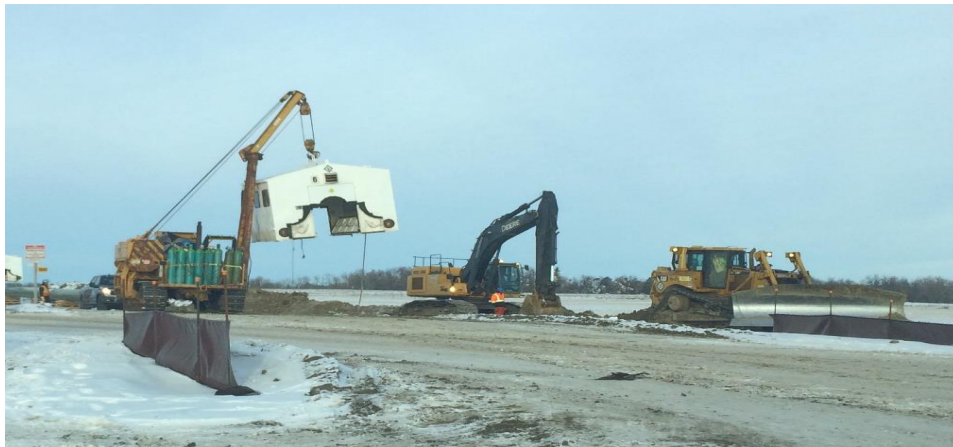
785 + 200 Area of interest roped off pipe strung along right of way

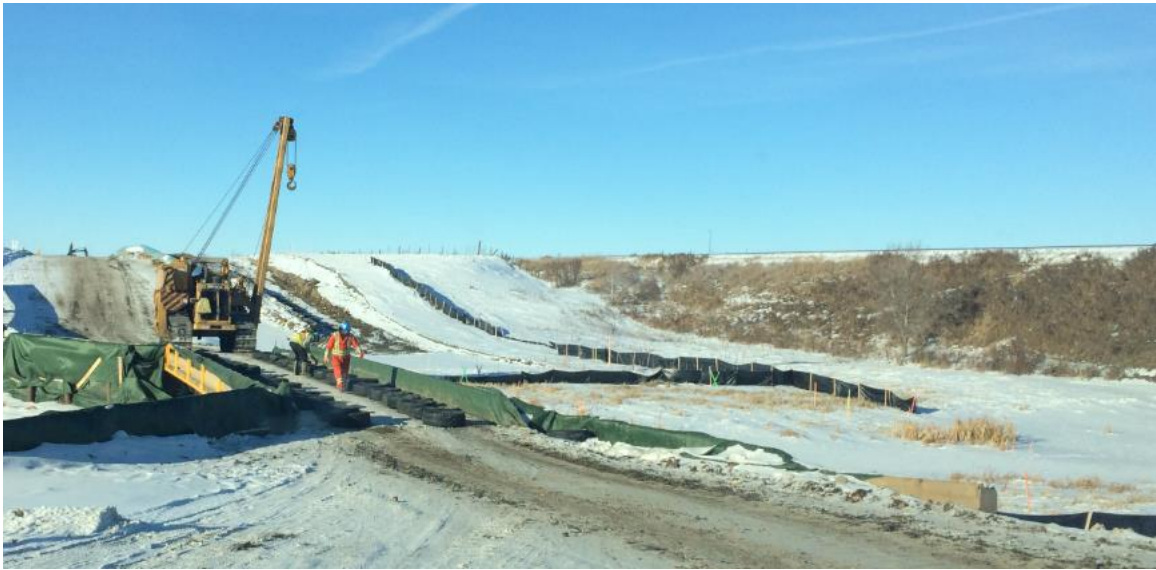
749 + 600 Little pipestone SK WC 87 Creek HER 138 and 139 – Side boom crossing bridge with spotter – pipe strung along right of way and HER sign

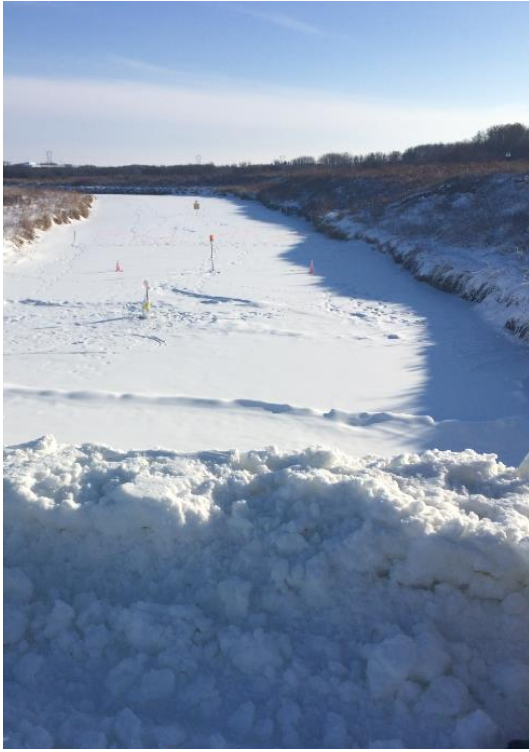
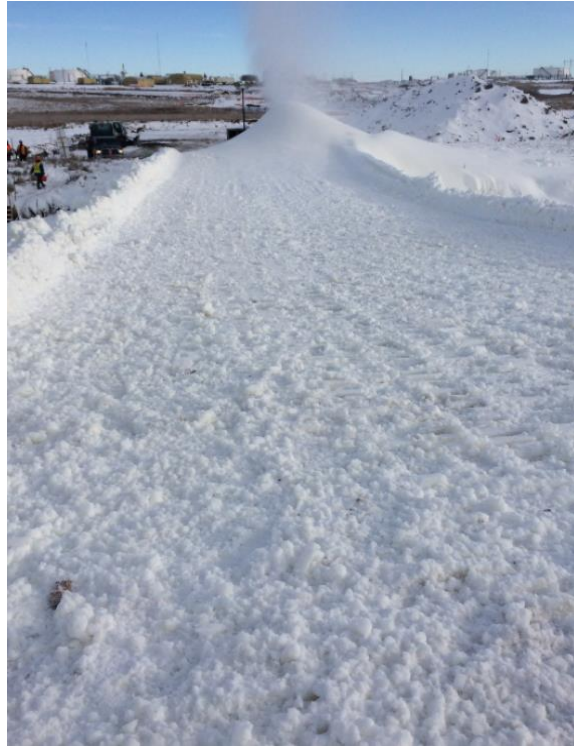
MB 1010 Pipestone Creek Ice bridge

Our team followed up monitoring 803 + 494 – Heritage resource TLU area 805.63 – 805 .93 East side of Pipestone Creek the ice bridge is completed across MB1010, Complete with geo wing walls installed on both sides of the bridge. Geo teck and access mats will be placed at the equipment laydown area, this area will not be stripped. At 805 + 550 Excavation for the tie in ditch was completed, track hoe loaded rock trucks with ditch material and equipment completed ripping ditch line from the bore bay and worked west. First joints were lowered in and welded followed by the third joint the hot bended pipe was set in and welded. The pipe was ultrasonic tested and towards the end of the week 1 m of sand padding was placed on top of the pipe before backfilling. Archaeologists and ICM's were on site throughout the week.

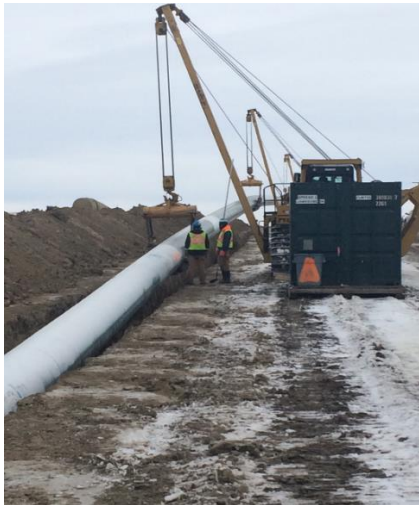
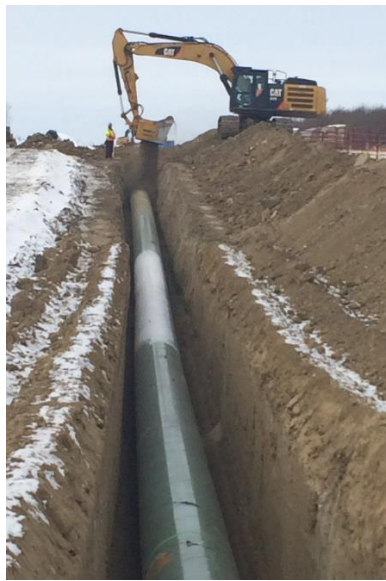
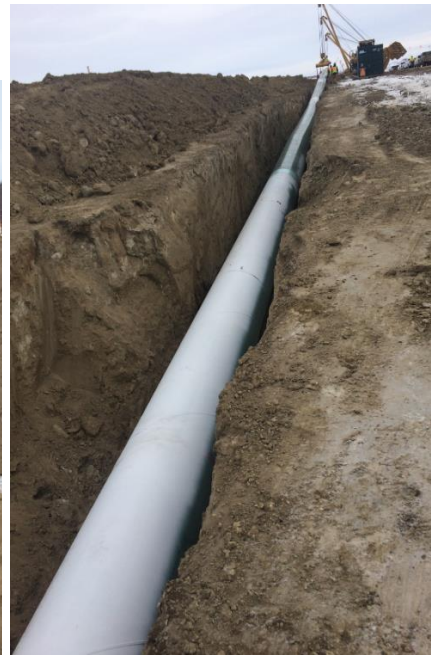
747+300 sidebooms cradle pipe and lowering in ditch with spotters
- middle picture below trackhoe shading pipe with spotter
