SGS MUSCOWPETUNG

ABORIGINAL CONSTRUCTION MONITORING

WEEKLY REPORT

NOVEMBER 19TH TO NOVEMBER 25TH, 2018

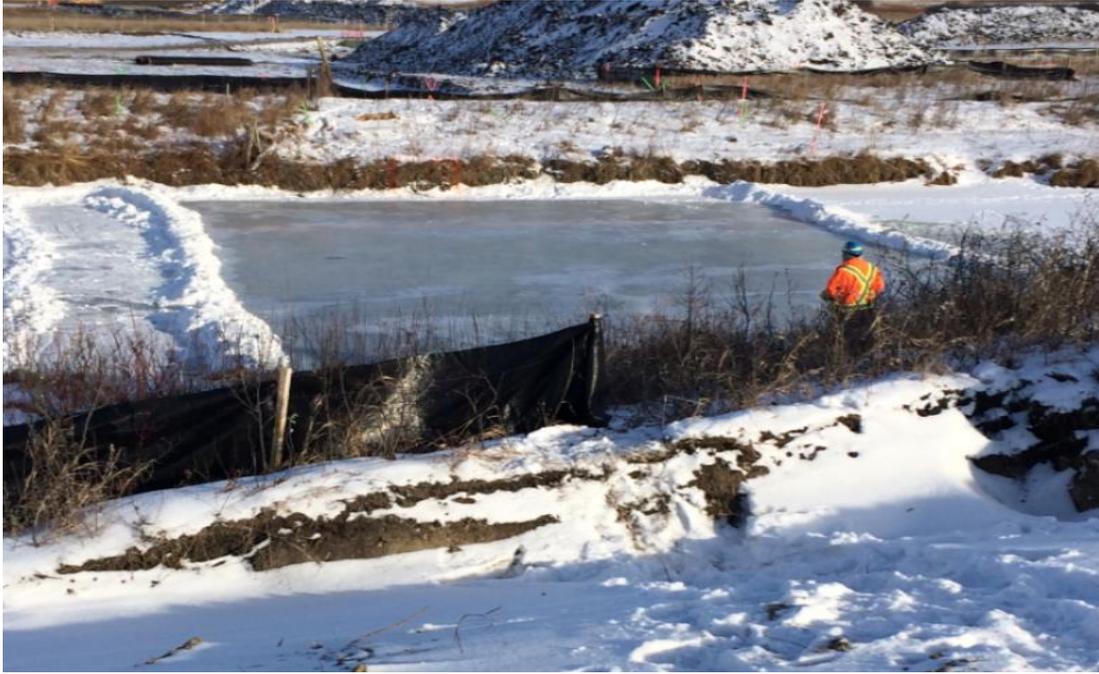
Ice Bridge across Pipestone Creek

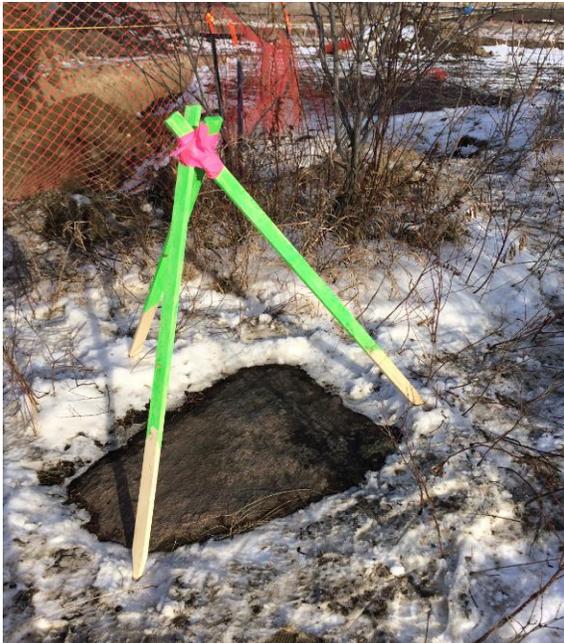
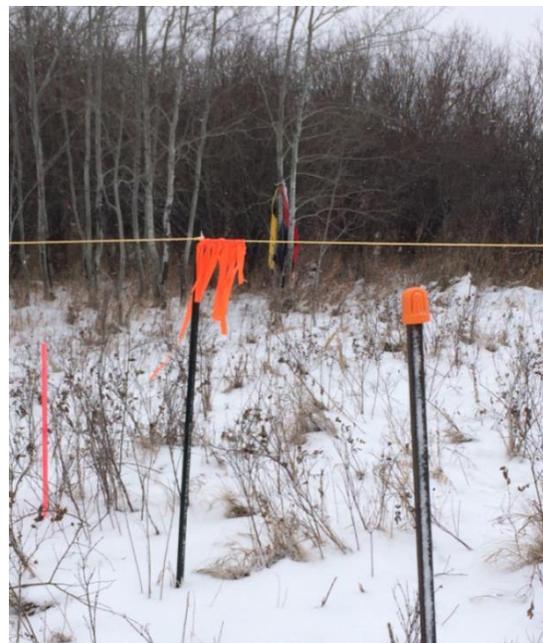
Rock of interest and ceremonial cloth in trees at the Pipestone Creek

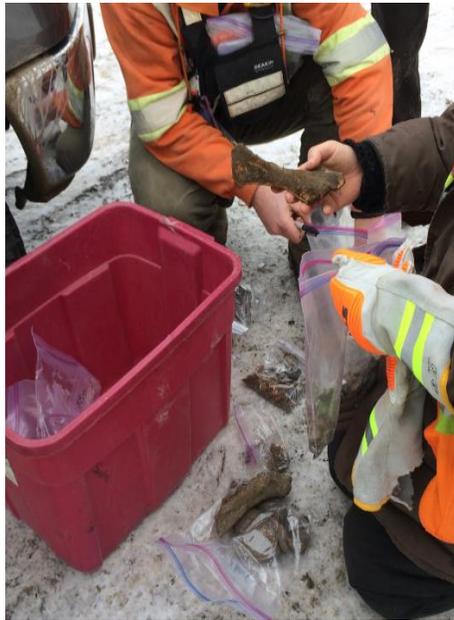
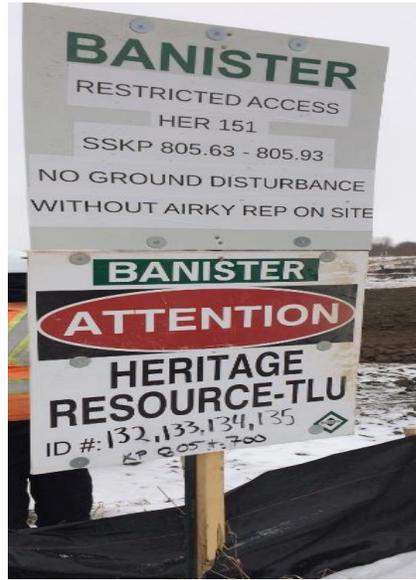
The Pipestone Creek continued to be an area of interest for our team, Archaeologists and ICM's. At 805 + 304 the pile driver was set up and completed four piles 16 ½ m deep with 1m above ground for the valves. Pipe was welded sand blasted and coated at the laydown area. Welders corked equipment at the laydown area as well. Tackifying (soil stabilization) was completed throughout the pipestone creek area. 805 + 612 West side of Pipestone Creek – Bore equipment broke down again due to lines freezing up, Crew defrosted the lines and continued with the pilot test. they were having difficulty pushing past a rock in the bore path, Crew pulled the drill for the pilot out of the hole moved it over 16" and continued to drill the bore under the railway tracks and area of interest. Pilot pushed through and bore continued completing the 90m bore. The slurry was pumped out and gravel was placed at the bottom of the pit. Spider was installed to lead the casing through the bore. Welders prepped the casing with auger to bore while the side boom held the pipe in place. By the end of the week the casing was 21m through. The east side of the tracks Heritage Resource TRU 151 SSKP 805.63 – 805.93 area was surveyed and re staked. Excavator filled in a portion of the tail ditch. At 805 + 800 On the Pipestone creek crew continued to build the ice bridge across MB1010. Stairs were made down to the creek and a light plant was set up at the top of the creek bed with spill pans placed underneath both the light plant and pump. The water was pumped from the creek onto the ice surface for the bridge. Screens are set up on the pump for water flow through only. At 805 + 700 East side of the pipestone creek dozer was stripping topsoil at HER 151 SSKP 805.63 – 805.93 Archaeologists ICM's and ACM's were on site. The area was walked, various bison bones were found, tagged and bagged by the Archaeologist.

Archaeologist and ICM's walking the area and picture of the bones that were found at the Pipestone Creek

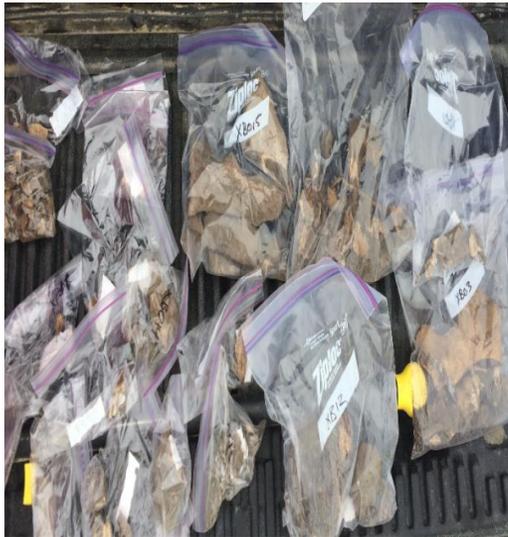
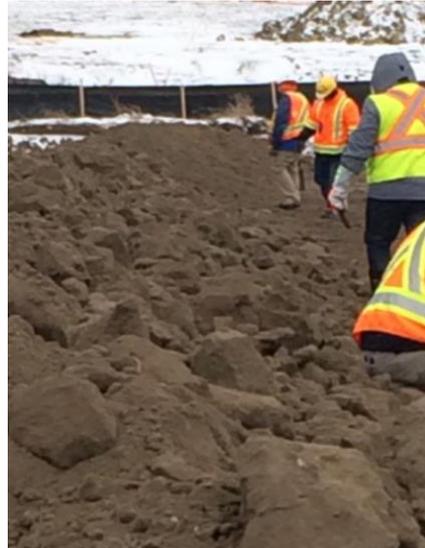
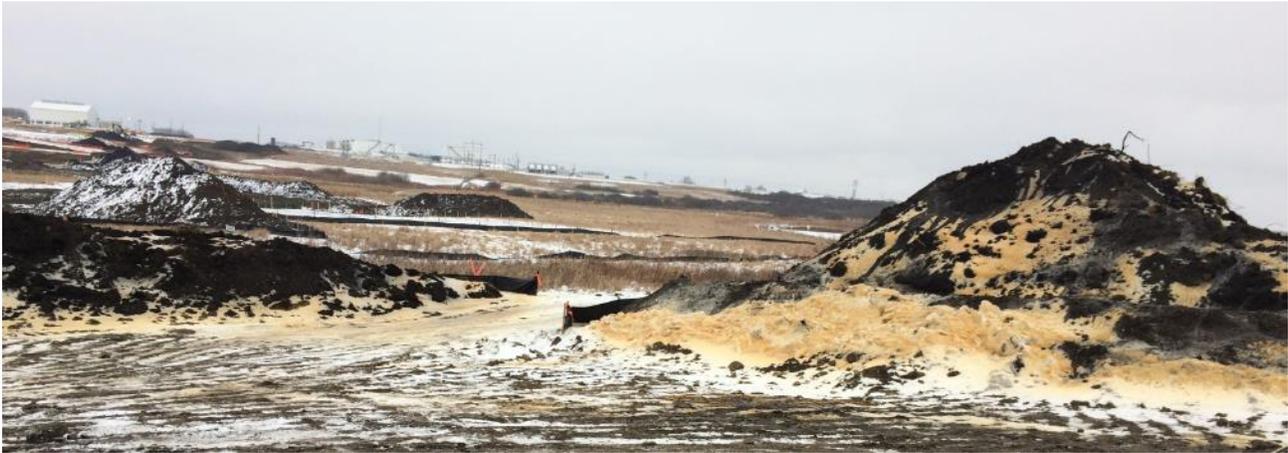
Additional observations this week included soil stabilization completed on spread six by the end of the week., Observed the straw waddled placed between the soil piles and at access ditches to eliminate erosion. With all the stripping completed the soils are separated and piled into windrows all along the right of ways. The ditch lines have clay covering to help prevent complete freeze up of the ground. These rows will be excavated for the pipe. Pipe was loaded from pipe yards and strung along the right of ways and placed on skids. Pipe was welded coated and in certain spots bending was completed to maintain contour of the land. Access bores were excavated with the pipe installed at road crossings. Excavators dug the trenches and the side booms lowered the pipe into the ditches/trenches.

Soil Stabilization at the Pipestone Creek and Stony Creek

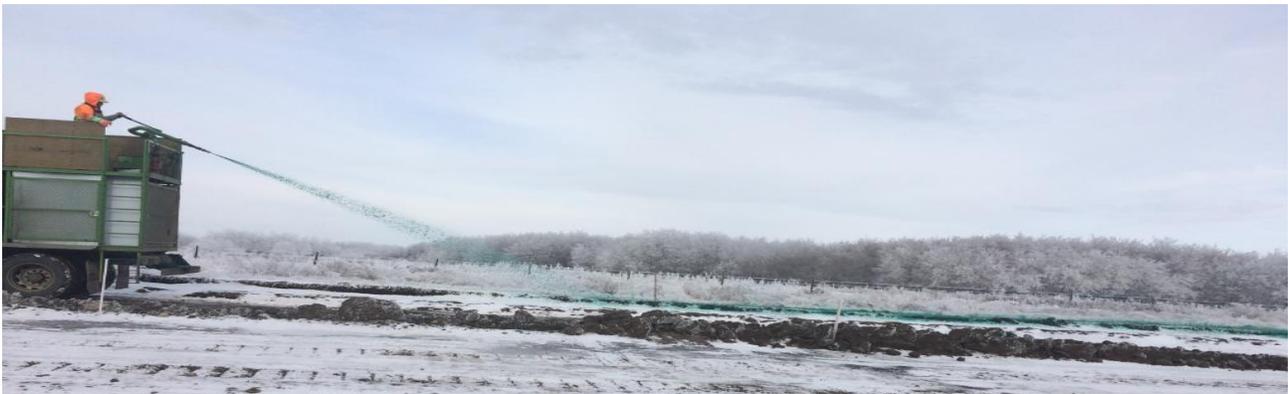
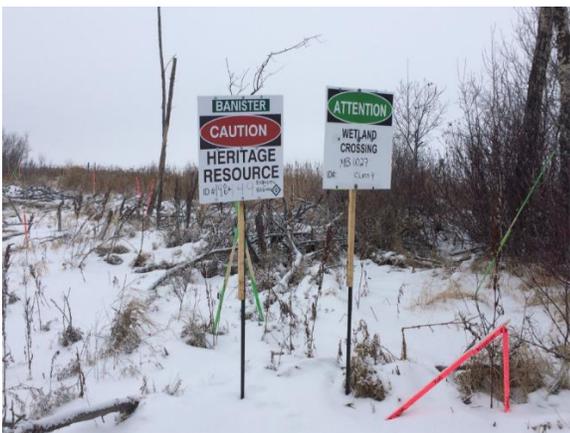
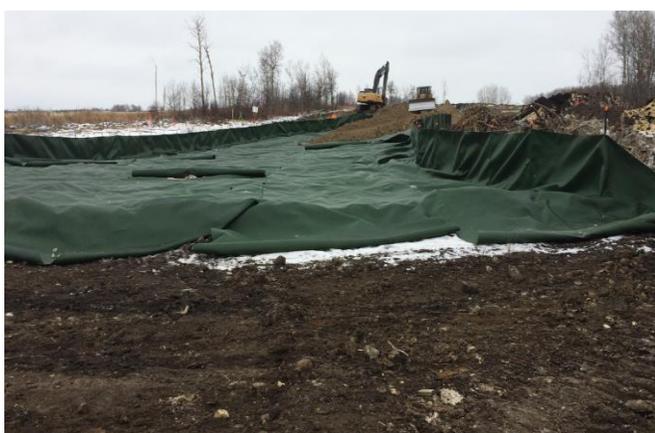
Monitored 802 + 050 – 802 + 500 Her 148 DKmh -42 and 149 adjacent to MB 1027 Wetland Class IV Brush was cleared to the South side and geo textile was stretch out throughout the wetland area. Clay fill was placed on top the ramp and wing walls were completed.

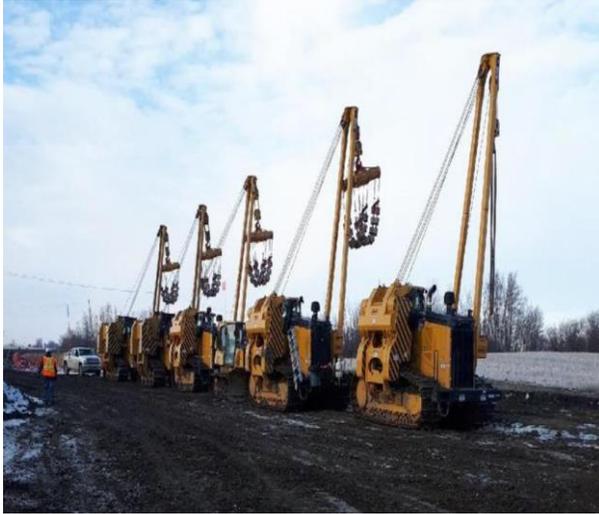
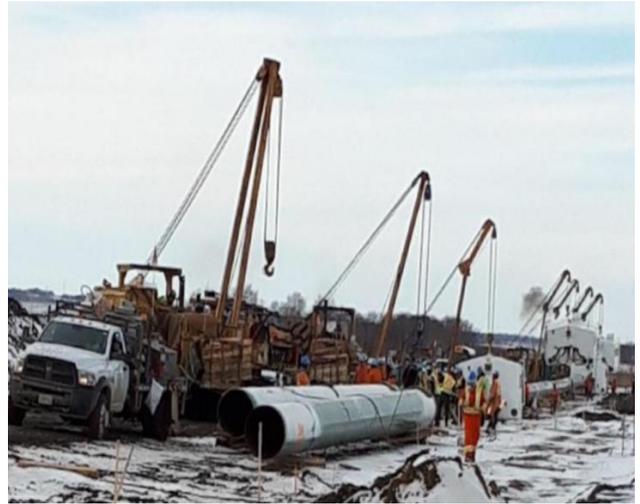
Pipe strung along right of way, side booms holding pipe and pipe placed in the ditches/trenches
