**SAMSON CREE NATION – MATRIX SOLUTIONS INC.
PARTNERSHIP**

ABORIGINAL CONSTRUCTION MONITORING

WEEKLY REPORT

OCTOBER 16TH TO OCTOBER 22ND

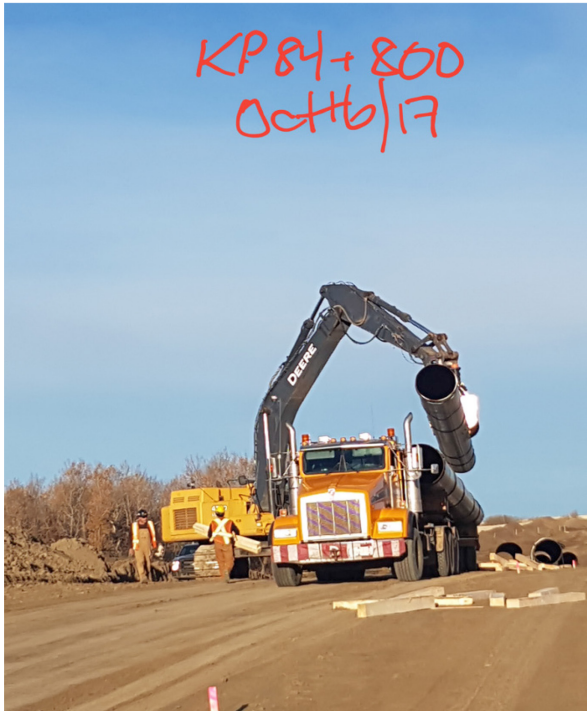
1. Stringing Crew –Location 84km+800 – Oct 16,2017

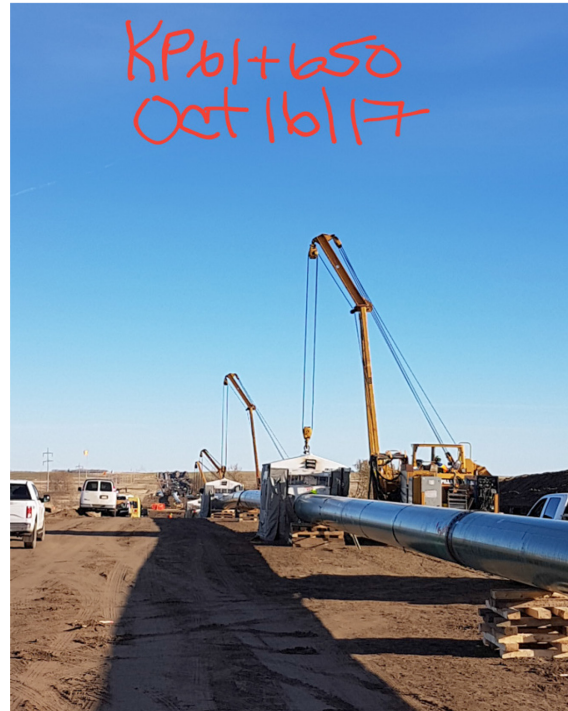
2. Welding Crew – Location 61+650 – Oct 16, 2017

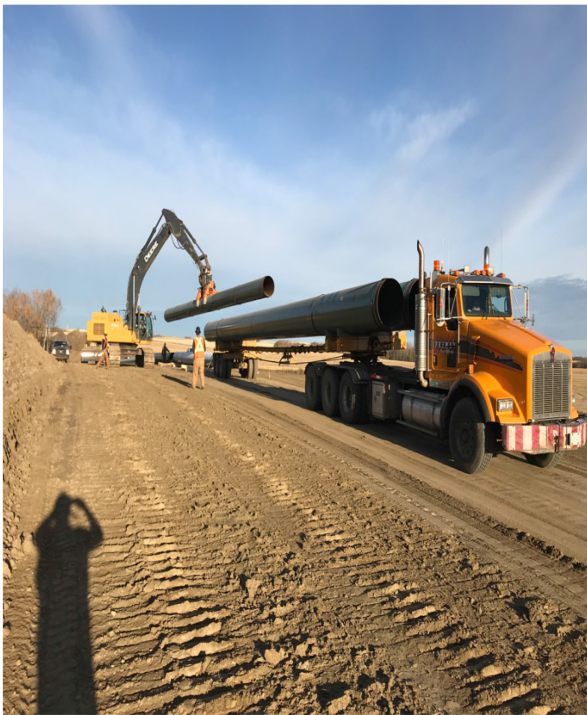
3. Stringing Crew – Location 84km+800 – Oct 16, 2017

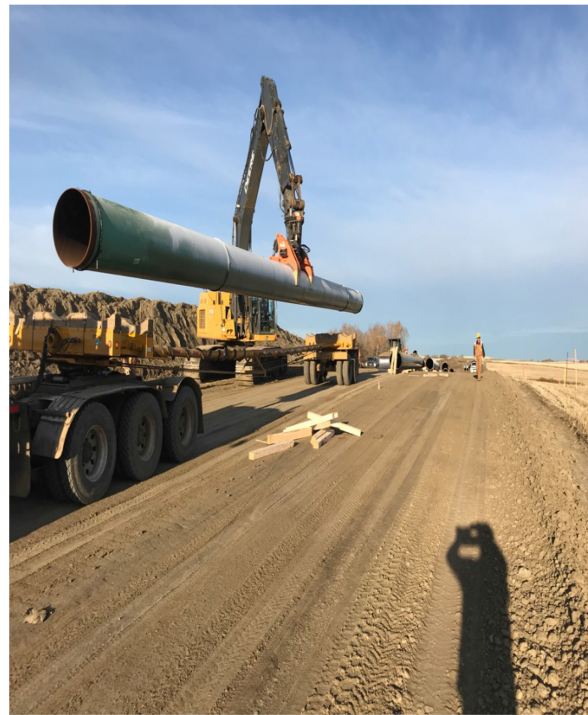
4. Stringing crew – Location 84km+800 – Oct 16, 2017

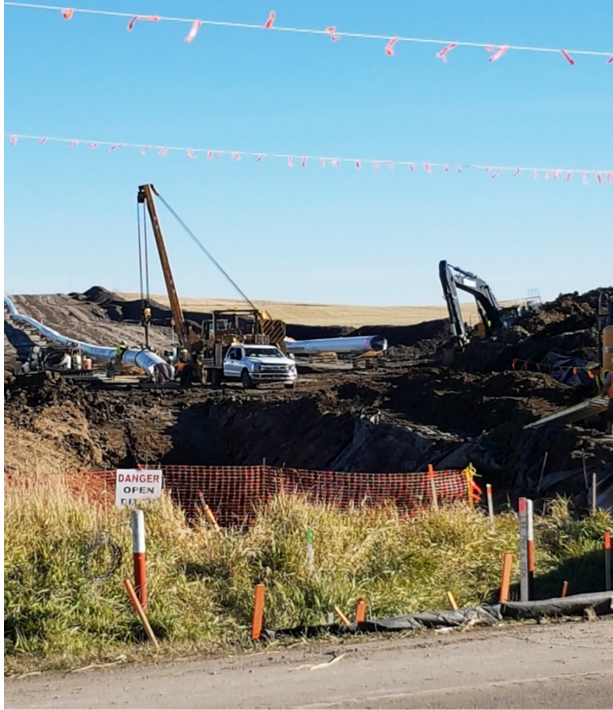
5. Boring – Location 36km+100 – Oct 16, 2017

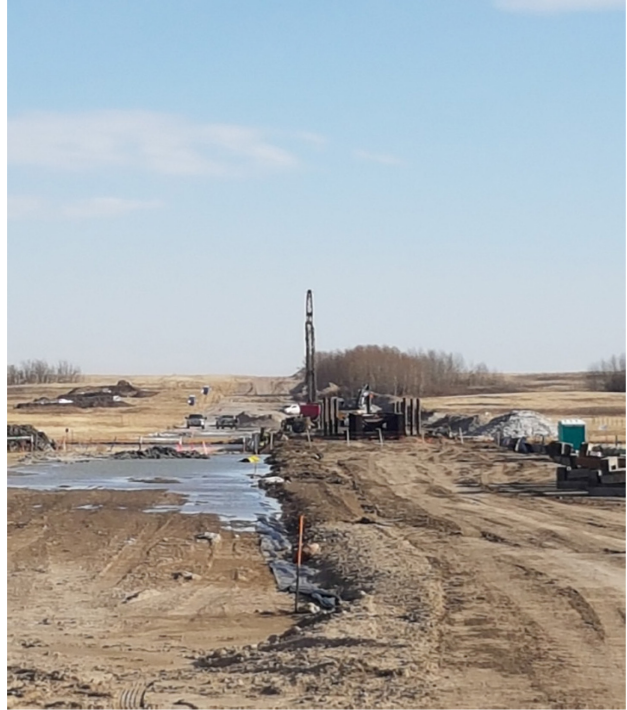
6. Driven Piles – Location 97km+200 – Oct 17, 2017

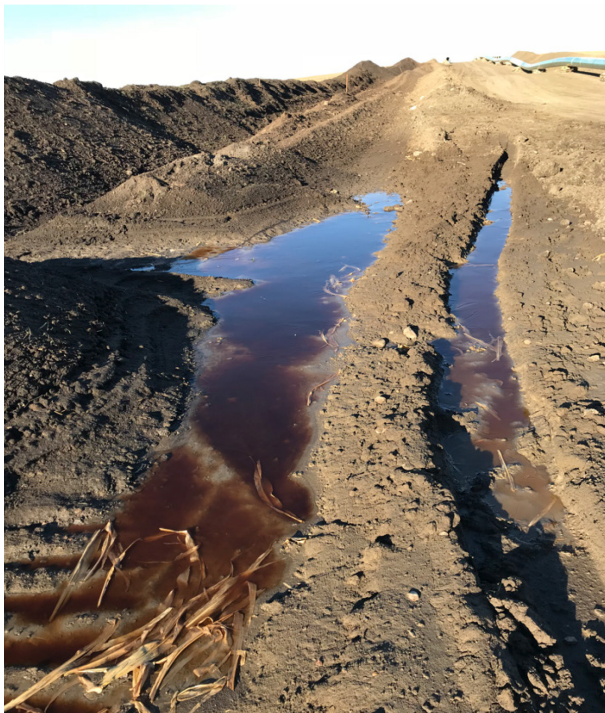
7. Takifier – Location 32Km+150 – Oct 18, 2017

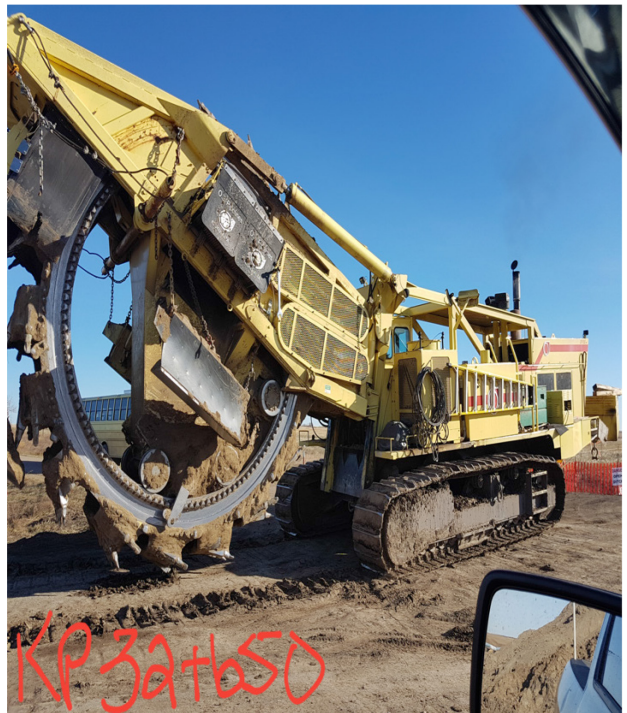
8. Ditcher Located 32km+650 – Oct 18, 2017

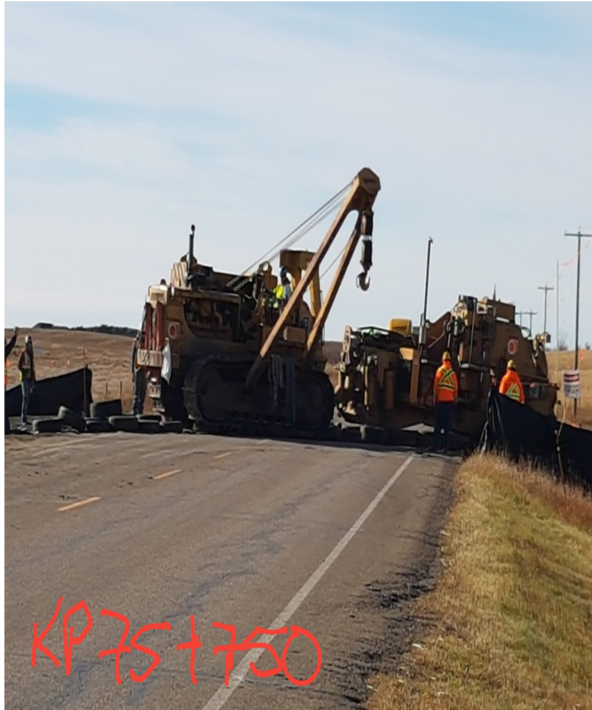
9. Bending Machinery/ Highway crossing – Location – 75km+750 - Oct 18, 2017

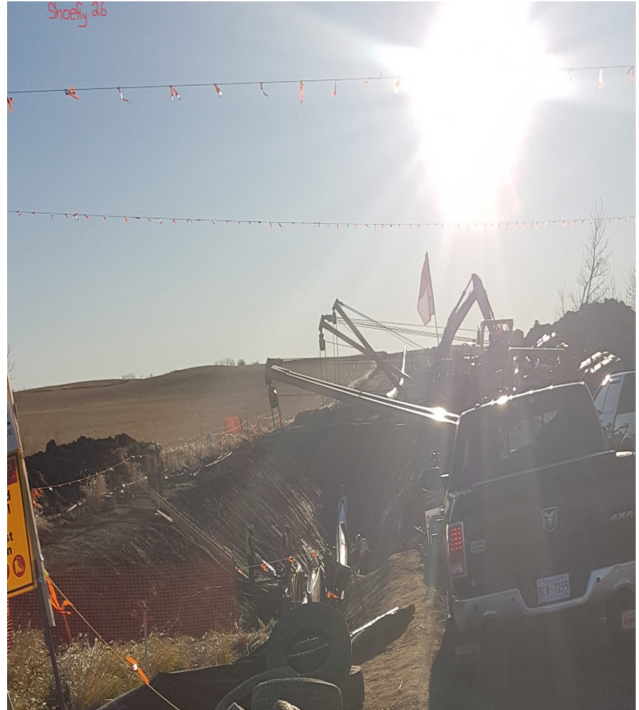
10. Laying pipe – Location Shoofly 26 – Oct 18, 2017

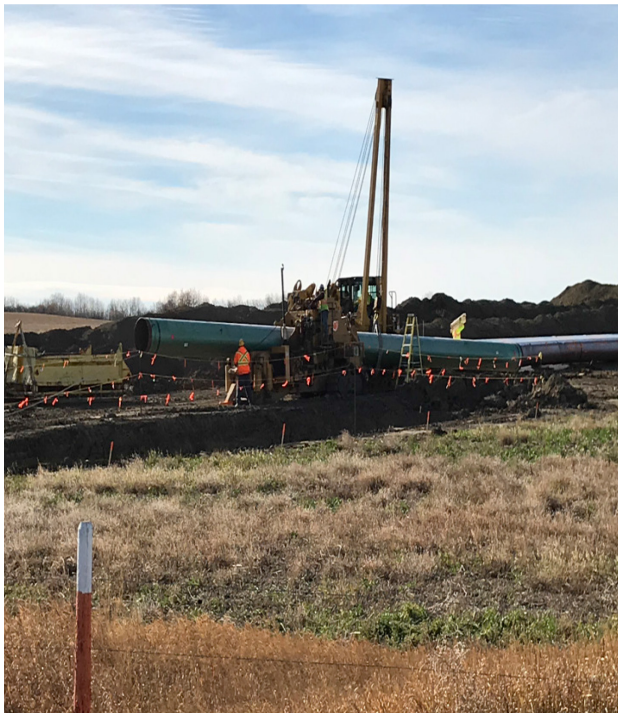
11. Bending Crew – Location – 75km+975 – Oct 18, 2017

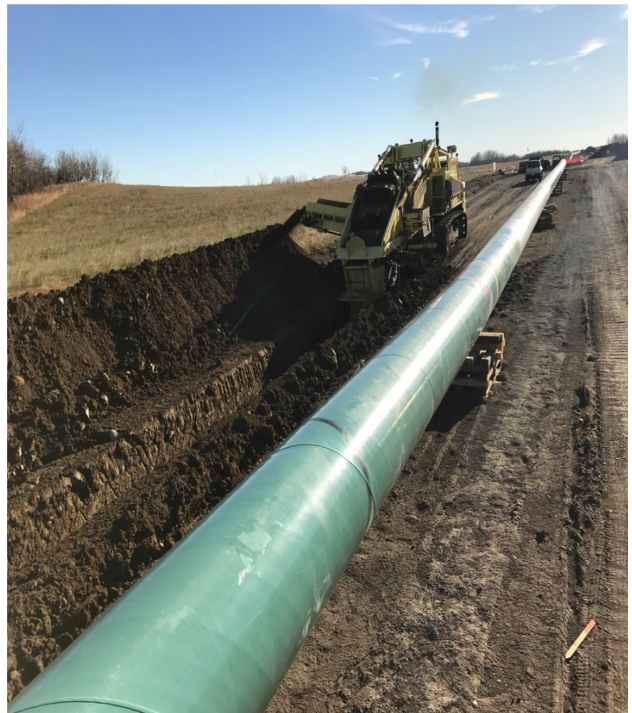
12. Ditcher – Location – 32km+450 – Oct 18, 2017

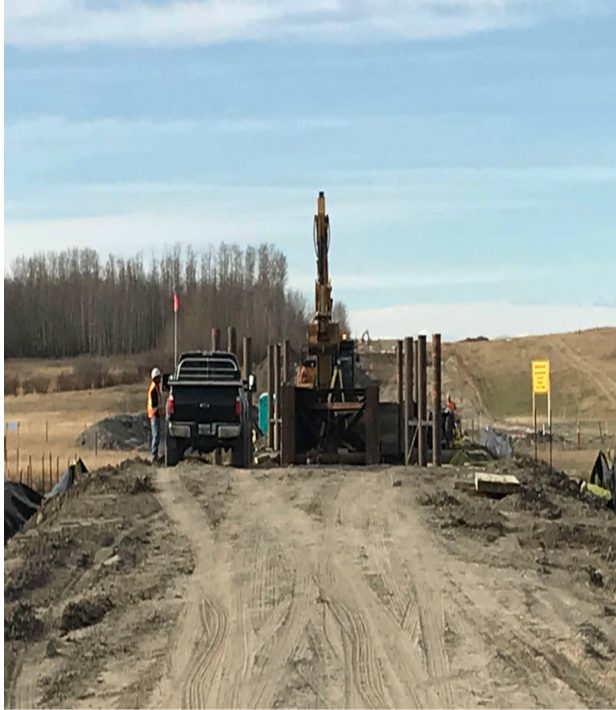
13. Bridge installation – Location 97+600 – Oct 19, 2017

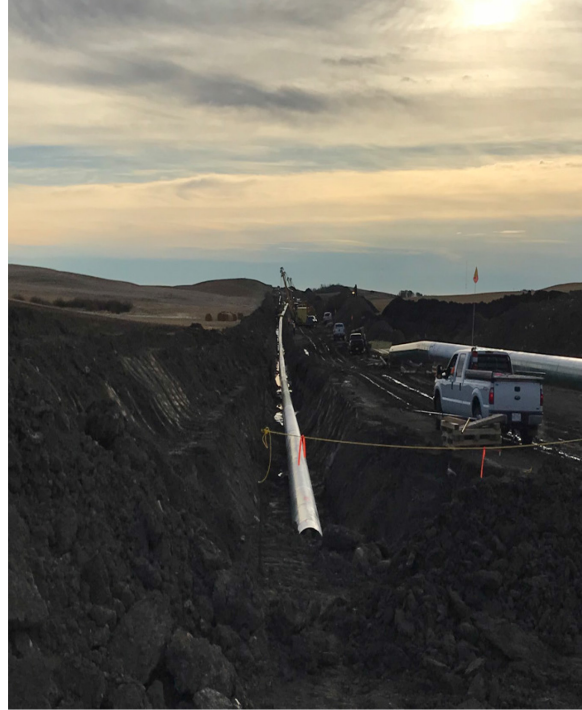
14. Laying in pipe – Location 29km+50 – Oct 19, 2017

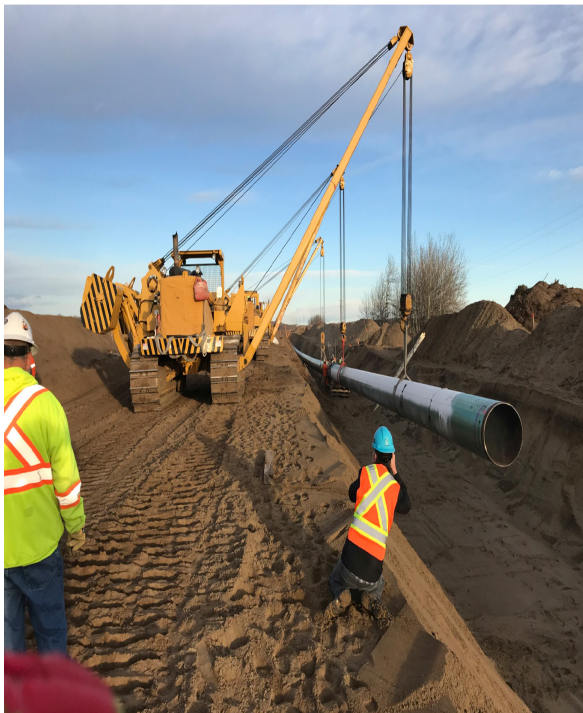
15. Welding in ditch – Location – 21km+600 – Oct 19, 2017
