**SAMSON CREE NATION – MATRIX SOLUTIONS INC.  
PARTNERSHIP**

**ABORIGINAL CONSTRUCTION MONITORING**

**WEEKLY REPORT**

**OCTOBER 23<sup>RD</sup> TO OCTOBER 29<sup>TH</sup>**

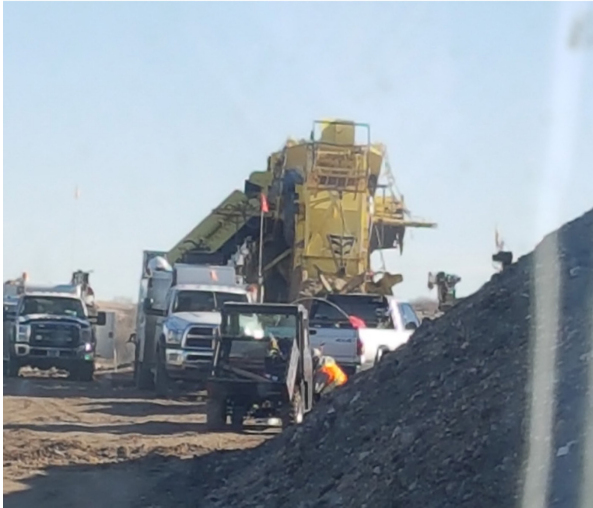
This week's activities began with a visit to km60+800. Arrived at 64+600 (shoofly 40) to observe ROW maintenance. Coating is complete at shoofly 31, and is ongoing at km59+200. Drove to km41+649 (shoofly 41) to track bore. Maintenance of the ditcher was taking place at km39+980 (shoofly 28) and at km38 (shoofly 28), pipe is going into the ground.

1. Ditcher Maintenance - 39+980km - Oct 23, 2017

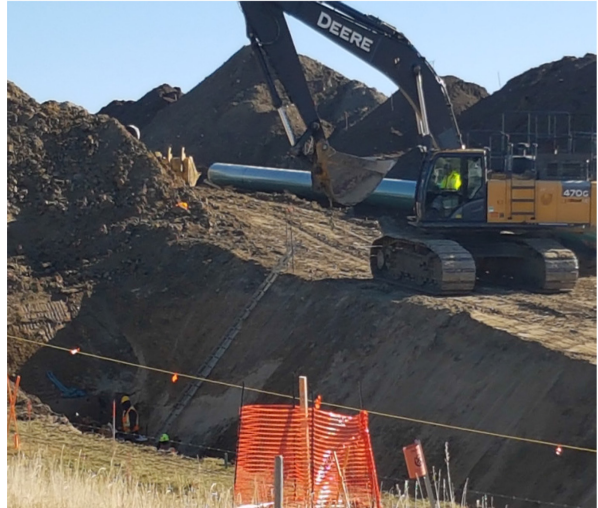
2. Bore tracking activity - 41km+649 - Oct 23, 2017

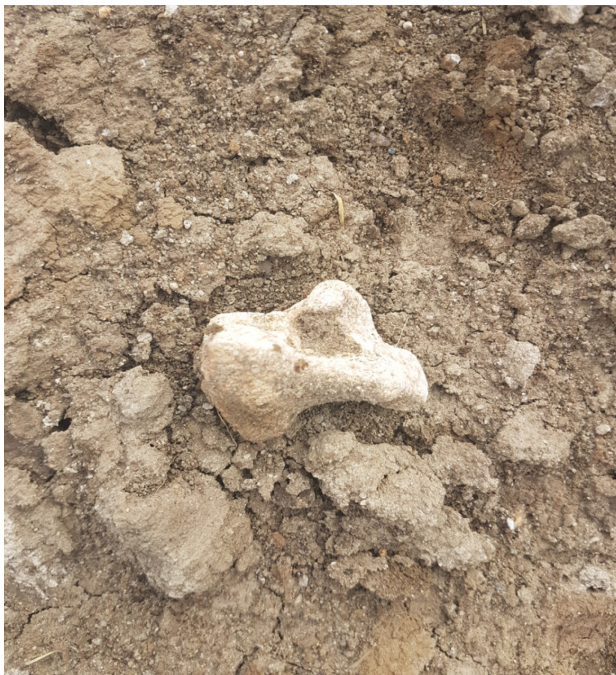
On October 24, while searching topsoil, a bone was found at location km116+500, a picture was taken and it has been reported. The following day, the crew checked out the newly installed bridge at km97+650. Viewed coating crew at location 66km+400. Conditions on ROW are very muddy due to rain, and reported at shoofly 42.

3. Bone - Km116+ 500 - Oct 24, 2017

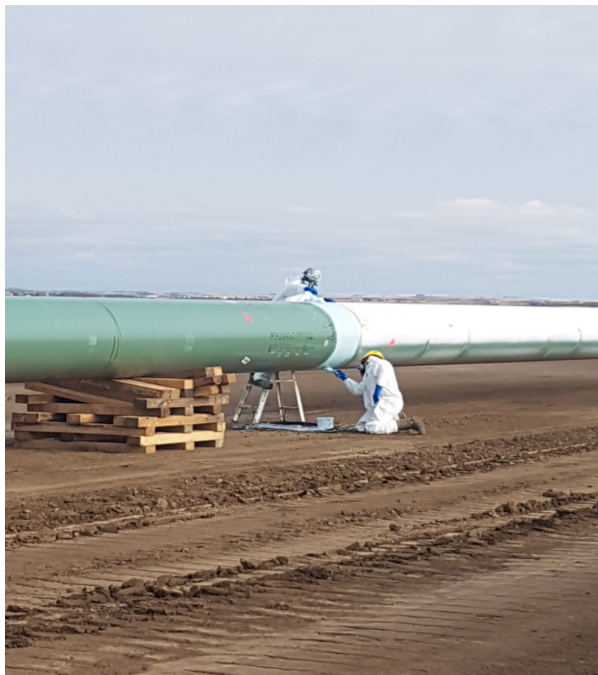
4. Coating - 70km+700 - Oct 26, 2017

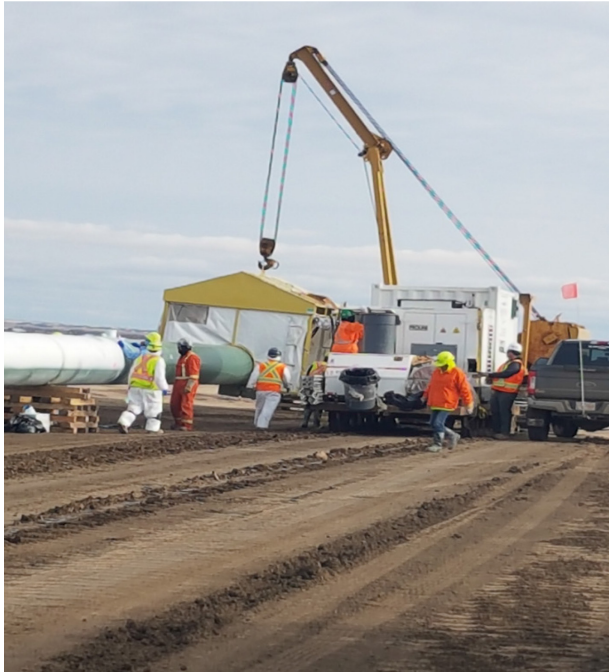
5. Coating Crew – Km70+700 – Oct 26, 2017

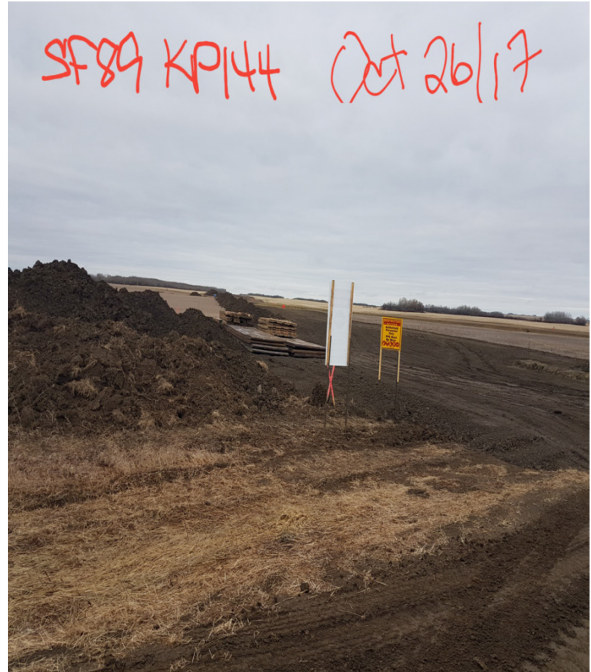
6. Area Stripped at Km 144 shoofly 89 – Oct 26, 2017

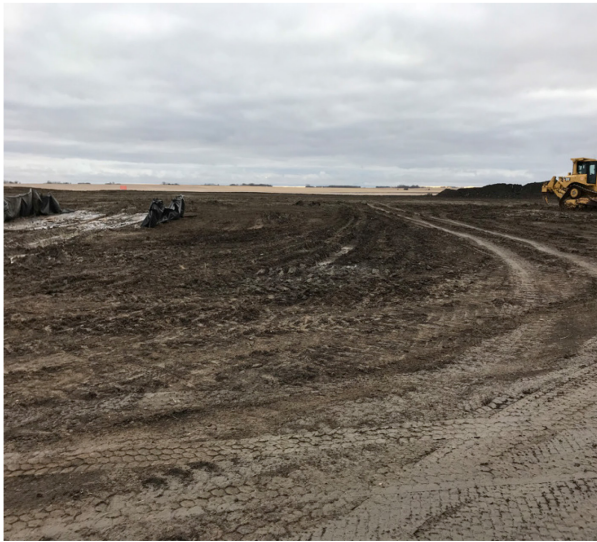
7. End of Spread 1 – Km 144+150 – Oct 26, 2017

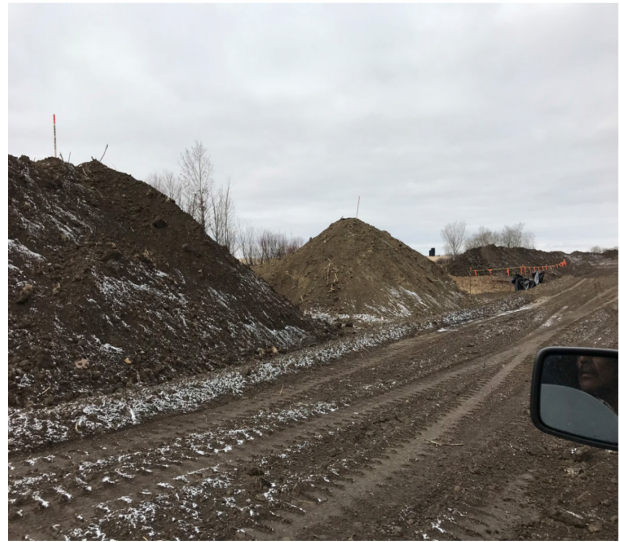
8. Dirt Piles on ROW – Oct 26, 2017

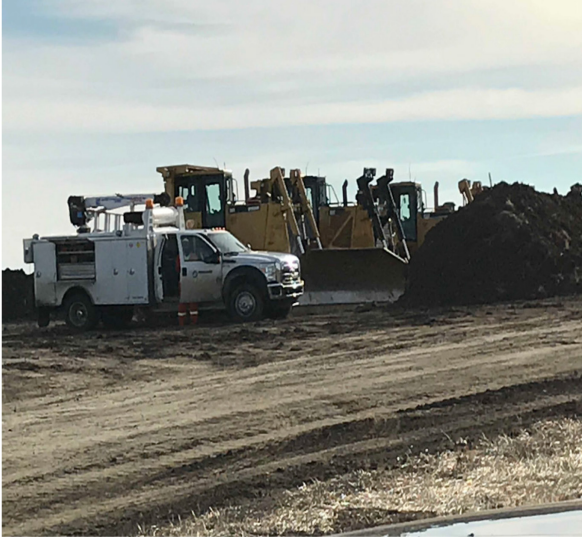
9. Stripping Crew Prep – Km144+200 – Oct 27, 2017

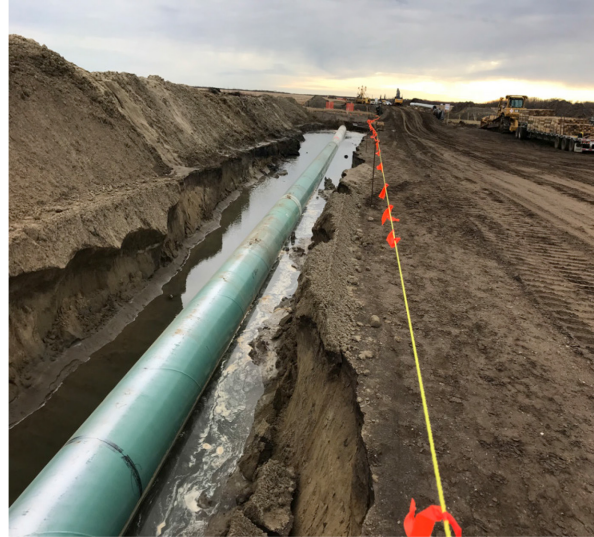
On October 28, the crew viewed the aqua dam and bell hole at shoofly 31, It appears that it is full of water. At 44+200, the ditch is flooded and the pipe is visible. The monitors then went to kick-off at shoofly 2, to take pictures after the pipelines have been completed. The area is cleaned up, the ground is graded and the pipe is in the ground.

10. Flooded ditch with pipe – Km 44+200 – Oct 28,2017

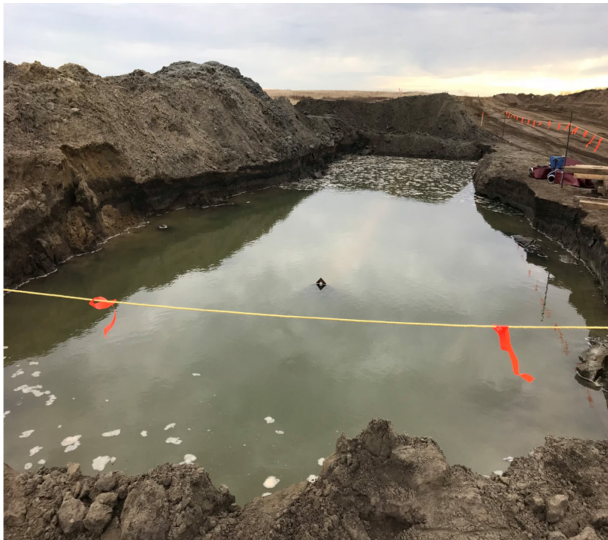
11. Flooded bell hole – km 43+650 – Oct 28, 2017

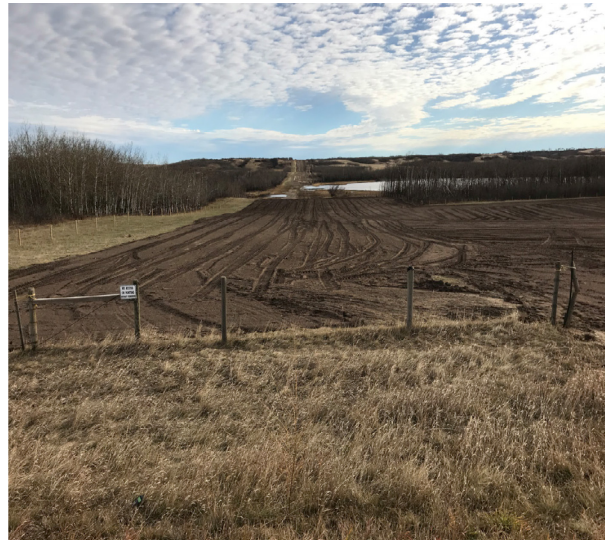
12. ROW East at kickoff – Km 0+800 – Oct 28, 2017
