**MANITOBA METIS FEDERATION – MATRIX
SOLUTIONS INC. PARTNERSHIP**

INDIGENOUS CONSTRUCTION MONITORING

WEEKLY REPORT

AUGUST 20TH TO AUGUST 25TH

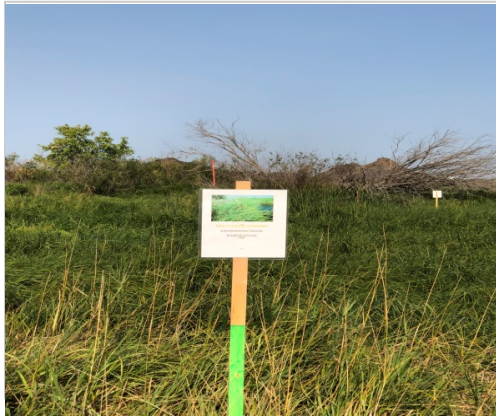
Rare Ecological Community
Scolochla festucacea community
Sprangletop community
S3S4, SF 23

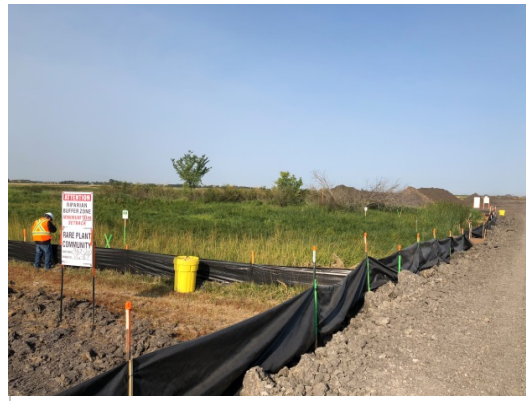
Rare plant community, SF 23

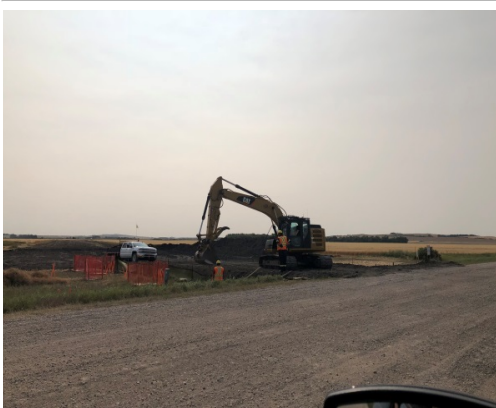
SF 25, east side, excavator tapping wooden
post into the ground with its bucket

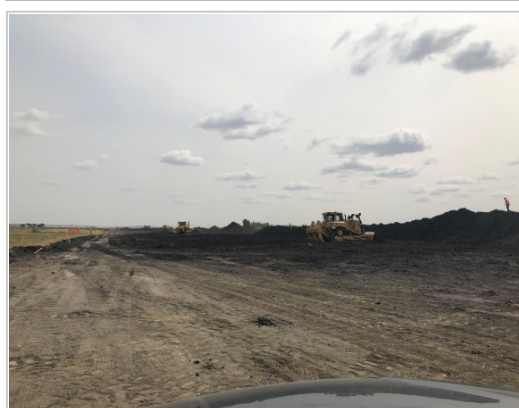
SF 23, east side, dozers pushing dirt

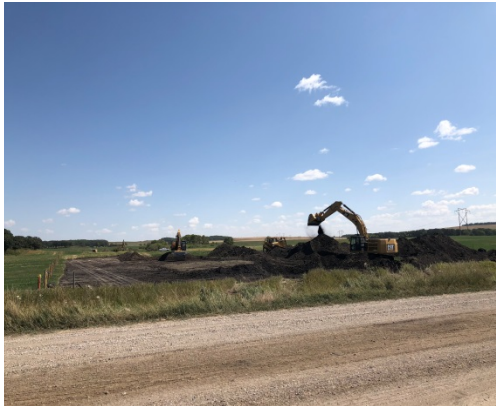
SF 30, east side, soil being stripped

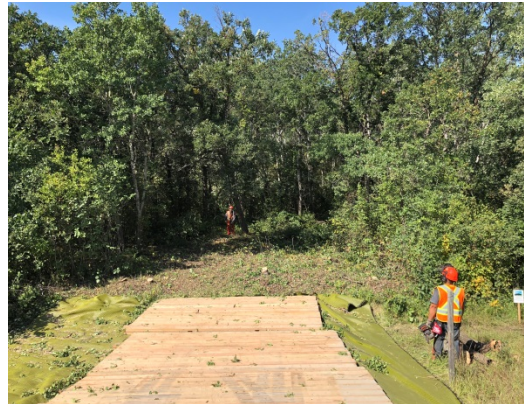
SF 31, west side, crews cutting bush

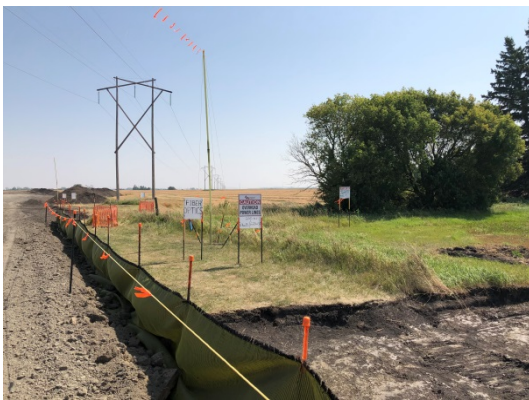
SF 21, wetland habitat SSKP 939+410, ID
147,
class I+II.

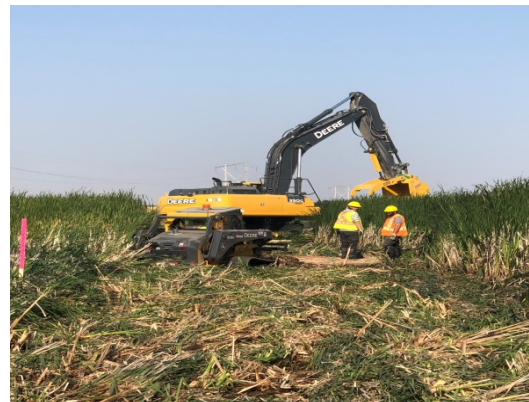
SF 30, west side, skid steer stuck in the
cat tails.

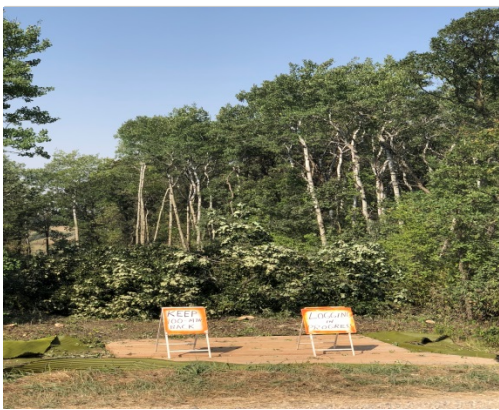
SF 31, west side, warnings signs set up due to logging that is in process.

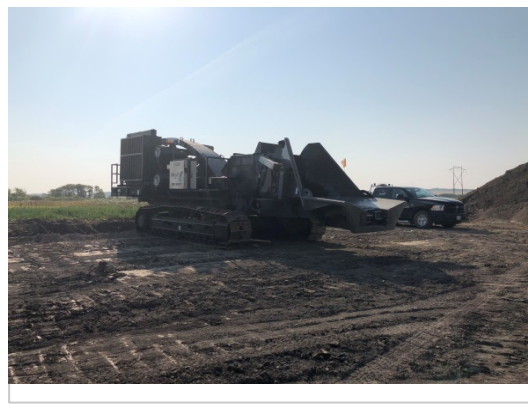
SF 30, east side, wood chipper.

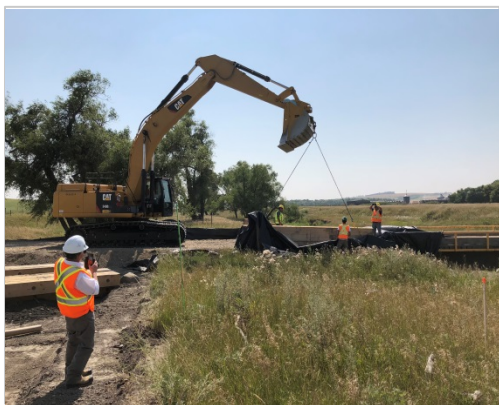
SF 28, west side, bridge being prepped for crossing.

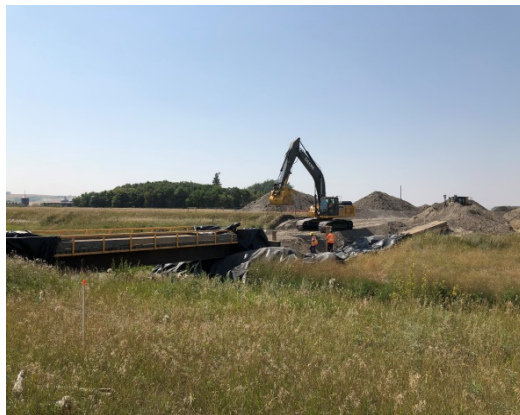
SF 28, west side, excavator working on bridge from the other side.

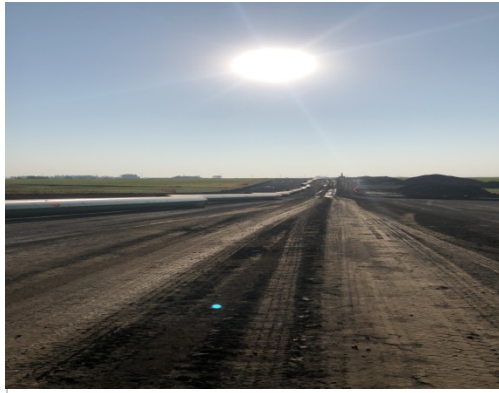
SF 1, (Kickoff), pipe is starting to get strung out on to wooden skids, photo facing east.

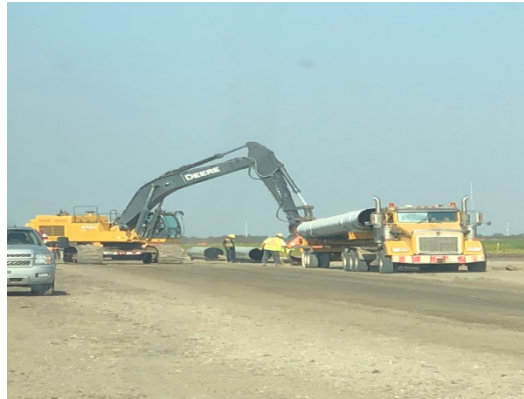
SF 1, excavator unloading pipe, photo facing west.

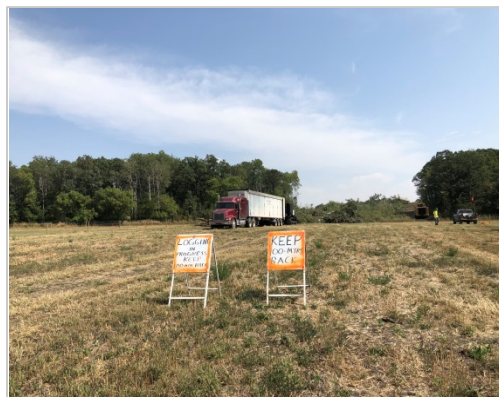
SF 31, photo facing west, trees going into chipper, which then are getting shot into the semi trailer.

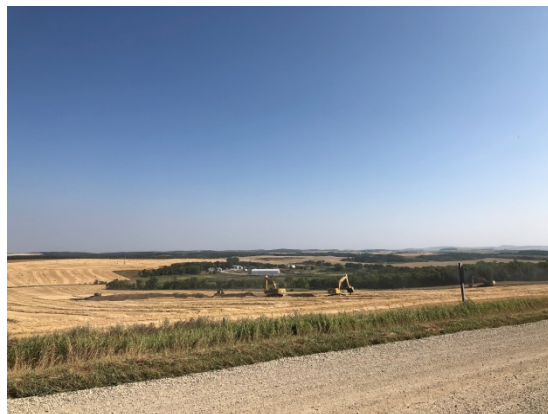
SF 32, photo facing north, excavators at work on the ROW.

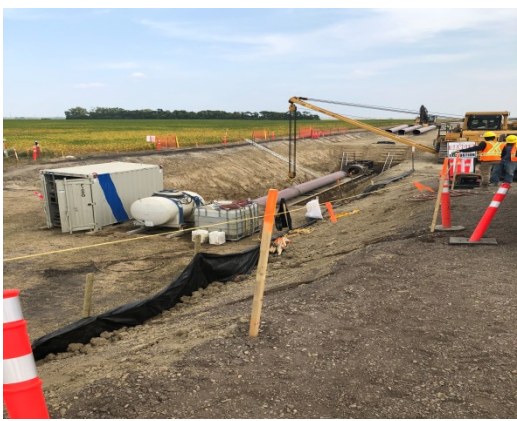
SF 2, photo facing east, not sure what to call this but it seemed pretty interesting.

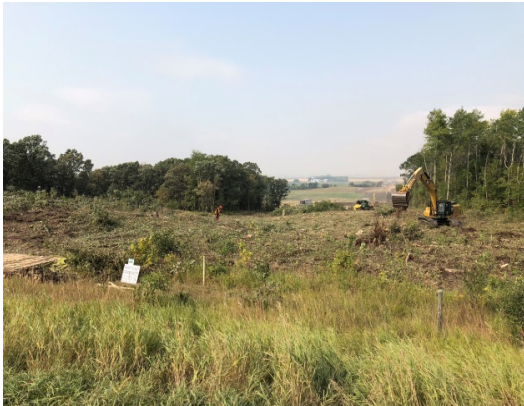
SF 31, mechanical logging. Photo facing west.

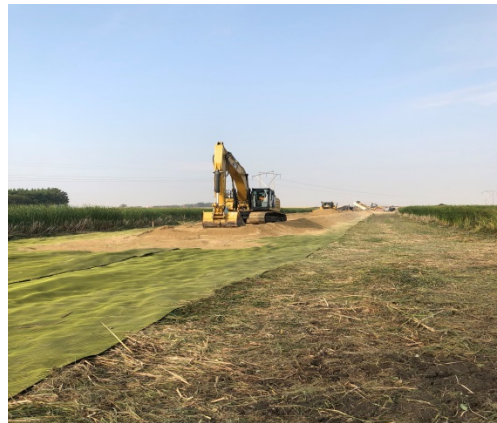
SF 30, access being built across cat tails. Photo facing west.

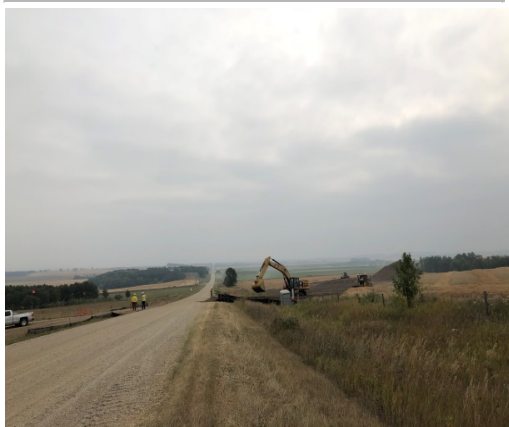
SF 32, excavator and dozer working on approach, photo facing east.

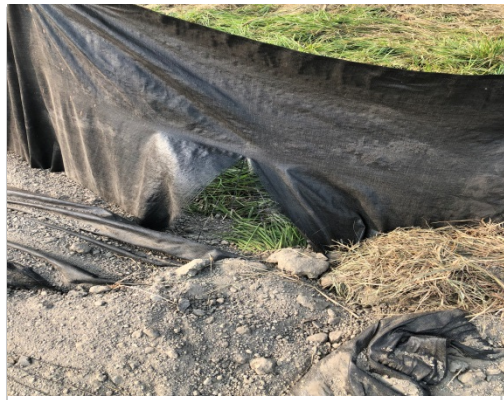
SF 22, wetland habitat, SSKP 941.49-941.94, ID MB-152, class IV, silt fence is ripped a bit causing dirt to go where it should not be going.

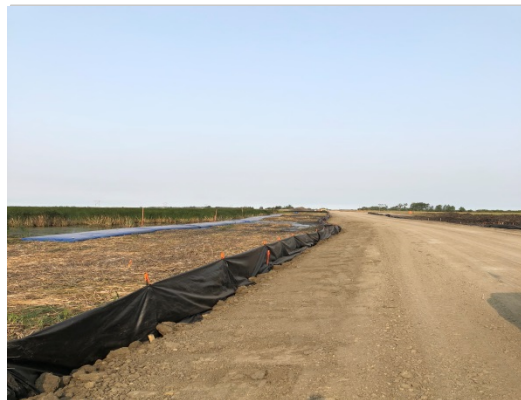
SF 22, wetland habitat, SSKP 941.49-941.94, ID MB-152. class IV, photo facing west.

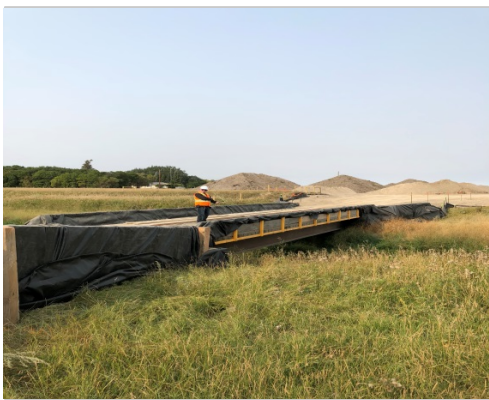
SF 28, west side, cypress river crossing, bridge completed. Photo facing west.

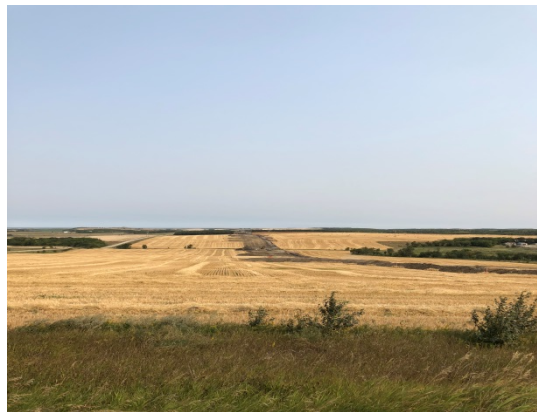
SF 32, picture of the ROW in the field, photo facing north.

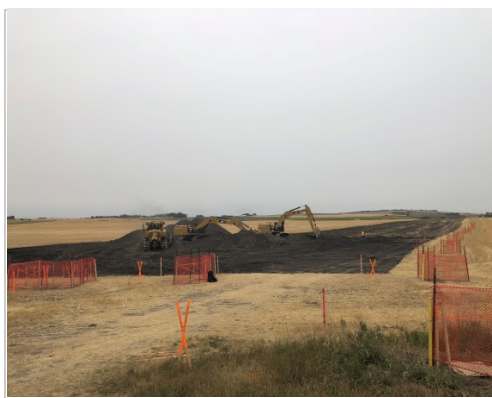
SF 34, two excavator's and one dozer working together to pile soil on the side of the ROW, photo facing west.

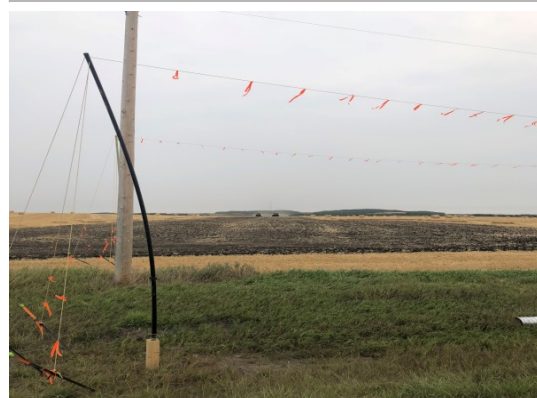
SF 34, two tractors disk the ROW, photo facing east.
