**SWAN LAKE FIRST NATION – MATRIX SOLUTIONS  
INC. PARTNERSHIP**

**INDIGENOUS CONSTRUCTION MONITORING**

**WEEKLY REPORT**

**AUGUST 7<sup>TH</sup> TO AUGUST 11<sup>TH</sup>**

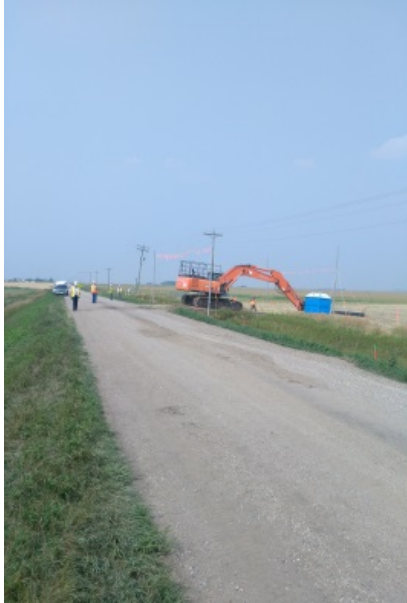
Access to ROW at road 59 Black Creek
