**SWAN LAKE FIRST NATION – MATRIX SOLUTIONS
INC. PARTNERSHIP**

INDIGENOUS CONSTRUCTION MONITORING

WEEKLY REPORT

SPREAD 7

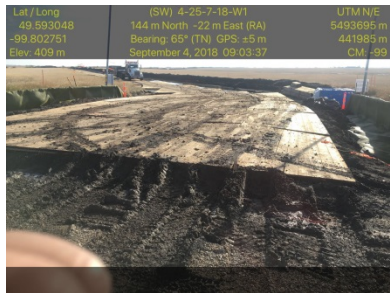
Sept 4/18
 Conditions on ROW muddy from rain
 At location noticed a knocked down sign
 Mats to step to access ROW
 Facing East with low bed truck in background

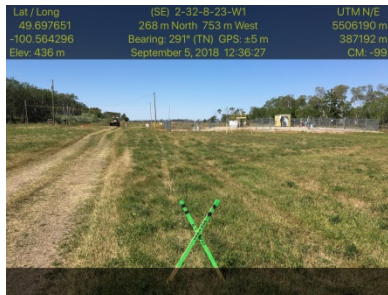
Sept 5/18
SSKP 842+440
Work area of importance
3 heritage sensitive areas
Enbridge valve site
Manitoba hydro powerline all on ROW

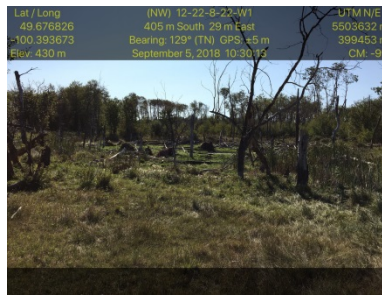
Sept 5/18
SSKP 855+100
Wetland Complex Broad Leaf Treed Swamp

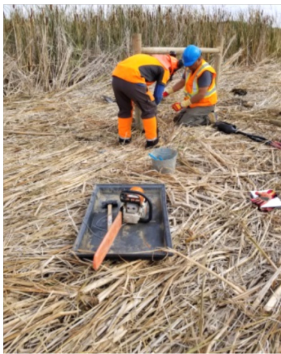
Sept 6/18
821 + 183.3
Photo taken facing east
workers putting up the post for fence

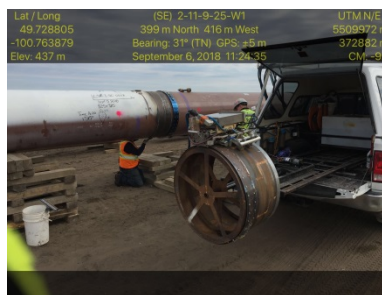
SSKP 825+400 monitored the crew with Rotoscan that detects and measures welding imperfections within the weld and associated heat-affected zone, determining both the circumferential length and the through-thickness dimension. During the transportation or storage of oil and gas, it is essential that pipelines are completely safe. With welding imperfections, it can be harmful for environment and company image if not detected, the work being done by Applus RTD is one of the most important jobs in pipeline. They showed me there monitors after ultra-sonic scan and I learnt what they look for when looking at their results. The weld was good and ready for coating.

Sept 6/18
SSKP 825+400
Applus RTD- Testing with ultrasonic scanner
Facing North

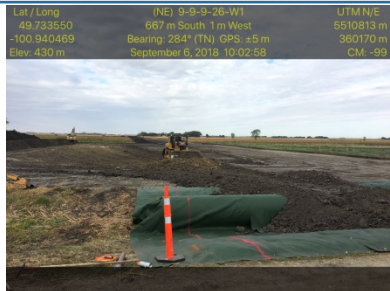
Sept 6/18
SSKP 808+600
Stripping Kick-off to Rd #1
Dozer building road approach
Flume pipe under geo tec, facing west
Flume pipe used to let water through

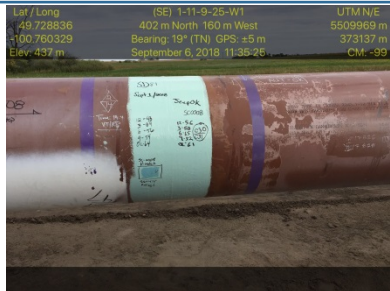
SSKP 826+426 Monitored another important role in pipeline the coating crew. They sandblast the weld after Applus RTD gives it the okay. They use an induction heat coil to get the weld to the right temperature. They clean the weld with a brush after and apply coating. It's not an easy process as they require the right temperature, proper mixture and correct application of millimetres of thickness around weld. It is then cured and inspected for quality assurance after 10-15 minutes of application. They also jeep the coating with a metal coil that is connected to a holiday detector which indicates if there's holes in the coating and sometimes there is which is usually on the weld as it sticks out more on the pipe and coating runs off of it. They repair it and jeep it again to 100% make sure there is no holes, it is then okay. I also noticed they are doing a good job cleaning the coating off the ground as it is toxic.

Sept 6/18
SSKP 826+475 – Facing north
Coated weld after inspection
Numbers indicate thickness
Also did a V-cut to check integrity

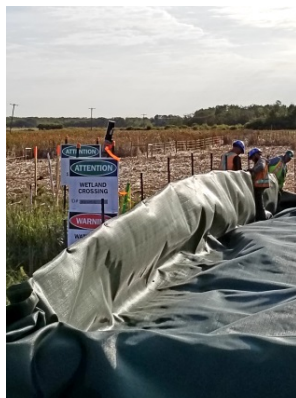
Sept 7/18
KP- 821+183.3
Photo facing east
Workers laying geo tech
Wetland Complex

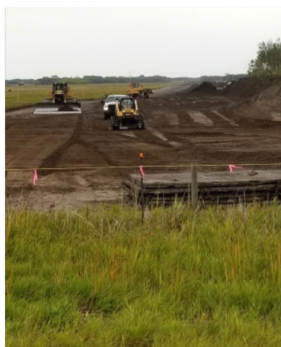
Sept 8/18
KP-830+923
D8-dozer stripping soil
Bob-cat moving mats

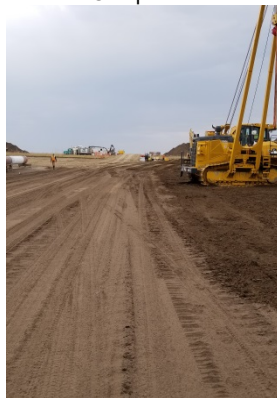
Sept 8/18
KP-826+650.0
Photo taken facing North.
Ream and pull the enbridge corridor bore. South fo SF #21

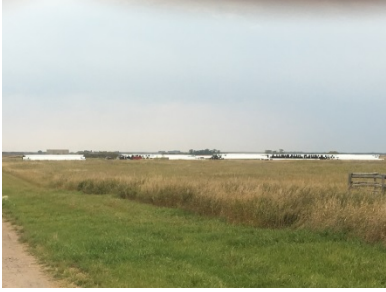
SEPT 8/18
Souris Stockpile Yard
Photo facing North west
White paint on pipe protects coating from sun
