**SWAN LAKE FIRST NATION – MATRIX SOLUTIONS
INC. PARTNERSHIP**

INDIGENOUS CONSTRUCTION MONITORING

WEEKLY REPORT

AUGUST 20TH TO AUGUST 25TH

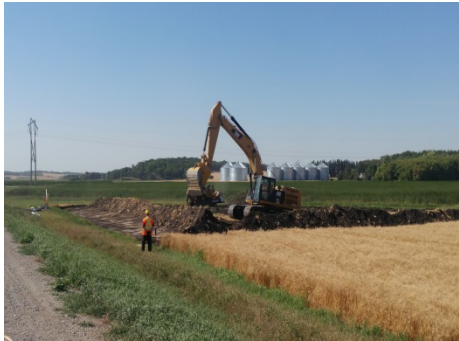
Aug 21/18
Photo facing South West
SF 30 access
Top soil stripping & Grader grading ROW

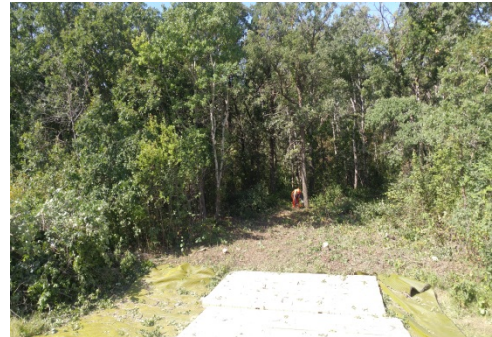
Aug 21/18 SF 31 (KP 961+025)
Photo facing West
Chainsaw operator falling tree

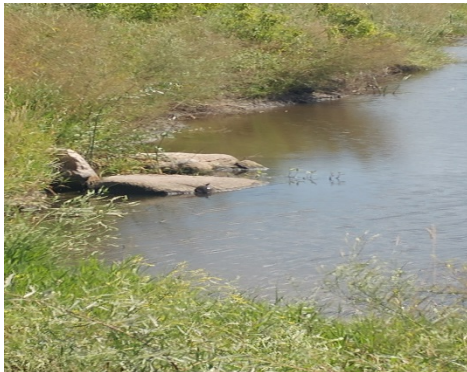
Aug 21/18
Photo facing South East
Cypress river East of SF 35
Turtle sunbathing on a rock. Two other turtles swimming in the same water body.
