**SWAN LAKE FIRST NATION – MATRIX SOLUTIONS
INC. PARTNERSHIP**

INDIGENOUS CONSTRUCTION MONITORING

WEEKLY REPORT

SPREAD 9

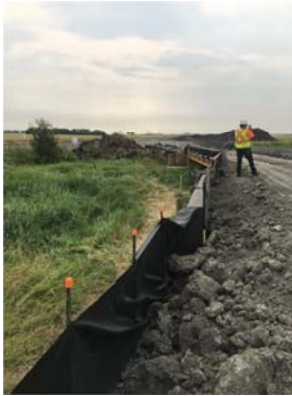
Aug 13/18
Water Course Bridge KP 1000+98
WC #MB-WC58
North side of bridge

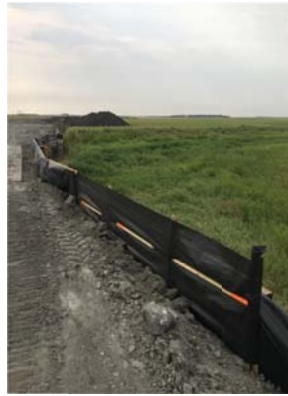
Aug 13/18
Water Course Bridge KP 1000+98
WC #MB-WC58
South side of bridge

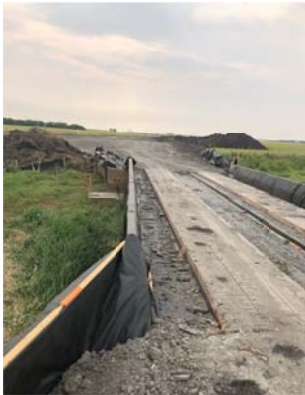
Aug 13/18
Mary Jane Creek temporary man made crossing
SSKP 1000.98

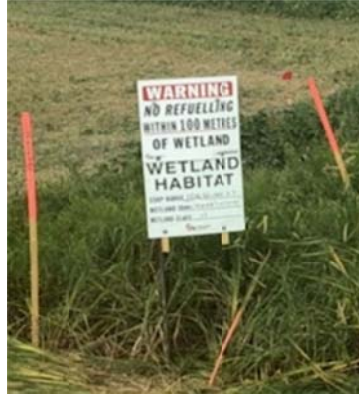
Aug 13/18
Signage of location and directions of
safety procedures SSKP Range 1016.56-1016.57

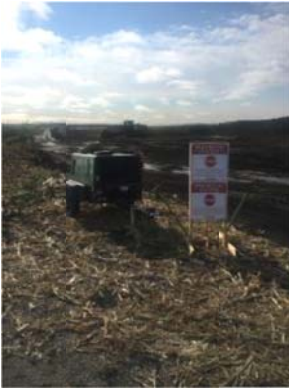
Aug 14/18
Compressor used for cleaning station
Rd #9

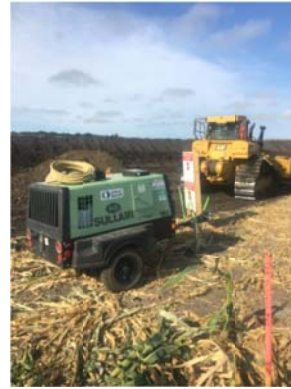
Aug 14/18
Dozer in background grading area for
station, compressor will be moved to
south boundary opposite from proposed
ditch

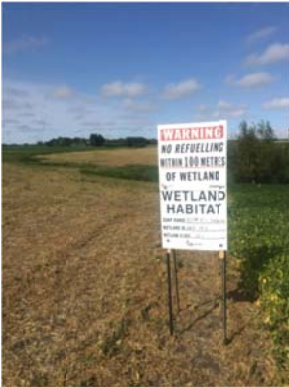
Aug 14/18
Wetland Habitat

Wetland ID MB-192
Road # 13

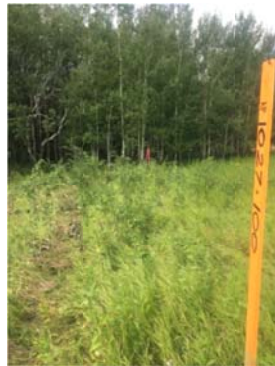
Aug 14/18
North boundary stake (pink) trees to left
will be cleared for RoW access

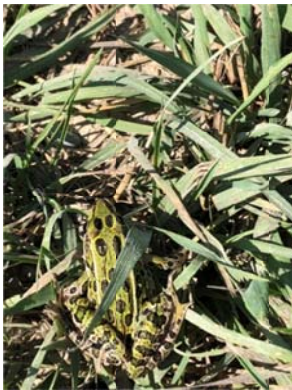
Aug 15/18
 Large Leopard frog

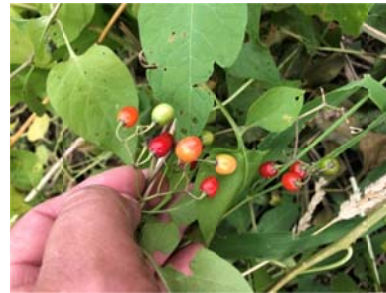
Aug 16/18
 pinch cherry's SSKP 1016

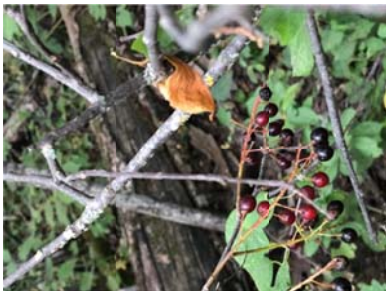
Aug 16/18
 Choke Cherry's SSKP 1016

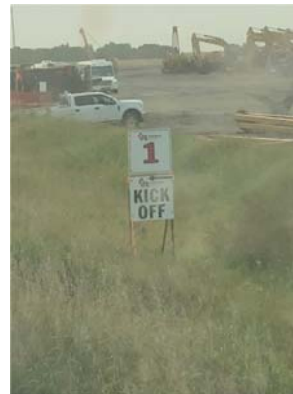
Aug 18/18
congested area at kick off facing East

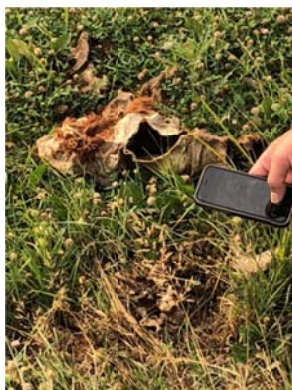
Aug 18/18
dead calf hide and bones
SSkp1035.13 looking down into gully
